**AVIATION INVESTIGATION REPORT
A04H0004**

**REDUCED POWER AT TAKE-OFF AND COLLISION WITH
TERRAIN**

**MK AIRLINES LIMITED
BOEING 747-244SF 9G-MKJ
HALIFAX INTERNATIONAL AIRPORT, NOVA SCOTIA
14 OCTOBER 2004**

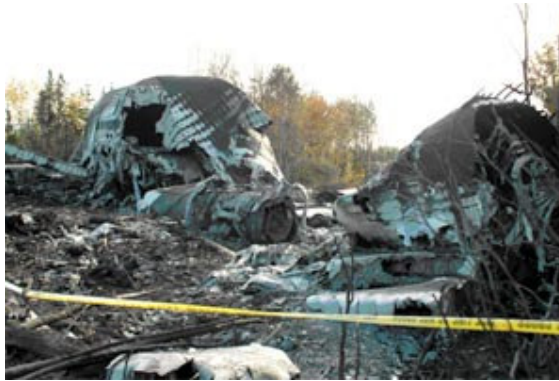
The first damage to the aircraft occurred when, on rotation, the aircraft's lower aft fuselage struck the runway twice and remained on the ground to a point 825 feet beyond the end of Runway 24. Severe damage occurred when the aircraft's lower aft fuselage struck the berm and the vertical stabilizer and both horizontal stabilizers separated from the fuselage. The final impact was in a wooded area where impact forces and an extensive post-crash fire destroyed the remaining aircraft structure forward of the aft pressure bulkhead ([see Photo 1](#)).

Photo 1. Main fuselage and number 4 engine

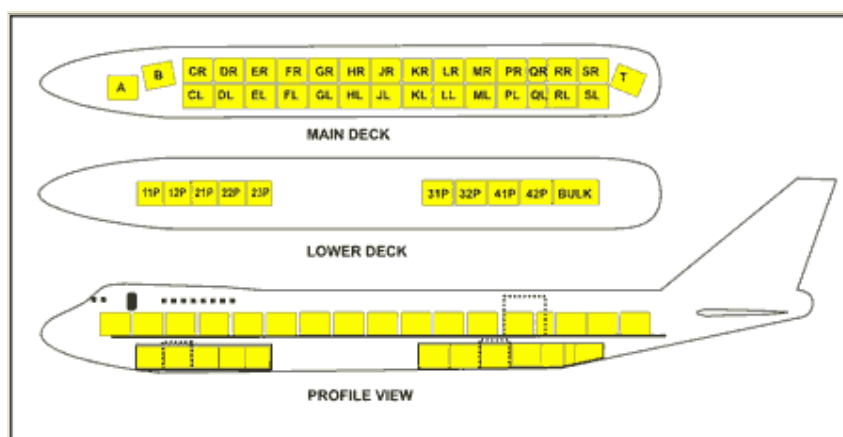
Figure 1. Cargo positions

The occurrence aircraft had a number of cargo floor power drive units (PDUs) removed from the aircraft and blanked off because they were unserviceable. As part of the cargo load, a large roll of steel was placed on a 20-foot-long pallet for a total weight of 13 206 kg. When the steel was being loaded onto the aircraft, it could only be moved by the cargo loading system as far as the functioning PDUs would permit. Normally, pallets can be manhandled into position if the PDUs are unserviceable, but, because of the weight of this pallet, it could only be loaded into positions LR and MR ([see Figure 1](#)).

The weight limits for positions LR and MR are 4264 kg respectively, for a total weight limit of 8528 kg. The weight of the steel and the pallet exceeded the limits by 4678 kg. The

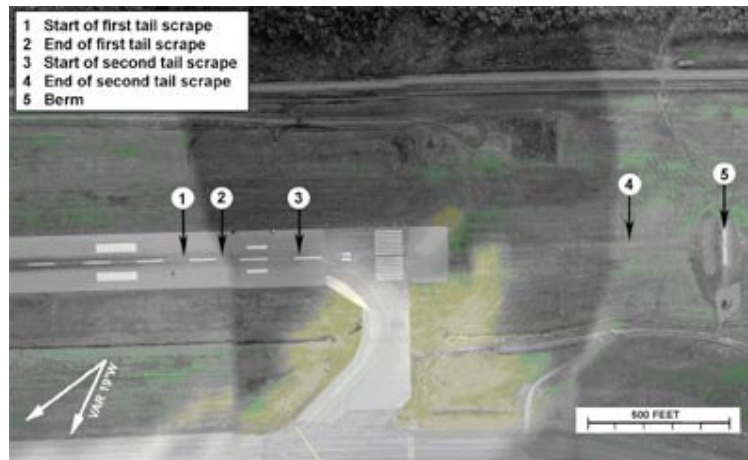
Photo 2. Location of scrape marks and berm

The first indication of aircraft contact with the runway was a scrape mark, which began 830 feet before the end of Runway 24 and was 30 inches left of the runway centreline; it became progressively wider, ending 705 feet from the end of the runway. The scrape mark formed a line approximately one-half degree off the centreline toward the left ([see Photo 2](#)).

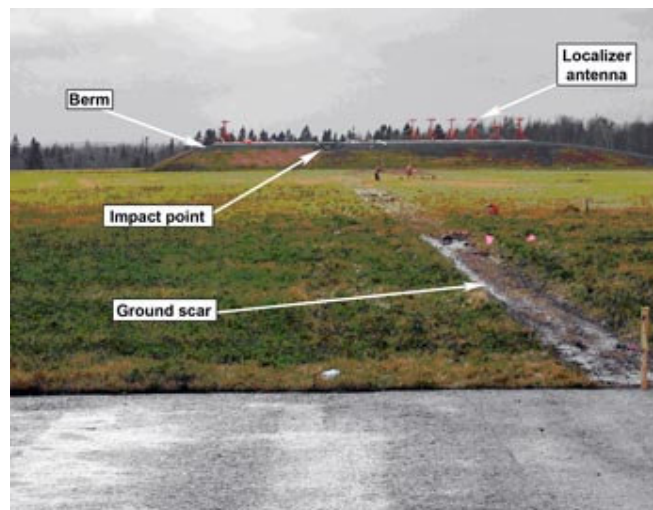
A second scrape mark began 412 feet from the end of the runway and was initially about 3 inches wide, expanding to about 24 inches wide at the runway threshold. There were aluminum scrapes and shavings all along this scrape mark. It continued through the paved runway overrun area and across the grassy area. On the grassy area, the ground scar was initially about 24 inches wide and 2 inches deep, eventually fanning out to about 30 inches wide ([see Photo 3](#)). The ground scar became less pronounced until it disappeared at a point approximately 315 feet before the berm, indicating that the aircraft became airborne. The only indication of aircraft contact with the ground was the ground scar caused by the lower aft fuselage. There was no indication that the tires contacted the ground beyond the paved surface. No primary aircraft structure was found in the debris trail before the berm.

Photo 3. View of ground scar and initial impact point with the berm

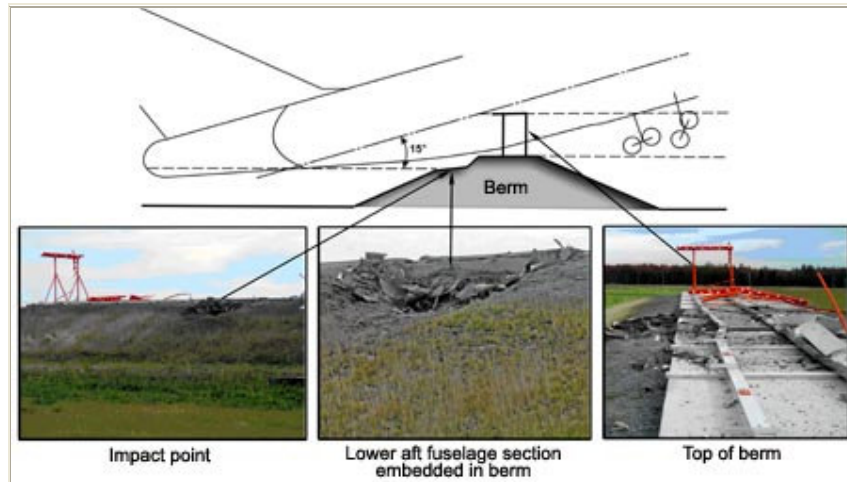
Fuselage structure, comprising the fuselage joint of the aft pressure bulkhead at Station 2360 and some adjacent belly skin, was found embedded in the berm. These pieces were embedded approximately 18 feet to the left of the extended runway centreline, about 30 inches below the top of the concrete pad, and had penetrated about 24 inches into the berm. Black rubber transfer marks, consistent with aircraft tire contact, were on some of the fractured pieces of the ILS antenna, indicating that the tires had struck the antenna ([see Photo 4](#)). No similar marks were observed across the concrete pad on top of the berm, indicating that the tires were above the concrete pad as the aircraft passed over it. The pieces of aircraft belly skin found embedded in the berm were identified as coming from the centreline of the aircraft and included roughly the same amount of structure from each side of the centreline. This is consistent with the aircraft having struck the berm in a roughly wings-level attitude. The aircraft pitch was between 15° and 24° at berm impact. If the aircraft was pitched at less than 15°, the wheels would have struck the top of the berm, and if the aircraft was pitched at greater than 24°, the tires would not have struck the antenna.

Photo 4. Minimum aircraft pitch attitude at point of impact with berm

Although the berms constructed at Halifax met ICAO and TC required obstacle-clearance standards, the aircraft's lower aft fuselage did strike the berm off the end of Runway 24, causing the tail to separate from the aircraft and rendering the aircraft uncontrollable. Also, there are no specific standards or recommended practices regarding the construction and risk assessment of berms or similar immovable objects in the runway overrun/undershoot areas beyond the established runway end safety area.

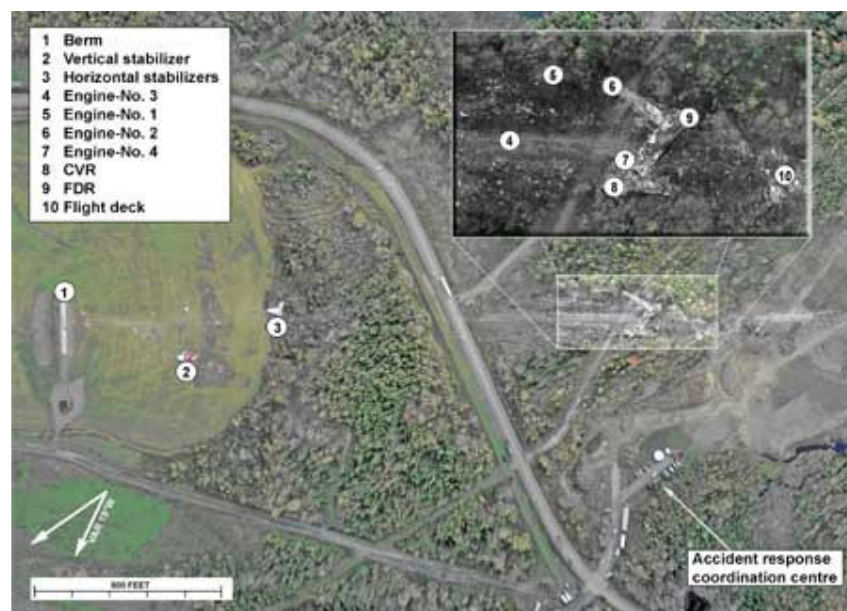
Immediately beyond the berm, there was extensive debris that included the vertical and horizontal stabilizers, a section of aft pressure bulkhead, the tail cone, the auxiliary power unit, and some pieces of aft fuselage belly skin. In the wooded area beyond the berm, there were numerous smaller pieces of aircraft structure and cargo. The debris trail then diminished until the main impact, suggesting that, following the separation of the empennage, the rest of the aircraft remained relatively intact until impact ([see Photo 5](#)).

Photo 5. Accident site and wreckage location

The aircraft struck a wooded area beyond the airport boundary fence in a downward trajectory of approximately 6° to 16°, in a roughly wings-level attitude. It struck nose-first, with sufficient force that the forward fuselage section separated from the remainder of the fuselage, resulting in severe structural break-up and an intense post-crash fire. The debris trail extended approximately 1000 feet into a quarry. There was no indication of pre-impact fire damage.

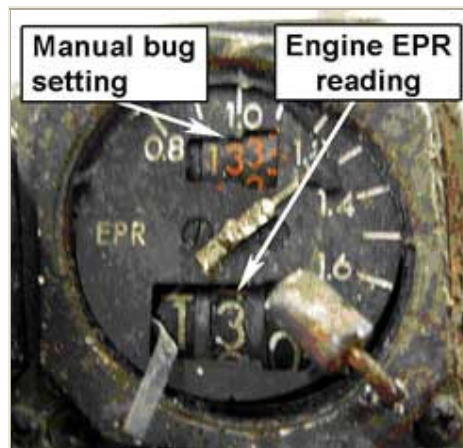
The number 2, number 3 and number 4 EPR gauges were recovered and examined. The number 2 EPR gauge had a manual bug setting of 1.32 and an engine indication reading of 1.01; the number 3 EPR gauge had a manual bug setting of 1.3X (the last digit had broken off at impact) and an engine indication reading of 1.02; and the number 4 EPR gauge (see [Photo 6](#)) had a manual bug setting of 1.33 and an engine indication reading of 1.305. The EPR settings on the three recovered instruments were set to 1.32-1.33. These readings were considered to be reliable, with the slight differences attributed to movement during the impact sequence.

Photo 6. Engine number 4 EPR gauge
