Air Accidents Investigation Branch

Aircraft Accident Report No: 6/2007 (EW/C2005/05/03)

Synopsis

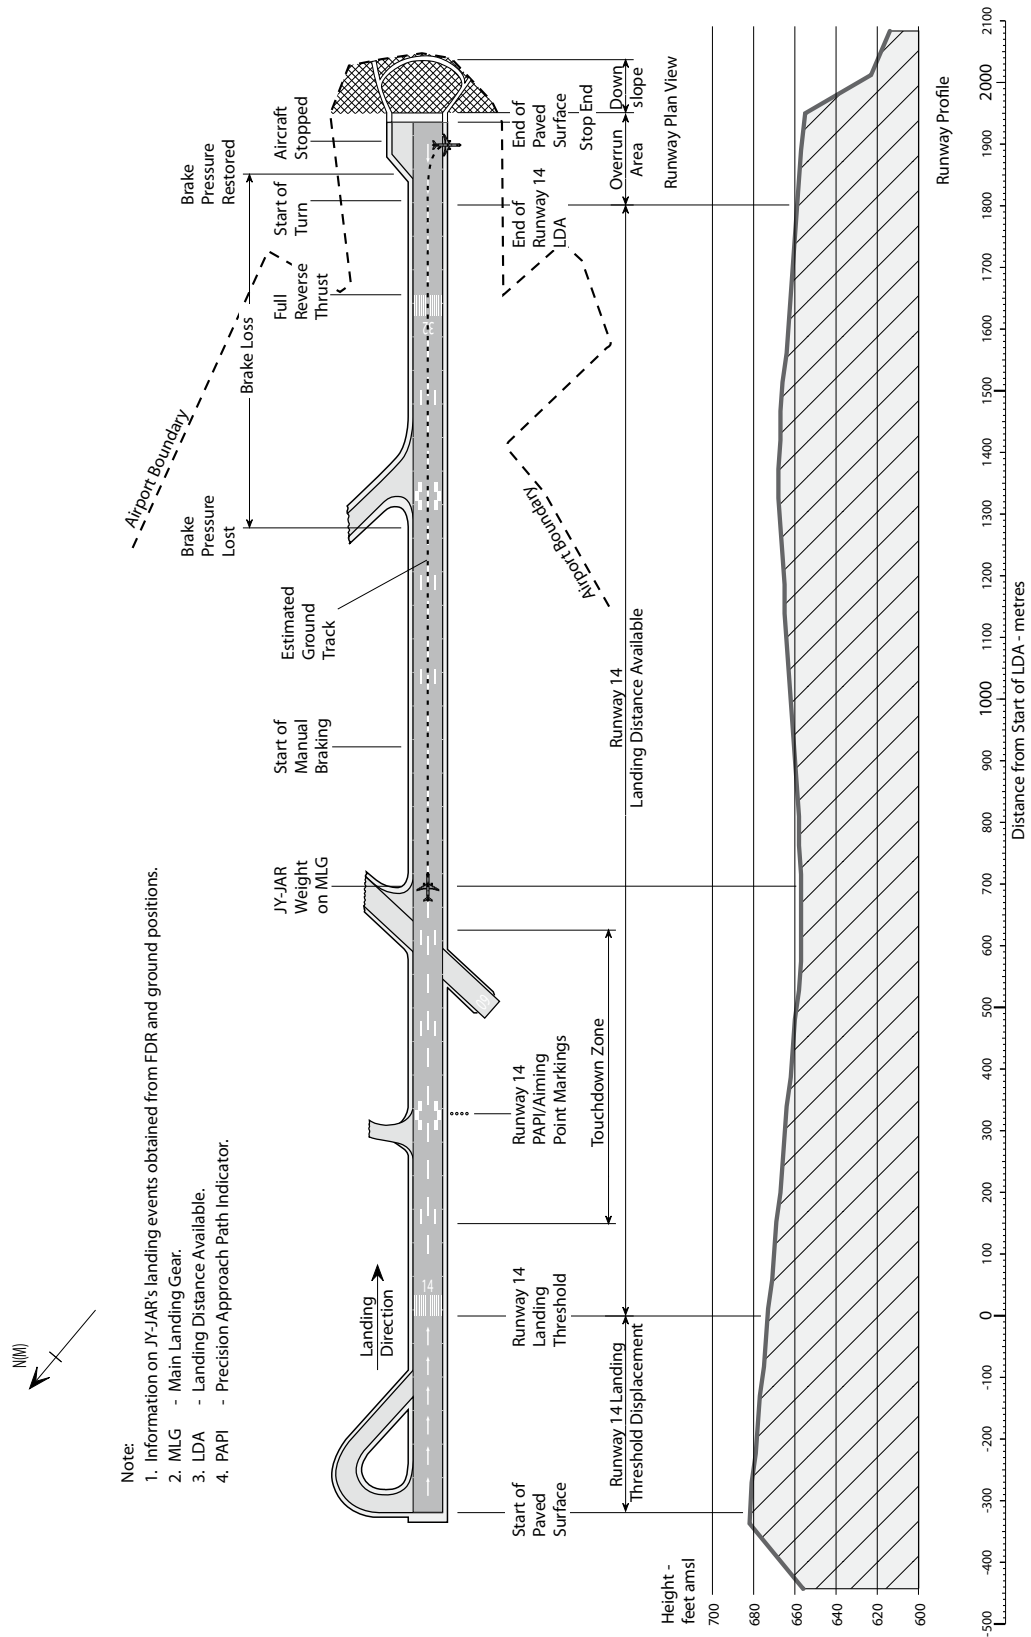
Figure 1
Runway and Aircraft Ground Run

At 1143 hrs the aircraft touched down just beyond the end of the marked Touchdown Zone (TDZ), approximately 700 m beyond the touchdown threshold and 400 m beyond the Aiming Point (Figure 1, page 5). The pilots stated that they observed normal indications of ground spoiler deployment and the selection of idle reverse thrust. The commander commenced manual (pedal) braking shortly after touchdown. A few seconds later, he considered the rate of deceleration was inadequate so he applied increased brake pedal displacement and then maximum reverse thrust. Adequate retardation was not restored. The co-pilot shared the commander's perception and firmly depressed his own brake pedals. Judging that deceleration was still inadequate, the commander ordered the co-pilot to release his brake pedals whilst he continued to apply his own. As the aircraft crested a hump in the runway about 600 m before the end of the paved surface, the commander saw the end of the runway, which hitherto had been hidden from his view, and judged that the aircraft would not stop before the end. At that point he considered selecting the alternate braking system, but knew that this would cause loss of nosewheel steering. Because of the limited runway distance remaining, he considered that the only course of action available to avoid overrunning the end of the paved surface was to turn the aircraft on to a level grassed area beside the right-hand edge of the runway. Using nosewheel

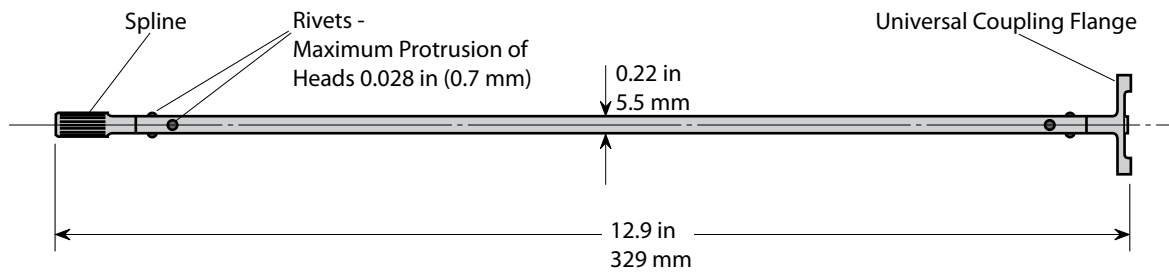
Figure 5
Tachometer Driveshaft

The driveshafts fitted to JY-JAR were of the original type, referred to as the ‘long hollow titanium driveshaft’. This consists of a hollow shaft, 0.22 inches (5.5 mm) in diameter, with a fitting at either end, forming an assembly 12.9 inches (329 mm) long (Figure 5). The outer fitting is formed into a male spline that mates with a female spline in the wheel cap and the inner

fitting carries a cross-piece that forms part of a universal coupling bolted to the tachometer rotor. Each fitting is connected to the shaft by two orthogonal rivets. The specified maximum protrusion of the rivet heads above the fitting surface was 0.7 mm. Only a small radial clearance is present between the shaft and the fan and TPIS units.

Examination of the mainwheel tachometer systems after removal from the aircraft showed no signs of excessive wear or looseness in the drive splines or universal joint. Each tachometer driveshaft had sustained local indentation damage to the surface of the spline fittings, consistent with moderate impact by hard objects, and moderate fretting damage to the mating faces of the universal joint had occurred. Both effects were rather more severe for No 2 and No 4 driveshafts than for the No 1 or No 3 driveshafts.

It was apparent that the No 2 and No 4 driveshafts were slightly bent and showed evidence of heavy rotational rubbing over their central portions. In both cases the bend was located approximately 1.8 inches (45 mm) from the outer end of the shaft and resulted in a radial displacement of the spline of approximately 0.04 inches (1 mm) relative to the axis of the unbent part of the shaft. In addition, the heads of the rivets securing the spline fitting to the shaft had suffered ‘machining’ damage in a number of cases, indicative of contact with surrounding static components while the driveshafts had been rotating. This was particularly severe for No 2 and No 4 driveshafts, where some of the rivet heads had been worn almost flush with the shaft surface.

The aircraft manufacturer has had a programme in place for some years to replace the titanium shaft with an upgraded, tapering, solid steel shaft. This has a resonant frequency of 130 Hz, which is outside the aircraft's normal groundspeed range. Data from the manufacturer indicated that this upgrading of the fleet slowed almost to a halt in mid-2004, and that this programme applied to new build and replacement on an attrition basis; it was not a retro-fit programme.
