# Investigation Report

1X001-0/06  
August 2009

Kind of occurrence: Accident  
Date: 12 January 2006  
Location: Freiburg, Germany  
Type of aircraft: Aircraft, fixed wing  
Manufacturer / Model: Beech Aircraft Corporation /  
Beech B300  
Injuries to persons: Two fatal  
Damage to Aircraft: Aircraft destroyed  
Other Damage: Damage to trees  
Source of Information: Investigation by BFU

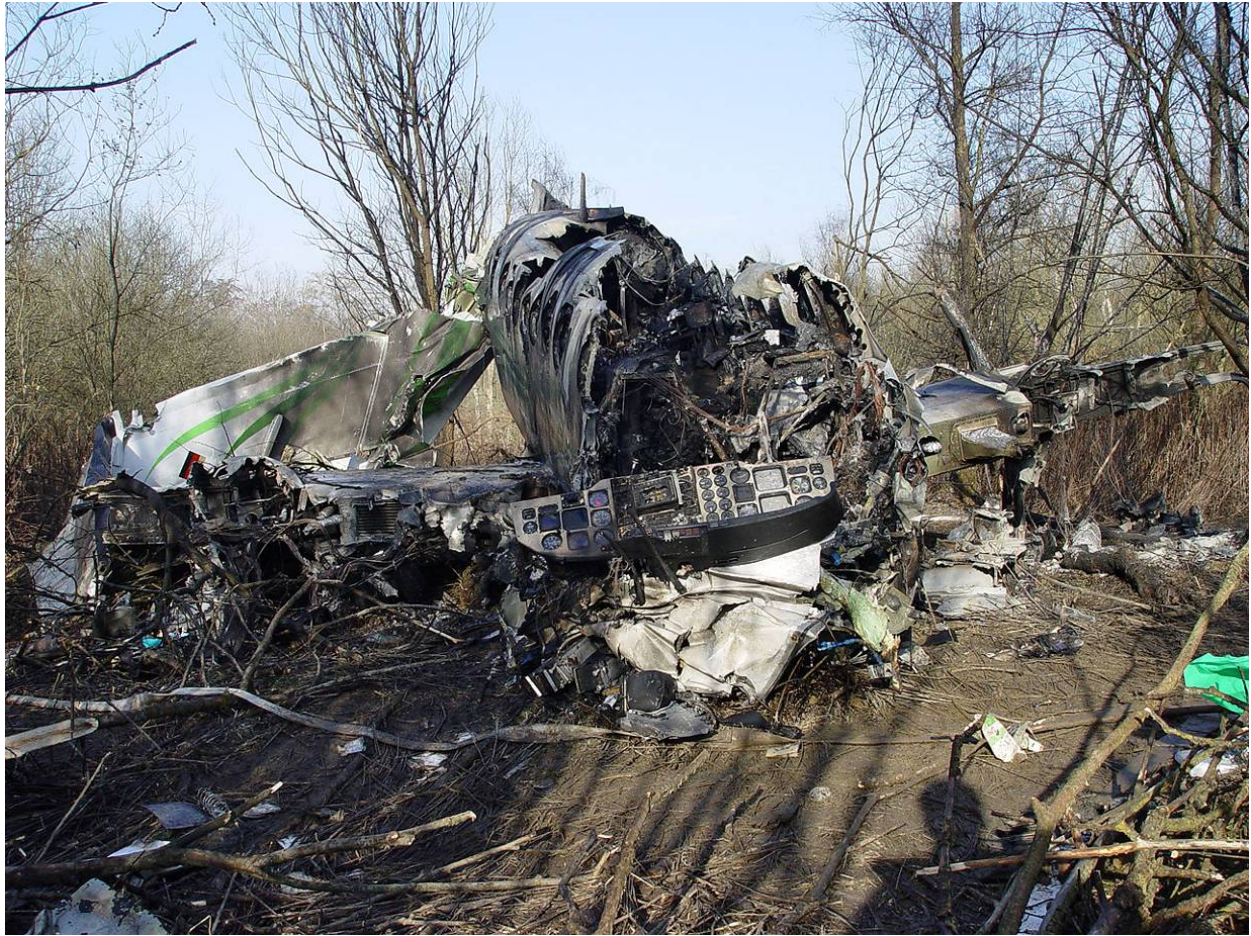
Picture 2: The main wreck at the accident site

After having made contact with the tree tops the aircraft came to a stop on the forest floor about 250 m farther on, and 450 metres from the Runway threshold. On impact, the right engine was torn from the wing and thrown forward about 15 m.

The wreck revealed the following:

- The cockpit area and forward fuselage were destroyed.
- The T-tail unit was bent and folded to one side.
- The landing gear was lowered and locked.
- The flap drive spindle was in the position for the 35° landing flap setting.
- The engine instruments, engine controls and cockpit avionics were destroyed by impact and fire.
- The altimeter on the right hand side of the cockpit was set to a QNH of 1,031 hPa. The altimeter on the commander's side of the cockpit (left) was mechanically destroyed and no longer suitable for evaluation.

Inspection of the wreck revealed no evidence of technical defects.

Fire spread through the main wreckage. The cockpit area and front fuselage were destroyed by fire. The upper side of the fuselage burned out almost completely.

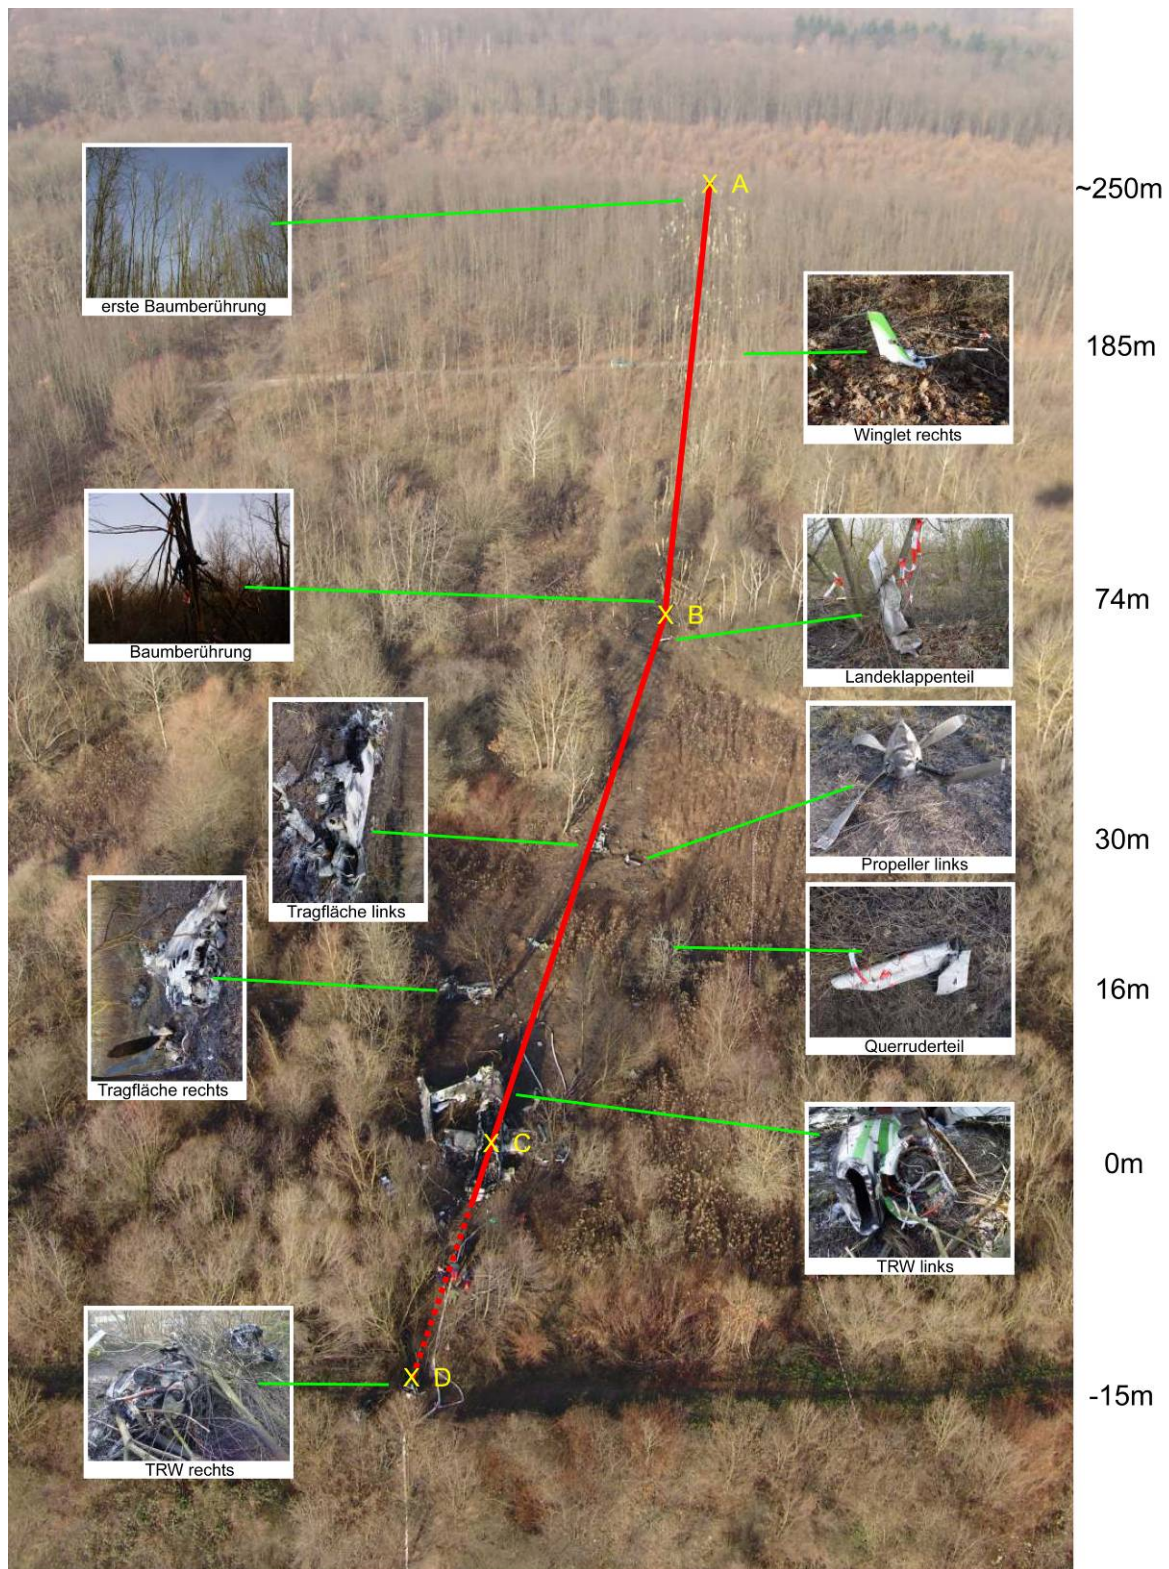
Wreck distribution at the accident site

During its approach to Freiburg Airfield the aircraft first made contact with the tops of a group of trees about 20 m high and 700 metres before the threshold of Runway 16. This initial impact ripped a winglet off the right wingtip, which was subsequently located about 65 m behind the trees; parts of the fuel tank cladding were found about 20 m farther.

As the aircraft continued (see Appendix 2) the right wing made contact with a branch about 15 cm thick, when a large quantity of fuel escaped and the aircraft slewed to the right. The wing flaps, ailerons and large parts of the wings and the left propeller were scattered over a wide area.
