# REPORT ON SERIOUS INCIDENT

## Runway Excursion

**M-03707/AIG-19**

**JetX**  
**Boeing 737-800, TF-JXF**  
**Keflavik, Iceland**  
**October 28, 2007**

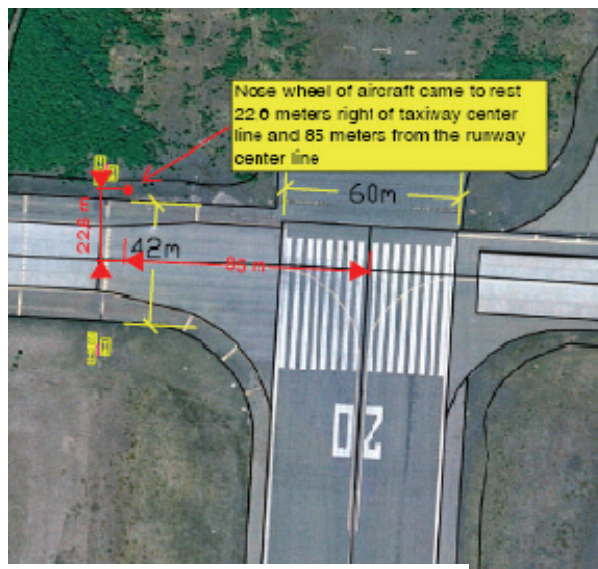
Nearing the end of the runway or the N-4 runway exit (requiring a left turn), approximately 56 seconds after touchdown, the aircraft heading began to decrease from 018 degrees, as the aircraft decelerated through a ground speed of 35 knots. The lateral acceleration parameter (body axis  $N_y$ ) recorded increasing negative values (peak -0.17 g), suggesting deceleration with a nose-left side-slip or yaw.

Figure 1: Area where aircraft came to rest

At this point, reverse thrust was increased with engine  $N_1$ 's rising to 80%. The ground speed was 25 knots and the heading was decreasing through 360 degrees. The wheel brake pressures then decreased through 19 knots ground speed, and nose-left rudder pedal was applied as the aircraft turned through 340 degrees. The aircraft came to rest on a final heading of 288 degrees with the right main landing gear and nose wheel off the paved surface of taxiway N-4.

The aircraft sustained some minor damage to the nose wheel. The main tires had no signs of reverted rubber (indications of skidding).

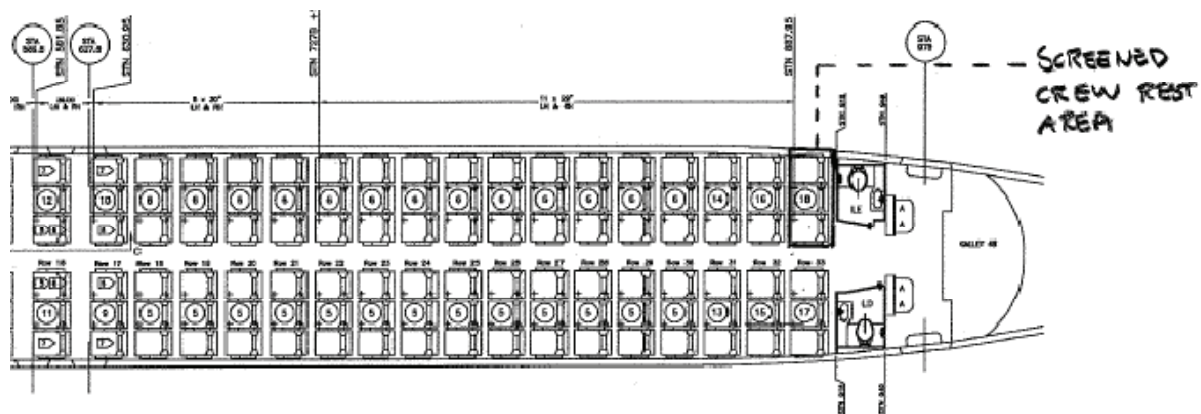
Figure 3: Aft section of cabin showing location of crew rest area

According to the pilots in the augmented flight crew, they preferred to rest in the cockpit as they felt the crew rest area was inadequate given their height and body size, making it impossible to sleep.

- 4.1.2 *Recommendation to EASA: Ensure operators have adequate on-board rest facilities when required by regulations. The crew rest facility should ensure a dark and quiet (most silent area on-board aircraft) environment where the skeletal muscles can fully relax in a horizontal position.*

- 4.1.8 *Recommendation to ICAA: Ensure operators have adequate on-board rest facilities when required by regulations. The crew rest facility should ensure a dark and quiet (most silent area on-board aircraft) environment where the skeletal muscles can fully relax in a horizontal position.*

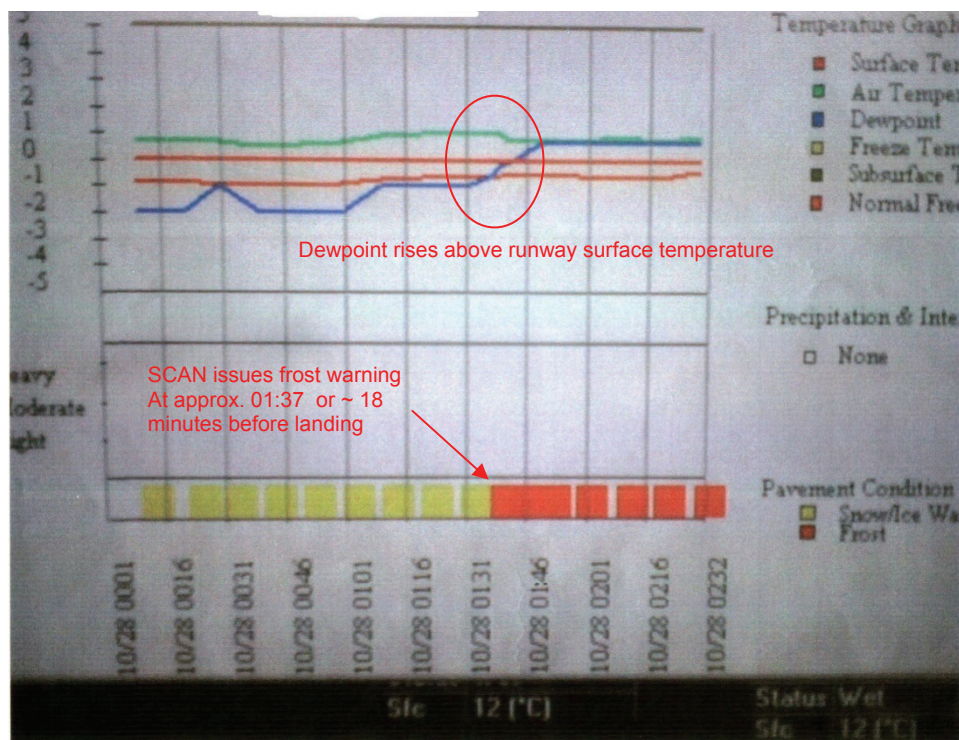
Figure 5: Screen capture from SCAN system. Blue line shows the dew point rising from -1°C to 1°C and the system issues a frost warning.

It is likely that during the time period the SCAN system issued a frost warning at 01:37 and until the aircraft landed at 01:55 the runway surface conditions were changing. The outside air temperature was around the freezing point of water. There was a sharp rise in the dew point temperature which reached the temperature of the runway surface. These conditions could have encouraged the formation of ice on the runway.

The SCAN system at Keflavik Airport was not actively monitored and the frost warning that the system issued at 01:37 went unnoticed (see Figure 5). The friction measurement for runway 02 was 2 ½ hours old and was thus outdated information. The Airfield Services division procedure do not require constant monitoring of the SCAN system. The SnowKing's active monitoring out on the runways have been considered adequate supervision.

- 3.1.11 *The SnowKing used a non-standard technique to measure the braking action of runway 02.*
- 3.1.12 *The SCAN system issued a frost warning at approximately 01:37 that went unnoticed.*

- 4.1.6 *Recommendation to ICAA: Ensure the SCAN system monitor at Keflavik Airport is actively monitored and its warnings are made available to the SnowKing.*

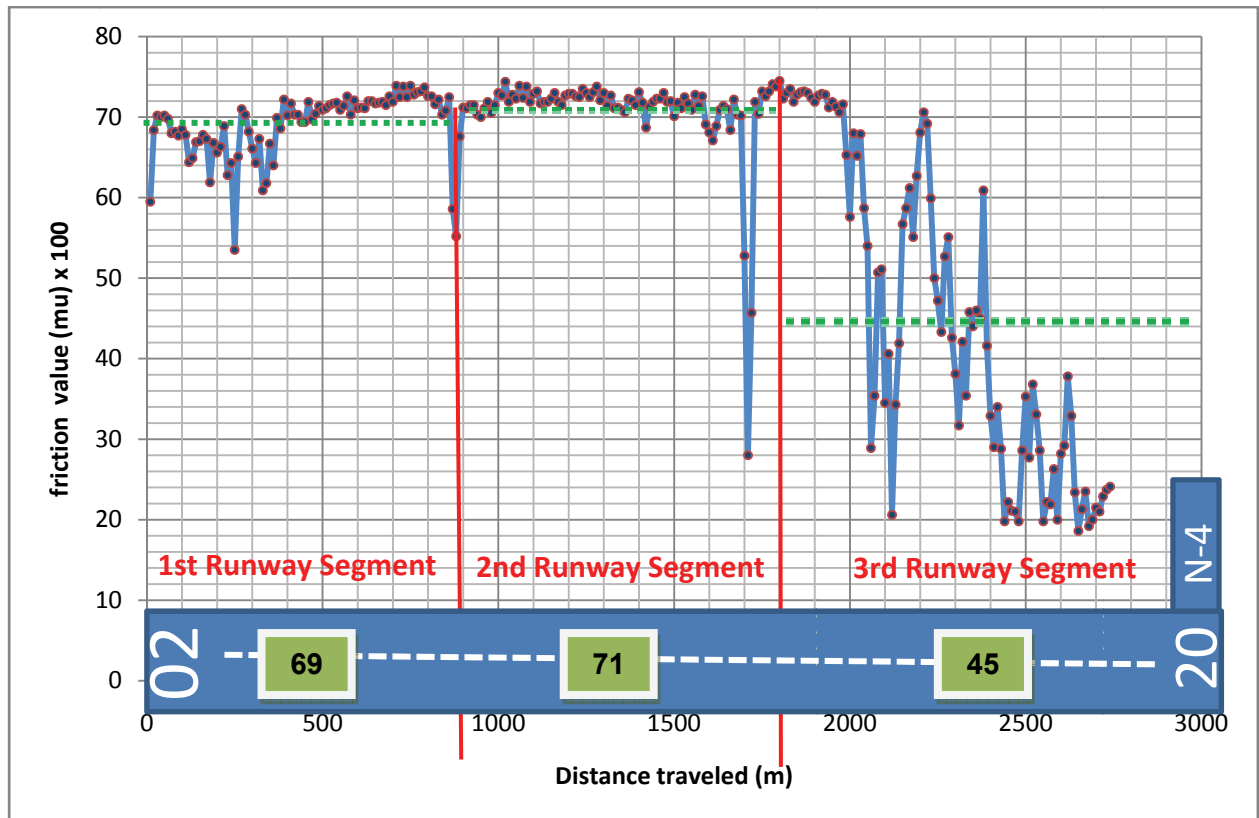
A regenerated graph (see Figure 6) of the Mu-meter run report (see appendix 5.1) that indicates the friction values for runway 02 can be seen in the figure 6 below. From the graph it can be seen that there is a great deal of variation in the measured friction values for the last third of the runway as compared with the other previous thirds. Also there is a considerable drop in the friction values which should indicate the braking action is deteriorating towards the north end of runway 02.

The method of measuring runway friction by towing a Mu-meter in a single winding course around the centerline of the runway is not according to the Airfield Services division's procedure and not in accordance with ICAO Annex 14 Airport Services Manual Part 2 Pavement Surface Conditions that stipulates that:

Figure 6: Measured friction values at 23:12 UTC by Mu-meter. Average values for each segment shown in by horizontal green dashed lines. The average friction values for each third shown in the boxes (69, 71, 45).

- 3.1.1 *The variation in the data collected by the Mu-meter for the third section of runway 02 was high and surface conditions were poor at the end of the runway.*

- 4.1.5 *Recommendation to ICAO: Review the limitations of the use of the mean value in runway friction measurements. Make it a design requirement for runway friction measurement systems to report the deviation in the measured values and issue a warning when the deviation from the mean value becomes large.*

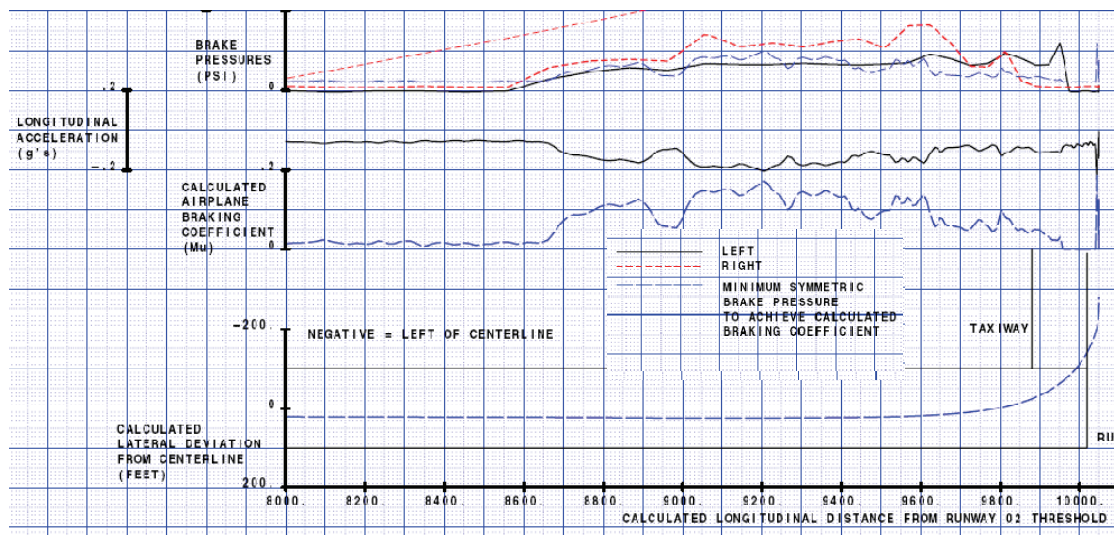
Between 400 and 200 feet from the end of the runway, the calculated symmetric brake pressure falls below the applied brake pressures suggesting a friction limited condition. The calculated aircraft braking coefficient was approximately 0.07 in this region.

After this point, the airplane was in a left turn and the right commanded brake pressure drops with asymmetric braking. The airplane does not appear to be friction limited in this region.

Figure 7: Braking action and deceleration of aircraft

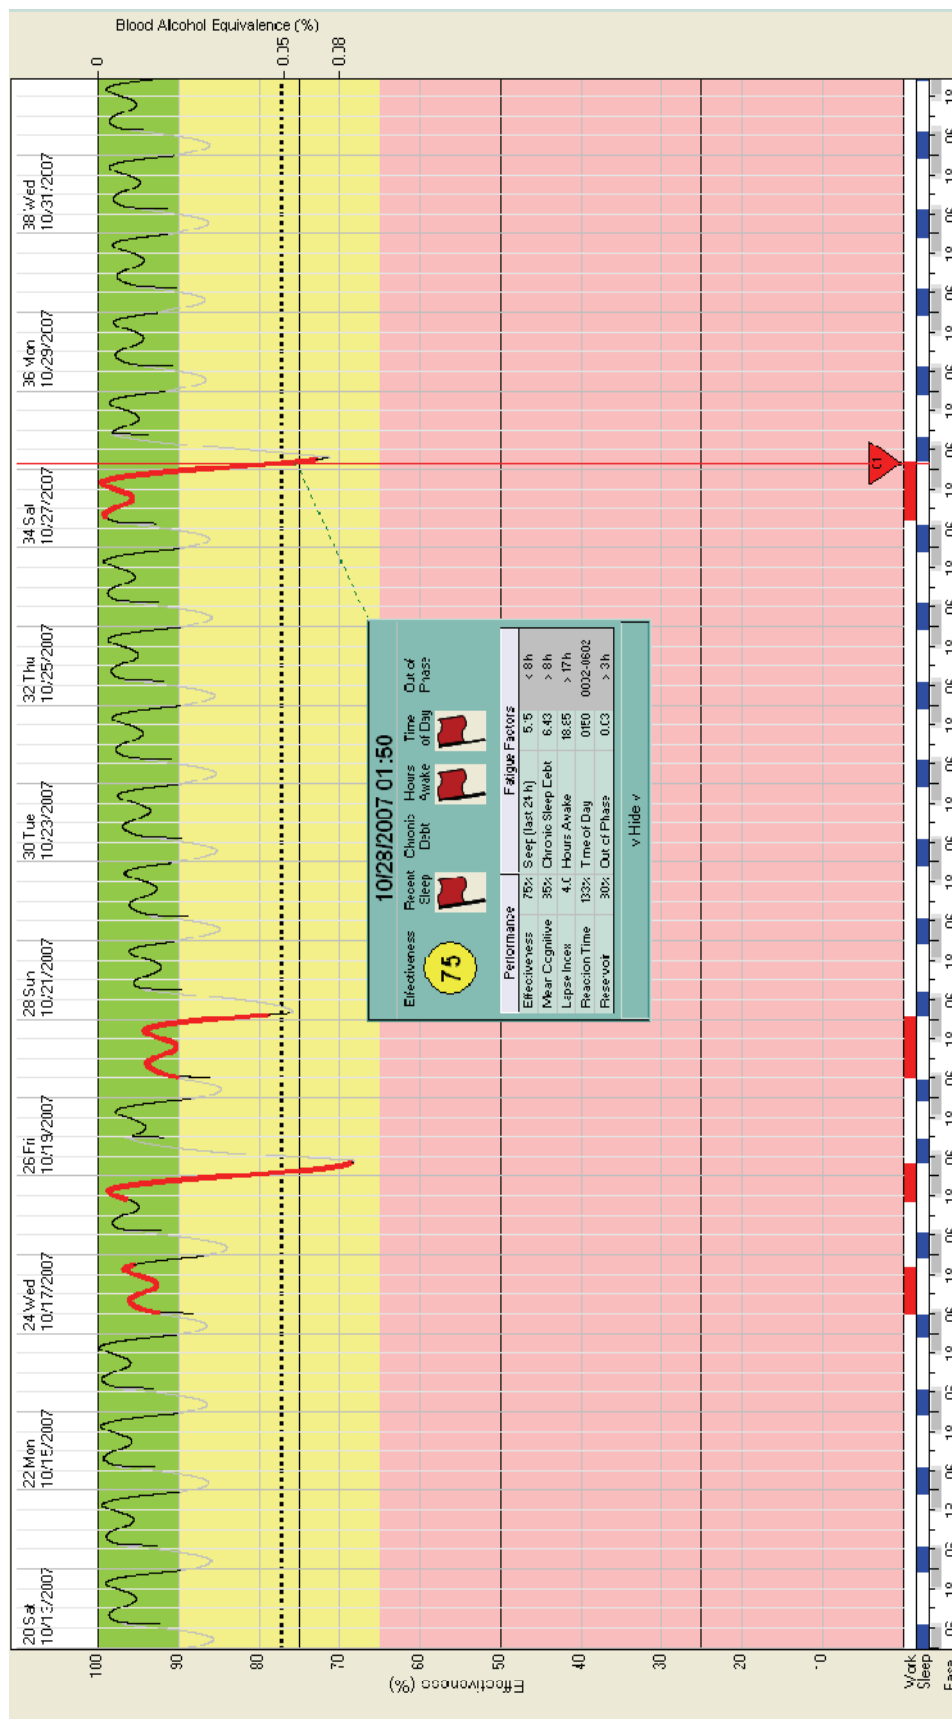
- 75% or lower Effectiveness (ability to maintain focus)
- 85% or lower Mean Cognitive (average speed of mental operations)
- 4.0 or greater Lapse Index (lapse in attention). Pilot is 4 times more likely to suffer from lapse in attention.
- 133% or longer Reaction Time

Figure 8: FAST prediction for pilot flying

These results support the previous statement regarding the pilot's performance and risk of fatigue related performance errors. Furthermore, the FAST analysis demonstrates that the pilots were likely fatigued and performing poorly in comparison to the performance that would be predicted for normally rested people.

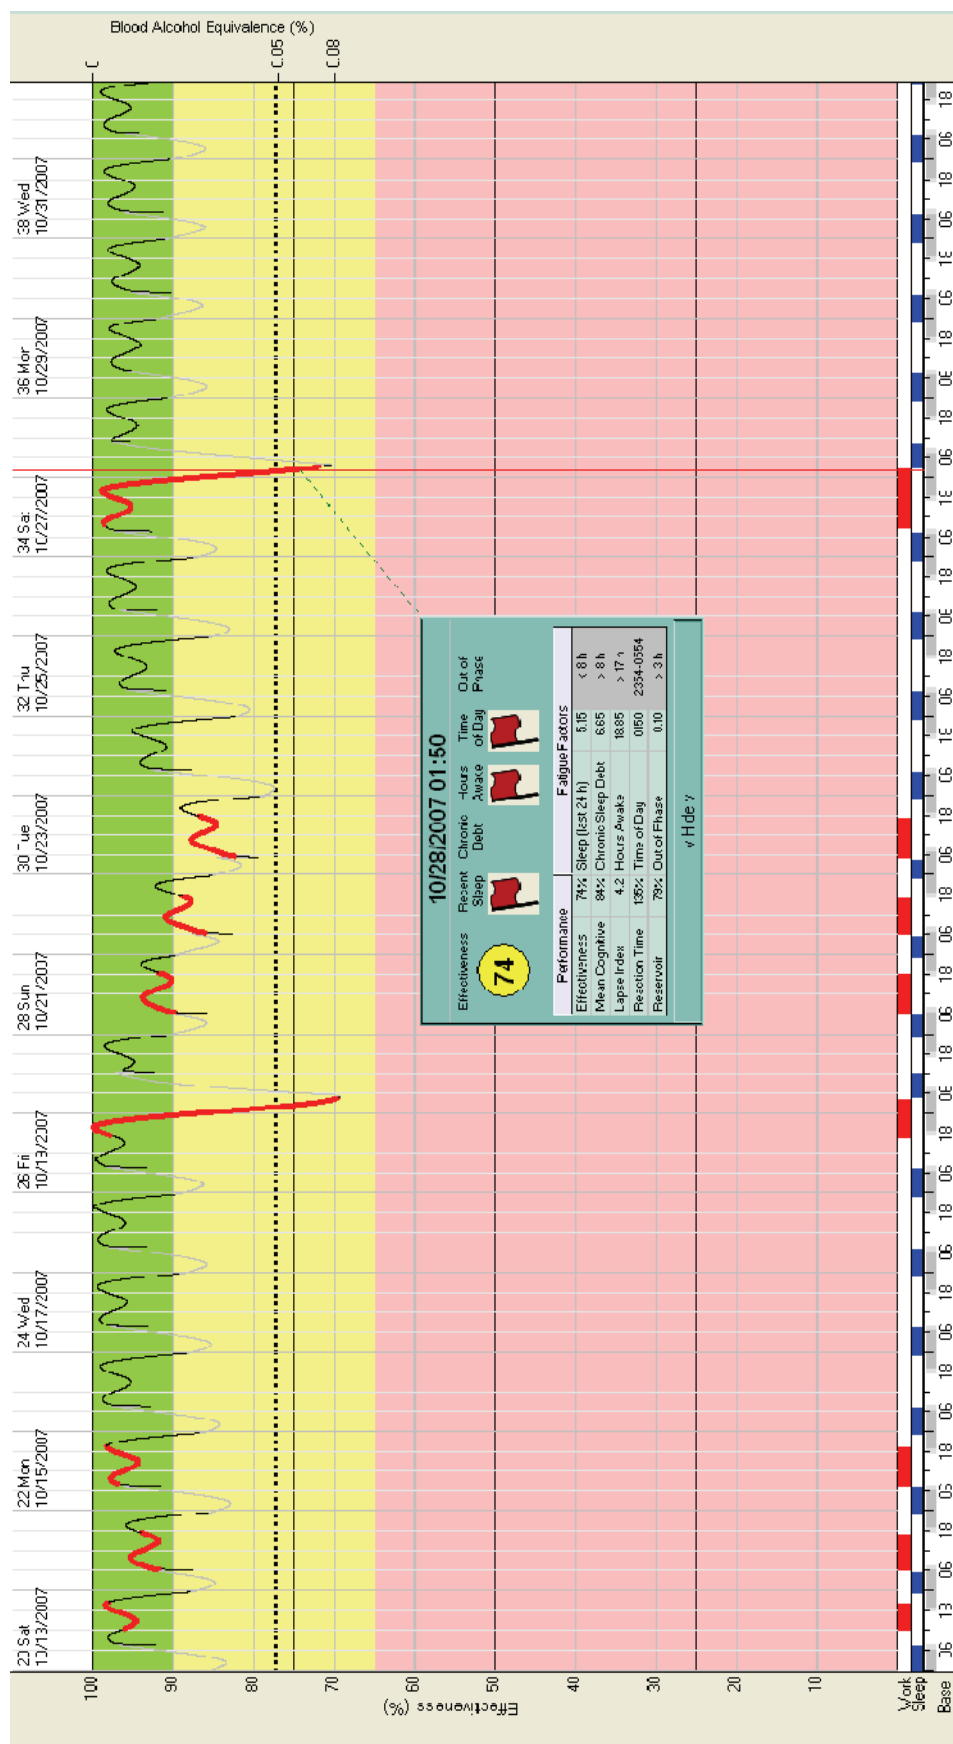
Figure 9: FAST prediction for pilot-not-flying
