**AERONAUTICAL ACCIDENT**  
**INVESTIGATION AND PREVENTION CENTER**

**FINAL REPORT**  
**A – N° 67/CENIPA/2009**

**AIRCRAFT**          **PR - MBK**

**MODEL**             **AIRBUS A-320**

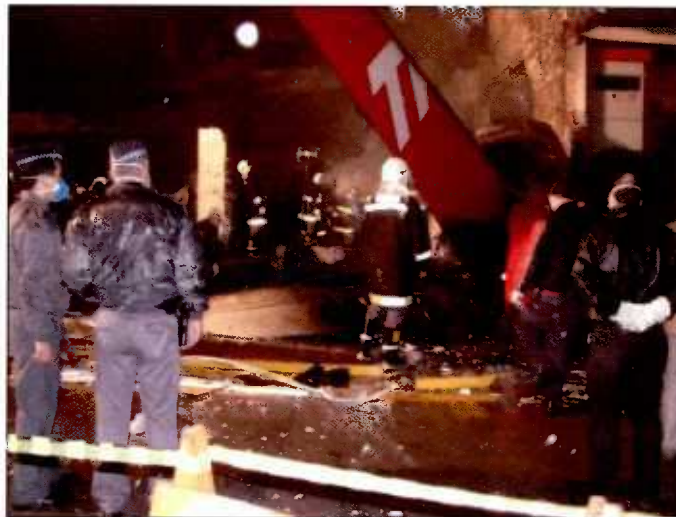
The collision of the aircraft occurred at a ground speed of 96 kt, at an angle of 7° roll to the left and a 7° positive pitch. With the impact, the aircraft was completely destroyed and the wreckage was concentrated in an area of about 100 m<sup>2</sup>.

Figure 3 - Wreckage of the aircraft at the site of impact.

The retractable type landing gear was locked in the extended position, and the flaps were also completely extended (landing configuration).

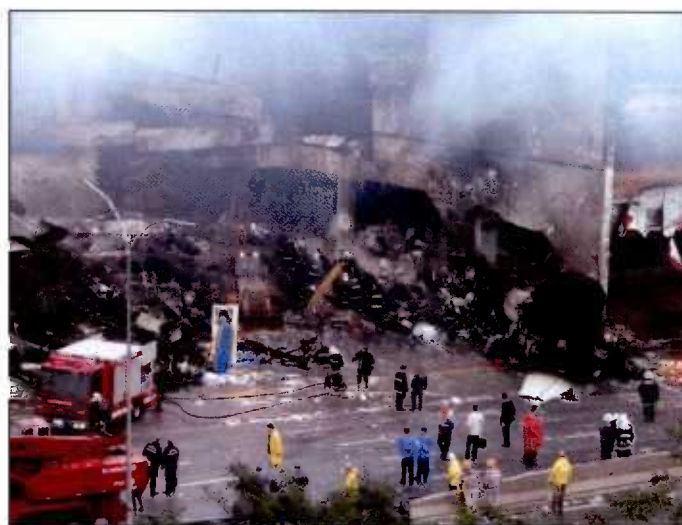
Figure 4 - Aerial view of the site of impact.

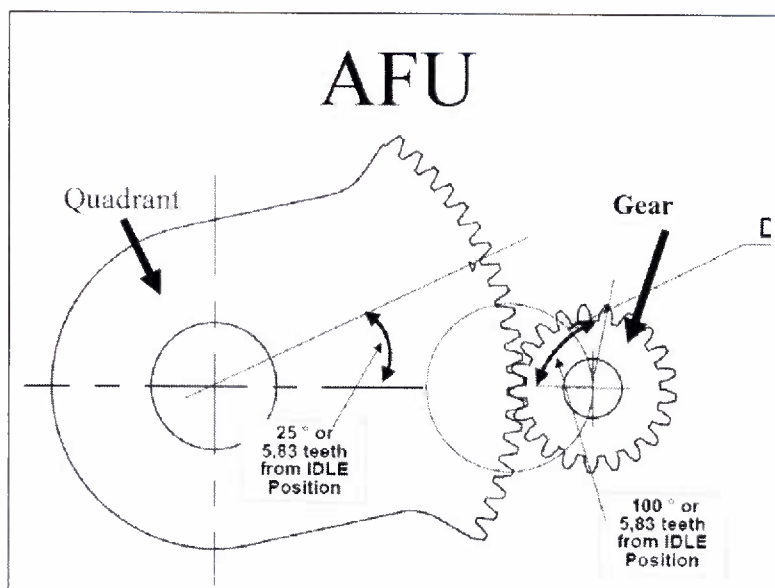
The aluminum structure of the units was found melted due to the heat of the post-accident fire. In the midst of the melted aluminum mass were the gears and the quadrants made of steel.

Figure 6 - Quadrant and gear of the AFU.
