## ACCIDENT

| <b>Aircraft Type and Registration:</b> | Dyn'Aero MCR-01, 21-YV (callsign F-JQHZ) | |
| <b>Location:</b> | Highclere, Hampshire | |

## Synopsis

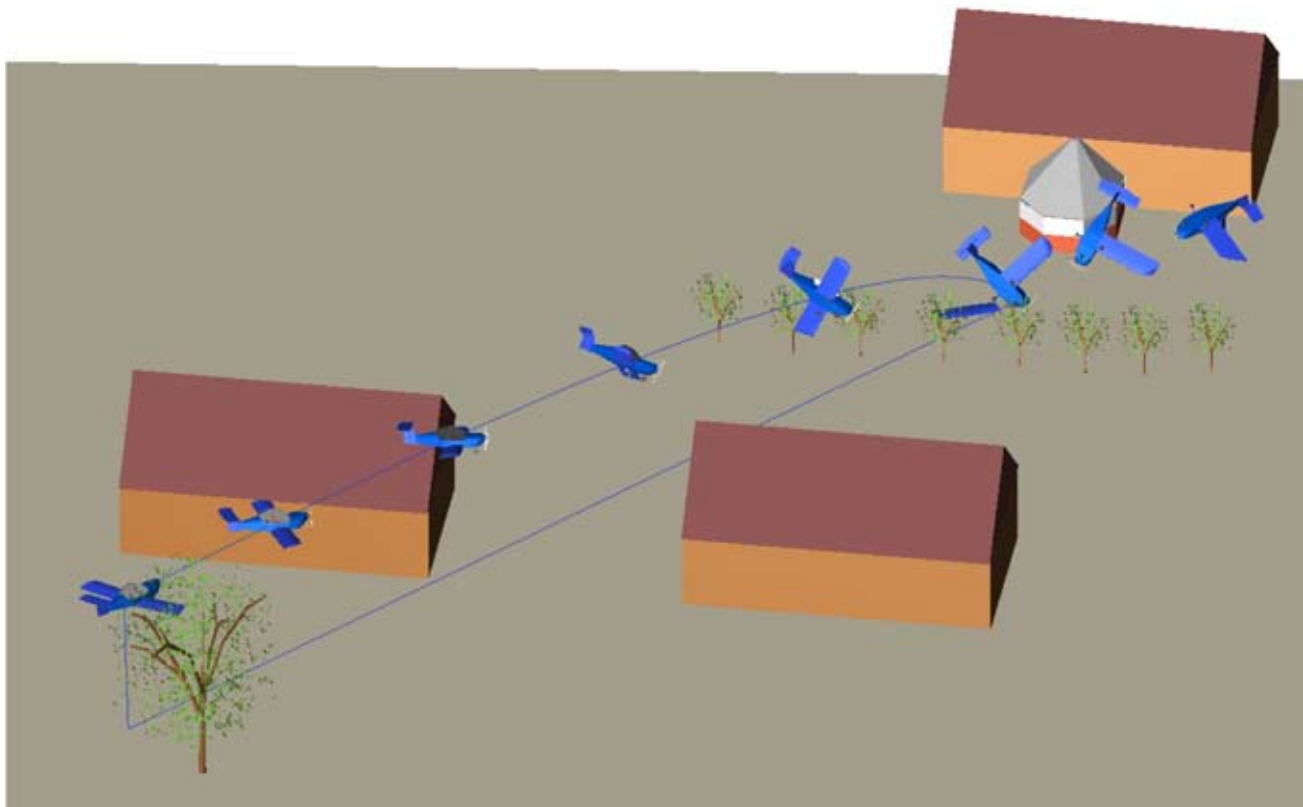
**Figure 1**

The distribution of debris and ground marks, together with inferences drawn from a three-dimensional CAD reconstruction of the impact sequence (using suitably scaled representations of the aircraft and principal ground features and objects), suggested that the aircraft was banked slightly left and travelling at significantly high speed, with a slightly upwards trajectory, at the instant it struck the tree. The impact between the right wing tip and the tree caused it to yaw violently to the right and, thereafter, it appears to have followed a slightly lofting trajectory whilst rolling left and pitching nose-down. Just before impact with the ground, the left wing tip struck the small tree bounding the garden into which it finally crashed. This sequence, taken from the CAD reconstruction, is shown in Figure 1.

CAD representation of the impact sequence

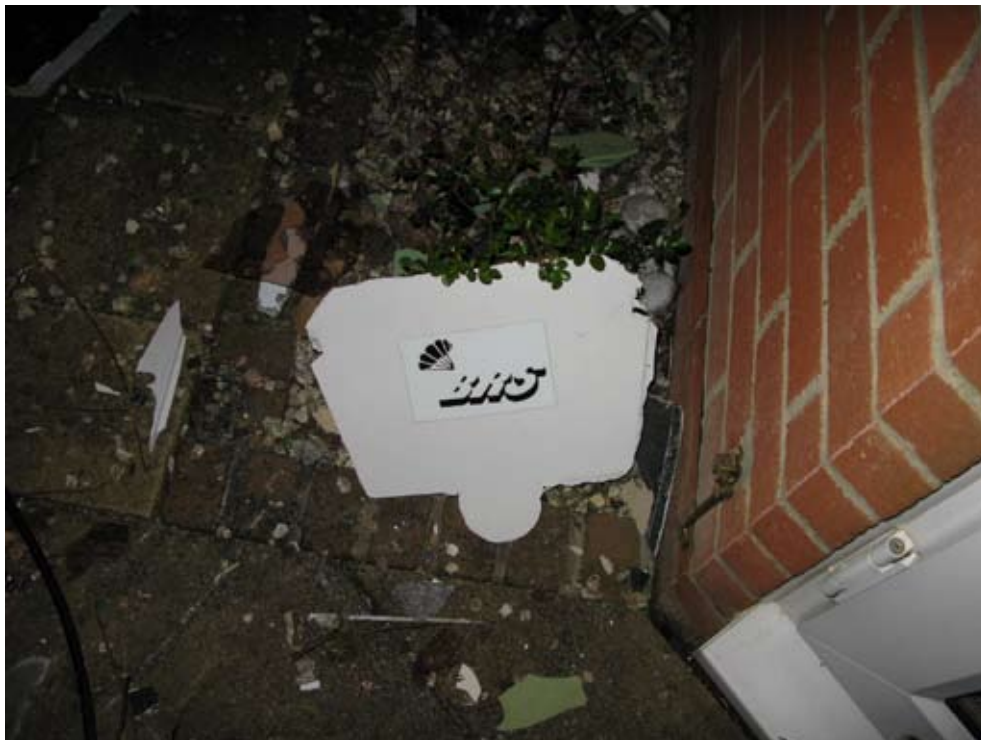
**Figure 2**

Two warning placards were displayed on the exterior of the aircraft; a BRS parachute logo on the parachute compartment cover, Figure 2, and a small red triangle on the fuselage top surface just aft of the parachute

Figure 3. Neither contained any explicit reference to pyrotechnic or projectile hazards. The BRS logo was also displayed on the top surface of the parachute within the compartment, Figure 3.

Parachute compartment cover displaying the BRS placard

of the potential danger. For the latter, there is a clear requirement for highly visible warnings to be placed on the aircraft, at positions where they are likely to be seen, regardless of the aircraft's orientation on the ground, capable of indicating to a lay-person both the nature of the hazard, the location and likely direction of discharge of any associated projectiles. Currently, there are no formal requirements concerning information placed on aircraft fitted with such devices. 21-YV displayed only a BRS parachute logo on the parachute compartment cover and on the top surface of the parachute within, neither of which contained any explicit reference to pyrotechnic or projectile hazards. The red triangle on the fuselage top surface, just aft of the parachute compartment, which bore the legend, '*DANGER FUSEE DEXTRACTION PARACHUTE* (DANGER ROCKET EXTRACTION PARACHUTE)', was small and not considered to be visually compelling.

It is recommended that the International Civil Aviation Organisation publish a Standard which defines internationally agreed warning placards for application to all aircraft fitted with ballistic parachute recovery systems, that give as clear an indication as possible at the greatest distance reasonable of the dangers posed to first responders to an accident aircraft fitted with a ballistic parachute recovery system.

It is recommended that the Federal Aviation Administration, the Civil Aviation Authority and European Aviation Safety Agency, cooperate to require the application of warning placards of a common agreed standard, to be applied to all aircraft fitted with ballistic parachute recovery systems for which they have airworthiness responsibility, to maximise the possibility of first responders being made aware of the danger posed by a live system following an accident. These placards should be applied in such a manner that at least one such placard should remain visible regardless of the stationary attitude of the aircraft.

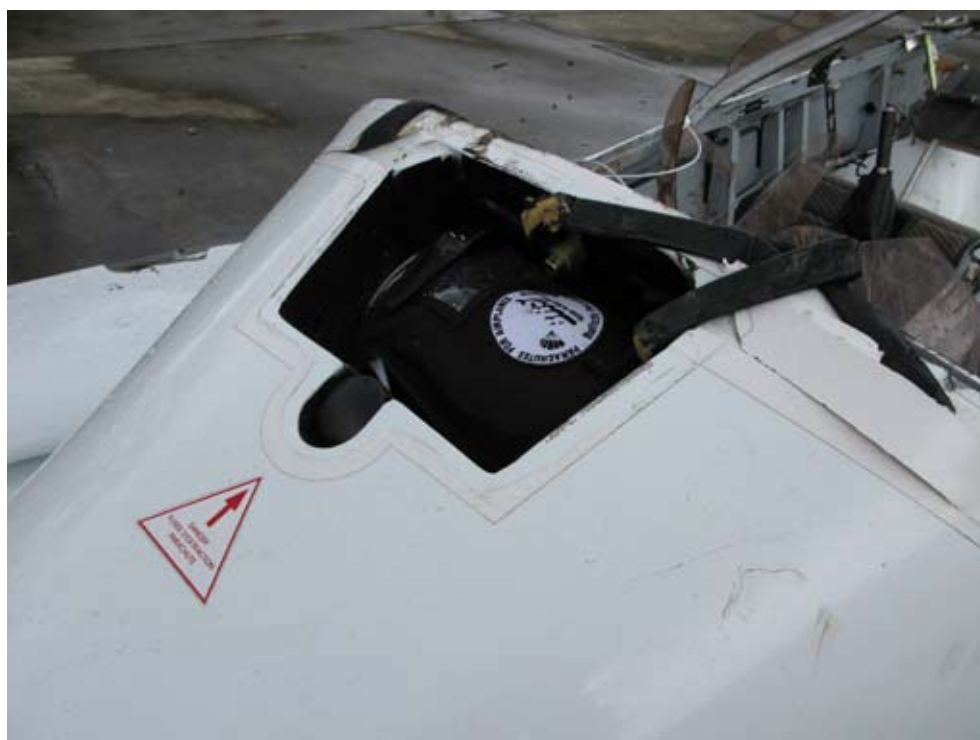
**Figure 3**

compartment, bearing the legend, '*DANGER FUSEE DEXTRACTION PARACHUTE*' (*DANGER ROCKET EXTRACTION PARACHUTE*), with an arrow pointing towards the parachute compartment,

Red warning triangle and BRS placard (displayed on the parachute)

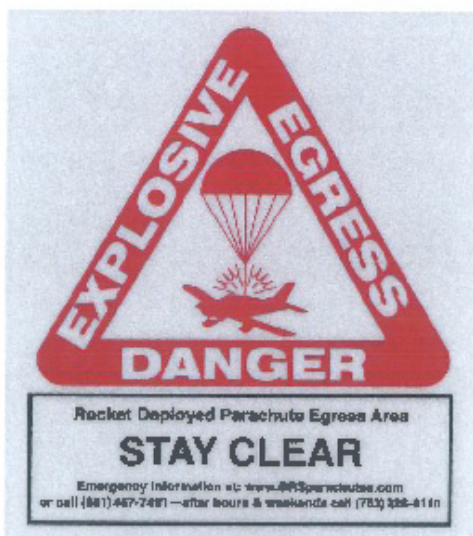
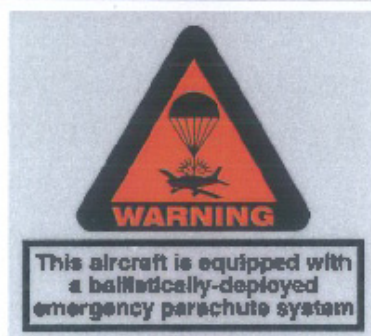
**Figure 4**

The SAIB provided an example of suitable placards, available from the manufacturer of the system fitted to 21-YV. These placards are not dissimilar to those used to mark ejector seat systems on military aircraft and are shown in Figure 4.

Placards provided by BRS Inc.

*'We recommend that all make/model airplanes (so affected) be equipped with the ASTM<sup>1</sup> conforming placards suitable to draw the attention of first responders. ASTM F 2316-06 specifies that the aircraft should be externally marked with one danger placard at the exit point of the rocket/parachute and another warning placard on either side of the aircraft that is visible to those entering or approaching the aircraft.'*
