# German Federal Bureau of Aircraft Accident Investigation

# **Investigation Report**

5X003-0/08 March 2010

Manufacturer / Model Airbus / A320-211

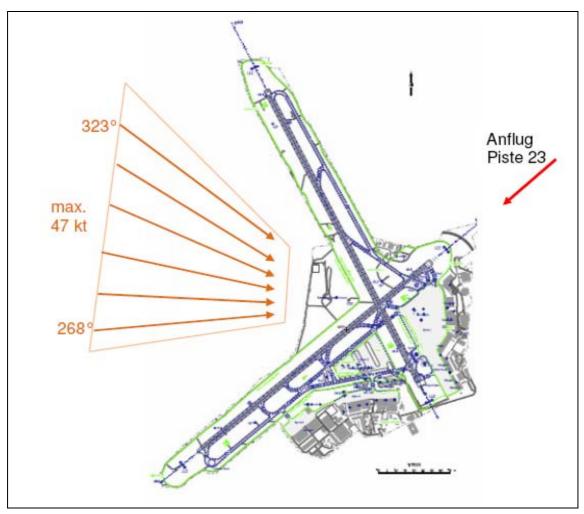
Diag. 4: Surface wind in the last 10 minutes prior to touch down.

At 1333:40 hrs the anemometer near the threshold of Runway 23/33 registered the surface wind as 299°/32 kt (here: 2-minute mean value). No change was registered in the wind at 1334:00 hrs (wind direction 299°).

In the final ten minutes prior to the occurrence the wind direction varied between 268° (minimum) and 323° (maximum). In this period, the maximum gust speed recorded was 47 kt.

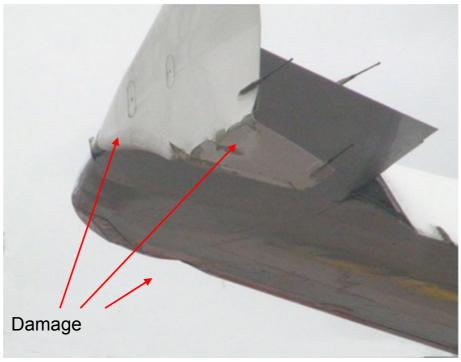
Diag. 12: Damage in the vicinity of the left wingtip

Contact with the runway resulted in damage to the wing tip fence, slat No. 5 and leading edge slat rail guides 11 and 12. These components were replaced before the aircraft was returned to service.

During the repair, a further inspection was made of the airframe, the control surfaces and the main landing gear. The inspection revealed no further damage that could be ascribed to the landing incident.

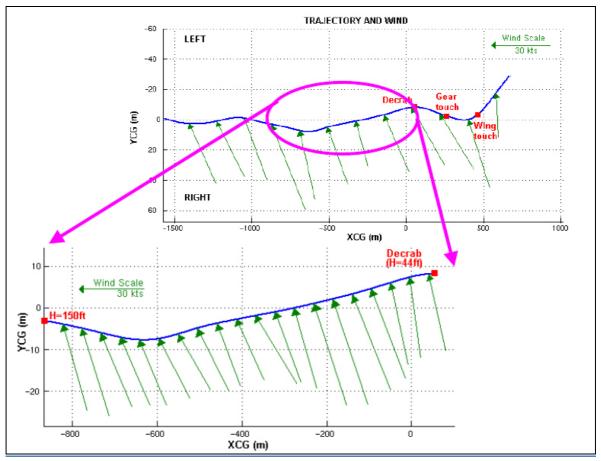
Diag. 16: Wind vector during descent from 150 ft to 44 ft

The horizontal zero line represents the runway centreline and the blue line represents the flight path. The lower horizontal scale represents the distance to the runway threshold. From this drawing it can be determined that the wind speed increased about 200 m prior to the runway threshold. The aircraft shifts left and on arrival over the threshold is about 8 m left of the runway centreline.

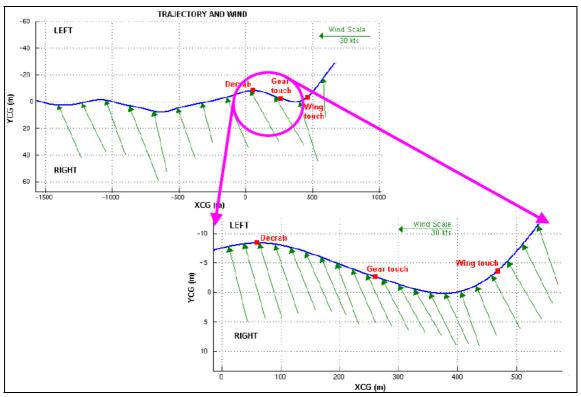
Diag. 17: Wind during the de-crab phase

- Wind Conditions
  - Headwind component 12.5 kt, gusts up to 24 kt
  - Crosswind component 30 kt, gusts up to 40 kt
  - There were no significant gusts during the de-crab procedure
- When at about 100 ft above the ground, a gust shifted the aircraft to the left and was corrected by copilot control input.
- The de-crab procedure was initiated at about 50 ft above ground with the sidestick still deflected on the left hand side while the rudder was deflected on the left hand side. Then, the left rudder deflection increased when the left main landing gear touched down.
- At the time of touch down by the left main landing gear, lateral control changed from Flight Law to Ground Law.

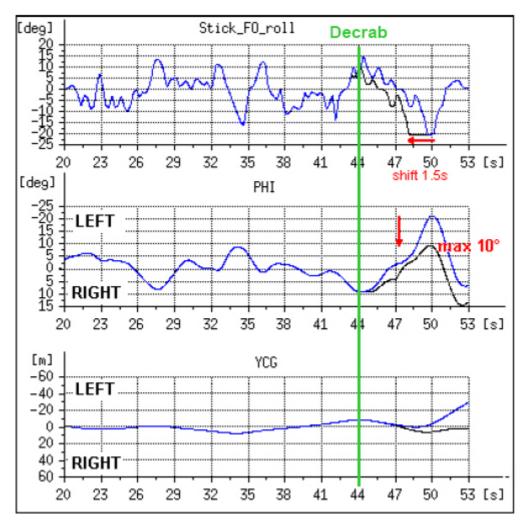
Diag. 18: Postponement of roll input by 1.5 seconds

It is in the opinion of the aircraft manufacturer, that contact between the left wingtip and runway could have been avoided if there had been an earlier, coordinated sidestick roll input, combined with less left rudder deflection.

The exemplary account of the aircraft manufacturer that, if the co-pilot's sidestick input had been delayed by 1.5 seconds the result would have been a maximum of 10° left wing down -- and would thus have avoided wingtip contact with the ground -- is theoretically understandable. However, from the practical point of view of a pilot, this assessment can be queried. With the aircraft under manual control, a time period of about 1.5 seconds would have been difficult to coordinate precisely. Further, it should be noted that in this specific case a reduction of the wing-down angle to a maximum of 10° would have prevented wingtip contact with the ground; but also that pilots are enjoined to avoid unintended changes in attitude just prior to touchdown. Any unintended wing drop to the left was unacceptable.
