## **Final report A-019/2008**

Accident involving  
a PILATUS PC6-B2H4  
Turbo-Porter aircraft,  
registration EC-JXH,  
in Lillo (Toledo),  
on 30 May 2008

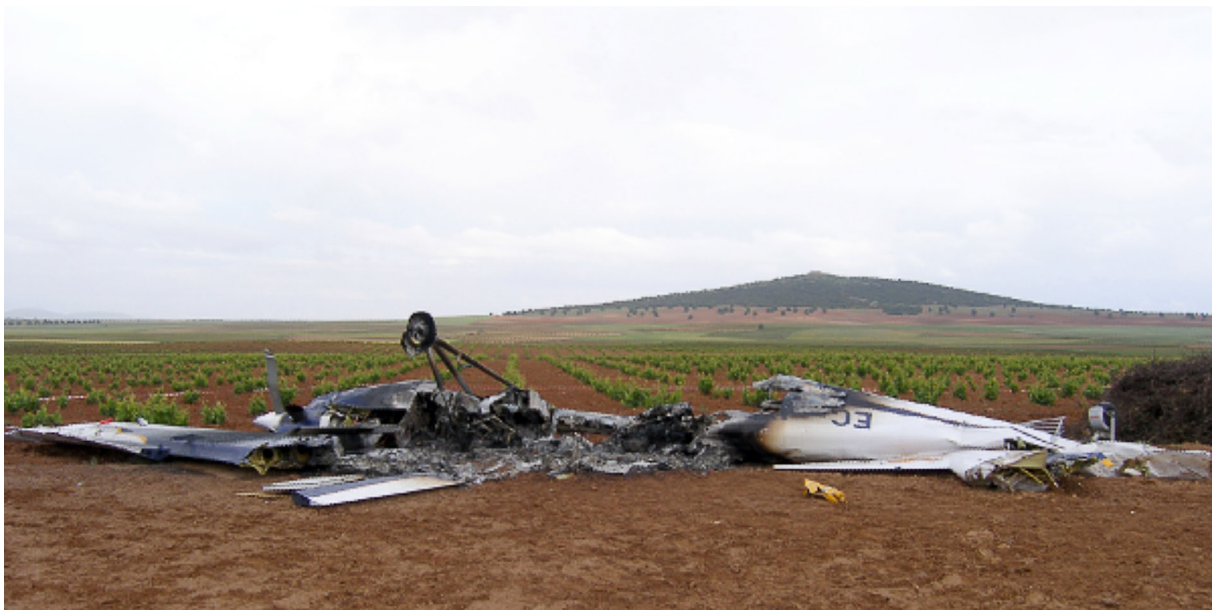
Figure 1. Photograph of aircraft at crash site

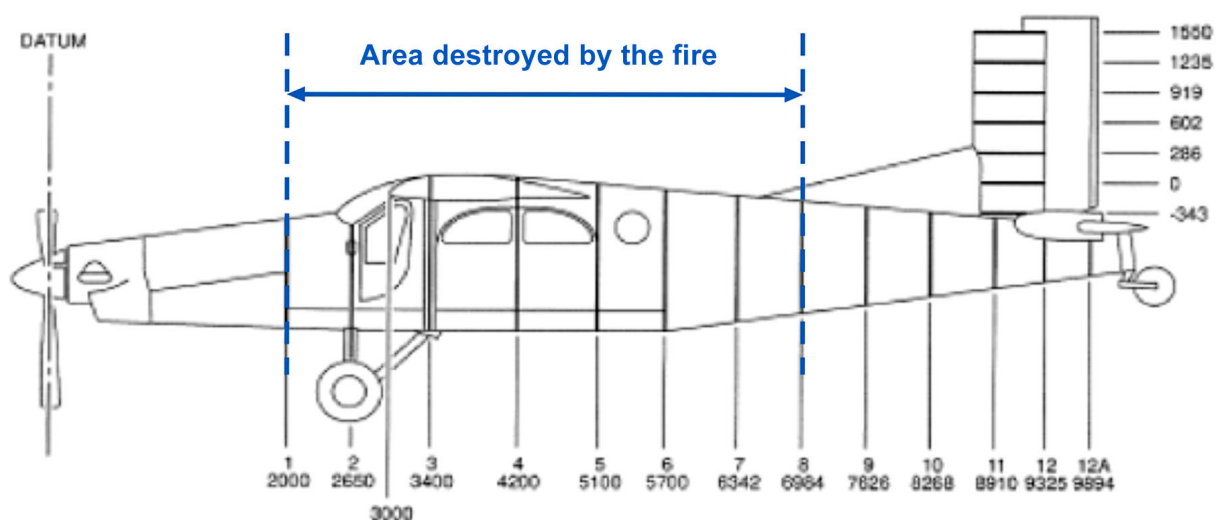
Figure 2. Section destroyed by the fire

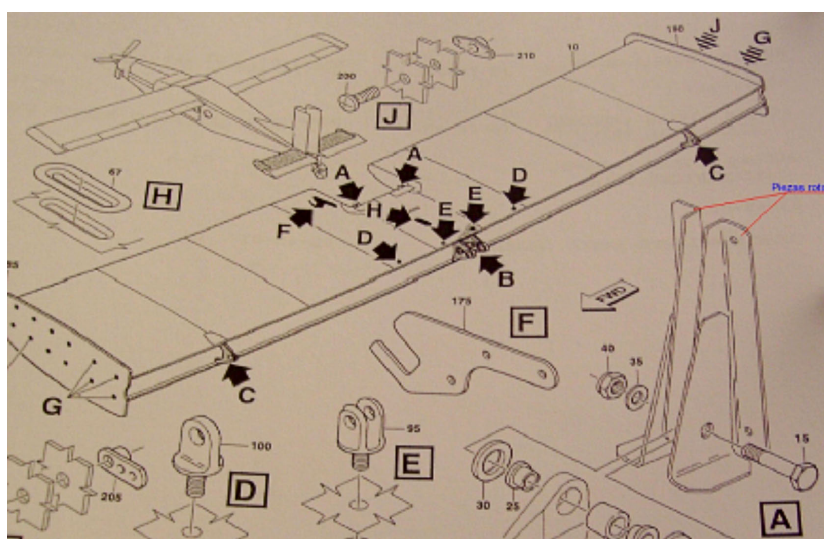
The previous inspection had also been done by the manufacturer's maintenance organization, from 15 to 17 January 2008, with 15,658 h on the airplane, during which the horizontal stabilizer support was replaced due to cracking.

Figure 5. Stabilizer support

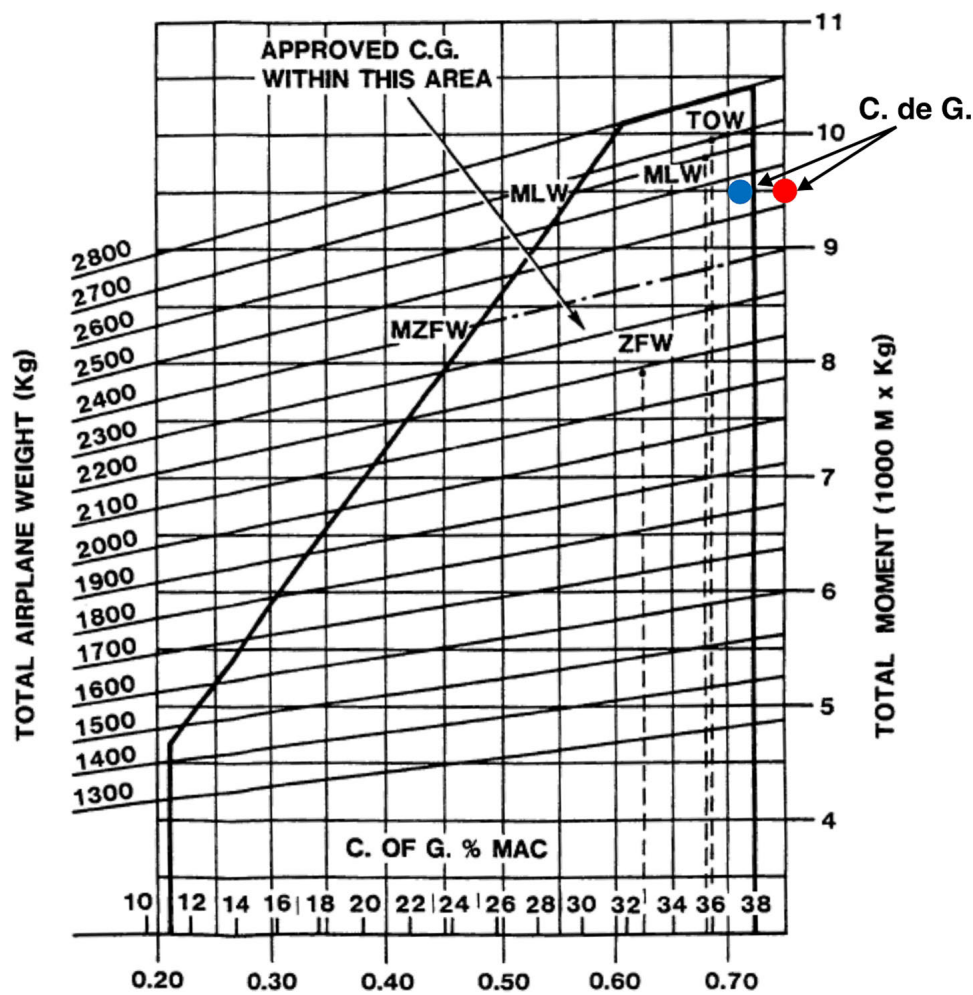
Figure 7. Position of the C.G. in load and balance graph

If we now consider the second load case, the center of gravity would be at 3.74 m (9,668.05/2,580.7) from the reference line, that is, 39.27% MAC, which is outside the limits.

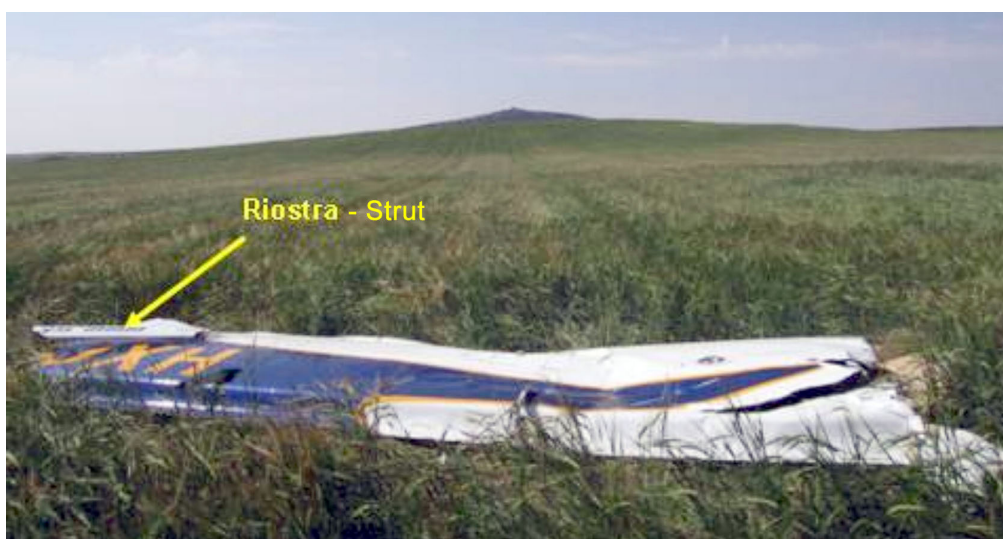
A part of the left wing spanning two thirds of its total length was missing. The part of the wing that remained attached to the fuselage was found with the main wreckage. It was joined to the inboard flap, and both components were completely charred. A 1.10-m long section of the strut was still attached.

The part that detached from the left wing was found alongside the Lillo-Villatobas road, in the segment that is known as the Cerrotraviesa trail, at coordinates 39° 46' 0.18" N – 3° 17' 10.8" W and an elevation of 680 m. It was oriented from east (part near the tip) to west (part near the root), and resting on its top surface. It was 5.75-m long measured along the spar closest to the leading edge. A 0.85-m long segment of the brace was still attached to it. The force of the impact had caused it to bend along its length such that it was convex along the top and concave along the bottom.

There were two dents on the leading edge. The wing tip was torn and a portion of the trailing edge had detached and come to rest in a separate area from the rest of the wing.

Figure 12. Left wing

During the investigation a macroscopic analysis of the left wing was conducted by an expert in structures and in-service faults. A laboratory microscopic study was not considered necessary, as there were no doubts regarding the cause of the fractures present, namely static overload. The progressive fracture and failure of the material was ruled out.

Both cords and the central core were fractured. Specifically, the upper cord had a 45° bevel fracture on a plane perpendicular to the spar's longitudinal axis. This fracture intersected two attachment holes drilled into the skin of the wing. The lower cord had a flat fracture that extended along two different planes, one parallel to the length of the wing and the other perpendicular to it. The entire spar near the fracture area was bent downward, meaning that the wing detached downward. There were several compression lines in the upper cord of the spar.

- The macroscopic analysis of the fractures found on the left wing concluded that they had been caused by a static overload. Progressive fracture mechanisms and material failure were ruled out.

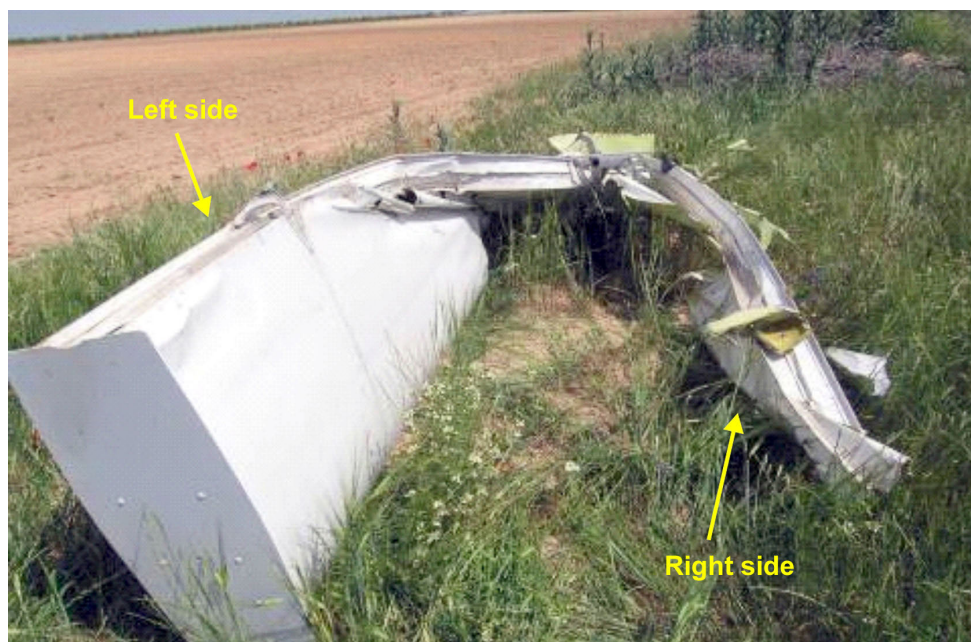
Like the left wing, the horizontal stabilizer was also found near the Cerrotraviesa trail, at coordinates 39° 45' 48.66" N – 3° 17' 47.58" W and an elevation of 700 m. It was bent at the center in a U-shape (see Figure 13) and ripped from its fittings at the center. The left side was practically intact. The right side was heavily damaged. It was missing the piece that had remained attached to the main wreckage. A part of the right side of the leading edge was found alongside the La Guardia-Corral de Almaguer road, at coordinates 39° 46' 16.2" N – 3° 17' 26.64" W and an elevation of 690 m.

Figure 13. Horizontal stabilizer

At the conclusion of this study, the INTA determined that the findings of the macrofractographic and microfractographic characterizations indicated that all of the fractures analyzed were ductile in nature and had progressed along their entire lengths due to static overload, there being no progressive fatigue or stress corrosion mechanisms involved in the process.

The study eventually concluded that the fracture and partial disintegration of part of the structure of the left wing and horizontal stabilizer, as well as their subsequent detachment, occurred as a result of a load being placed on these components that at one point exceeded the structural strength specified for the maneuvering envelope.

- The analysis of the horizontal stabilizer revealed that the fractures found on it occurred as a result of a load being placed on it that at one point exceeded the structural strength specified for the maneuvering envelope.

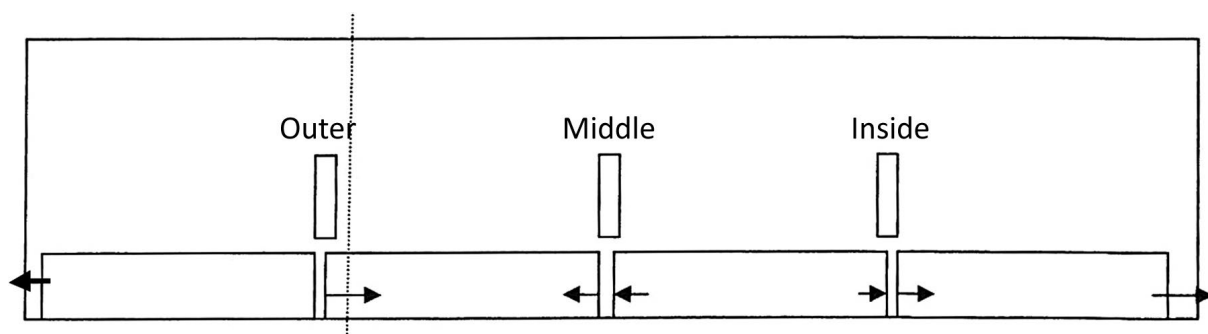
The outboard fitting was practically intact. The middle one was bent significantly to the left as seen from behind and below, and the inboard one was missing. Since it was located very close to the area where the wing broke, it is fairly likely that it remained attached to the part of the wing that did not detach; however, it was not found in the wreckage, meaning it must have burned completely in the fire.

Figure 14. Position of fittings on left wing
