**Air Accidents Investigation Branch**

**Report on the accident to  
Eurocopter EC225 LP Super Puma, G-REDU  
near the Eastern Trough Area Project (ETAP)  
Central Production Facility Platform  
in the North Sea  
on 18 February 2009**

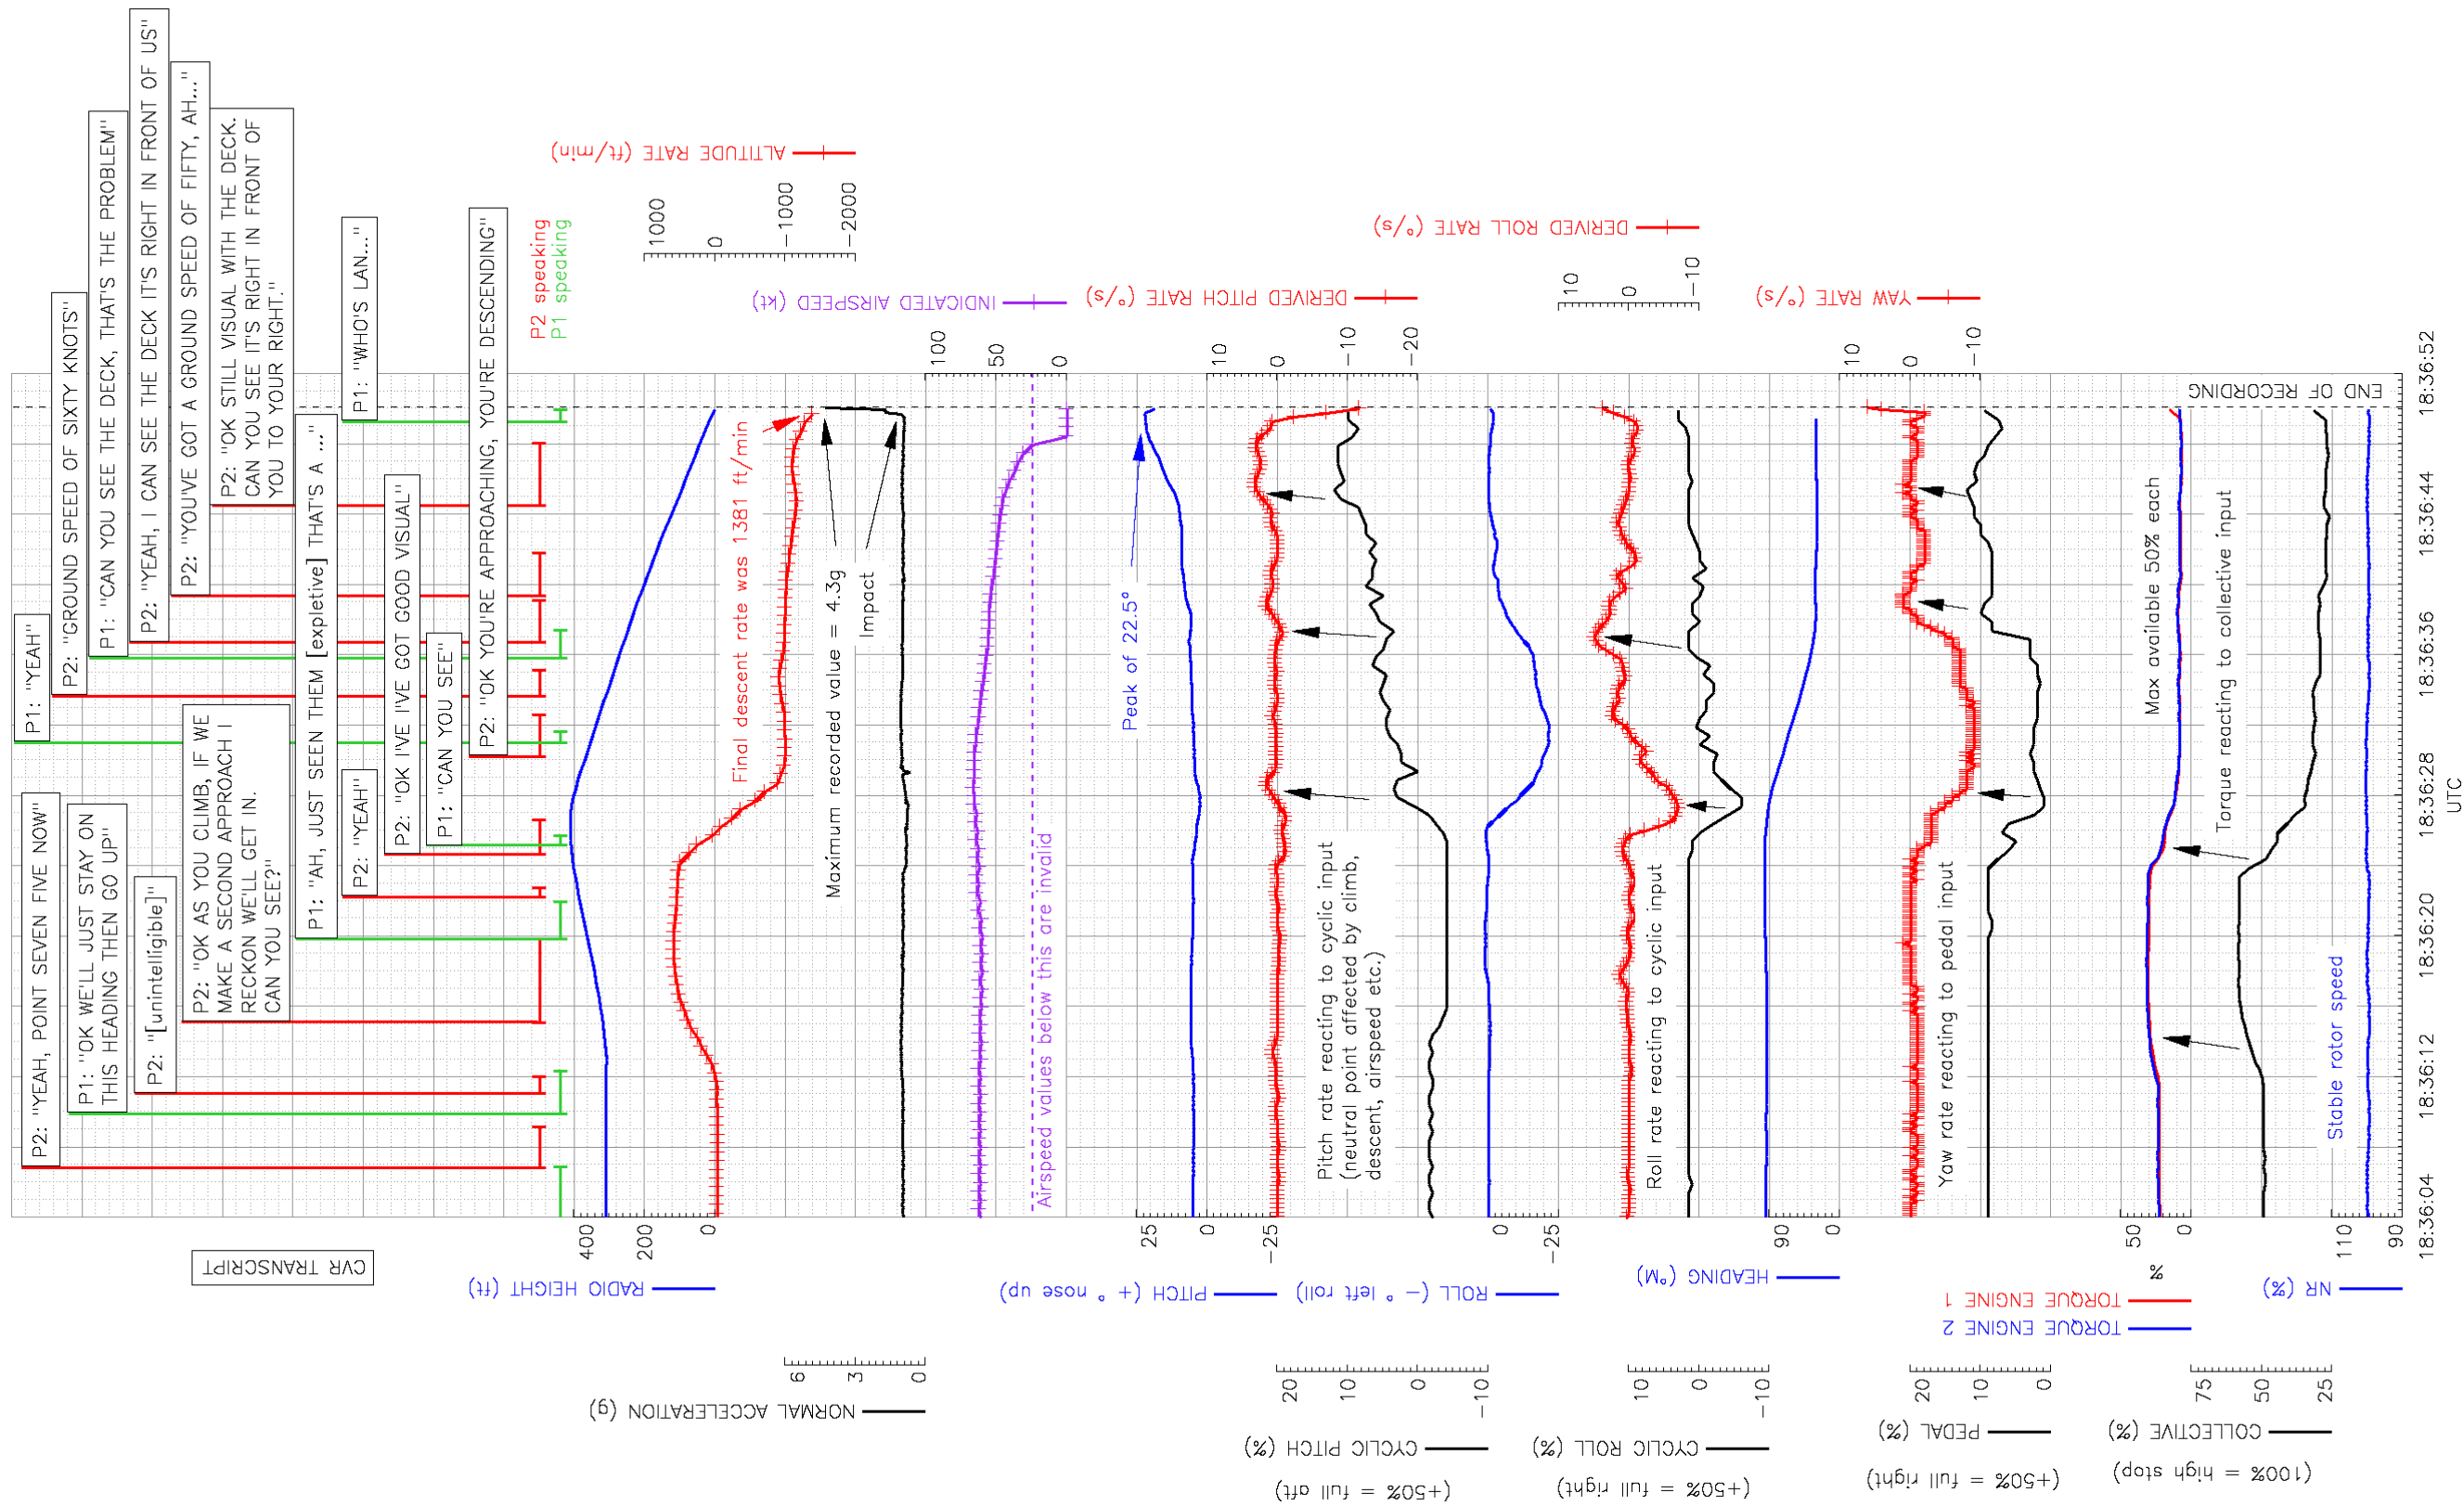
**Figure 2**  
Recorded data and pertinent CVR extracts at the end of the accident flight

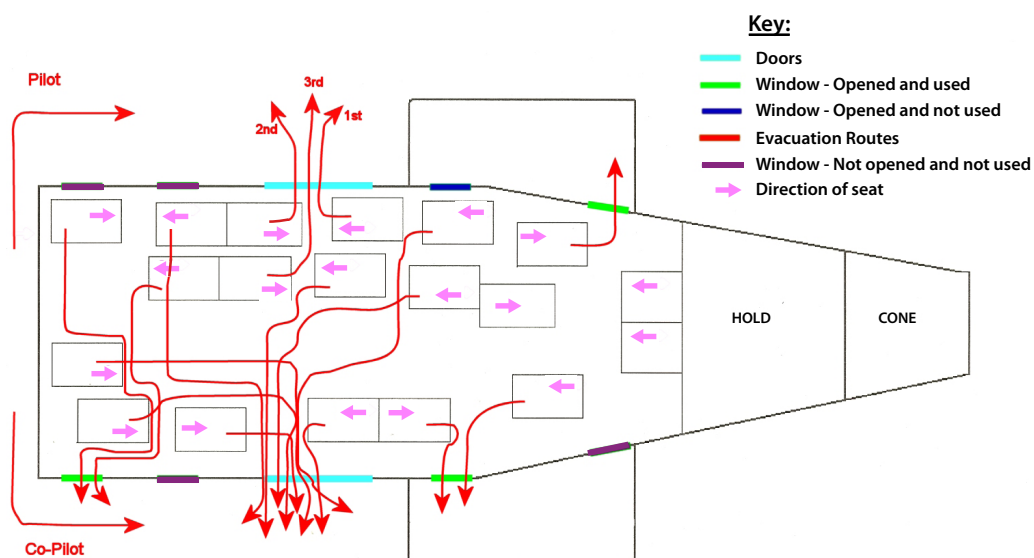
**Figure 11**

The helicopter remained stable and upright on the surface and the passengers evacuated through windows and doors (see Figure 11). The passengers, and the commander, exited the aircraft directly into the life rafts. The co-pilot jumped into the water, via his own door, then climbed into the left liferaft.

Passenger seating arrangement and evacuation routes

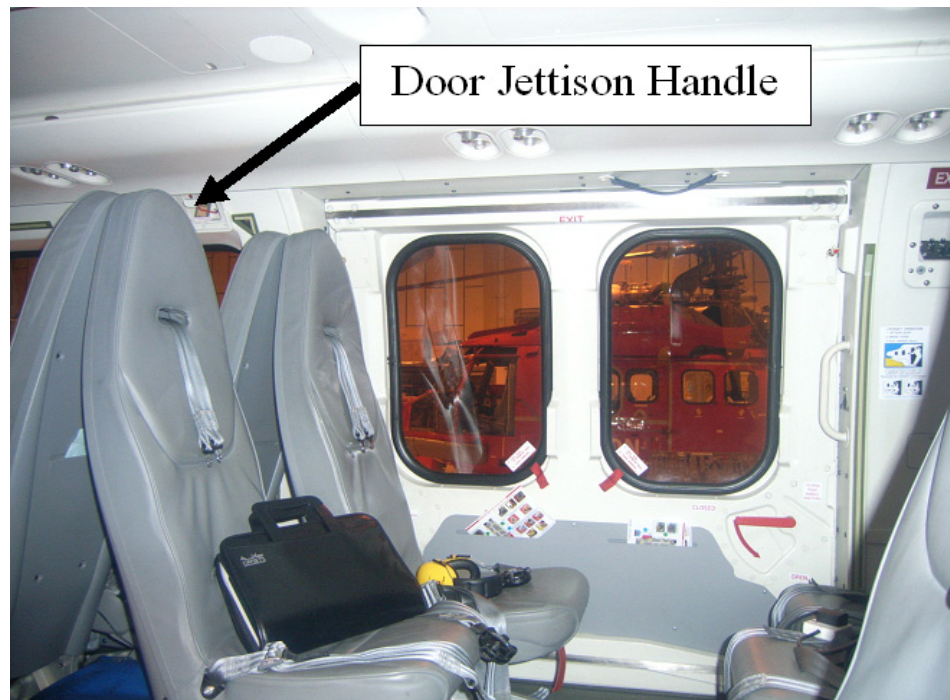
**Figure 12**

Most of the passengers did not experience any problems with the exits. However, those who were sitting beside the right cabin door were unable to locate that door's jettison handle. They opened the cabin door using the normal method and, in so doing, blocked the right forward cabin window exits (see Figure 12).

Position of right cabin door internal jettison handle

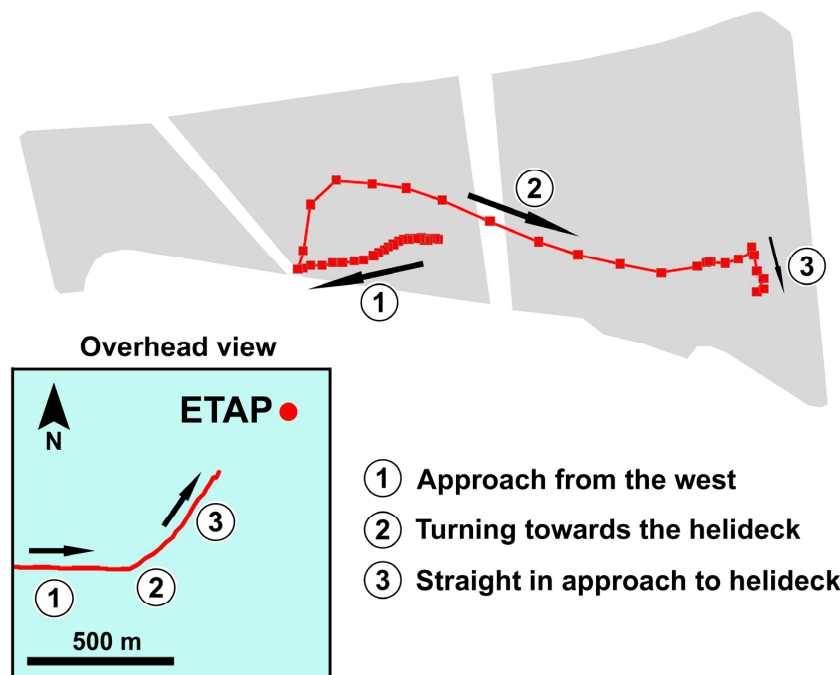
**Figure 16**

Without a visible horizon or good surface texture cues, the apparent position of the platform would have led to the perception that the approach was normal but becoming high and fast in the final 5 seconds before impact. This accords with the commander's impressions. See Figure 16.
