**CRASHED DURING APPROACH, BOEING 737-800,  
NEAR AMSTERDAM SCHIPHOL AIRPORT,**  
25 February 2009

The Hague, May 2010 (project number M2009LV0225\_01)

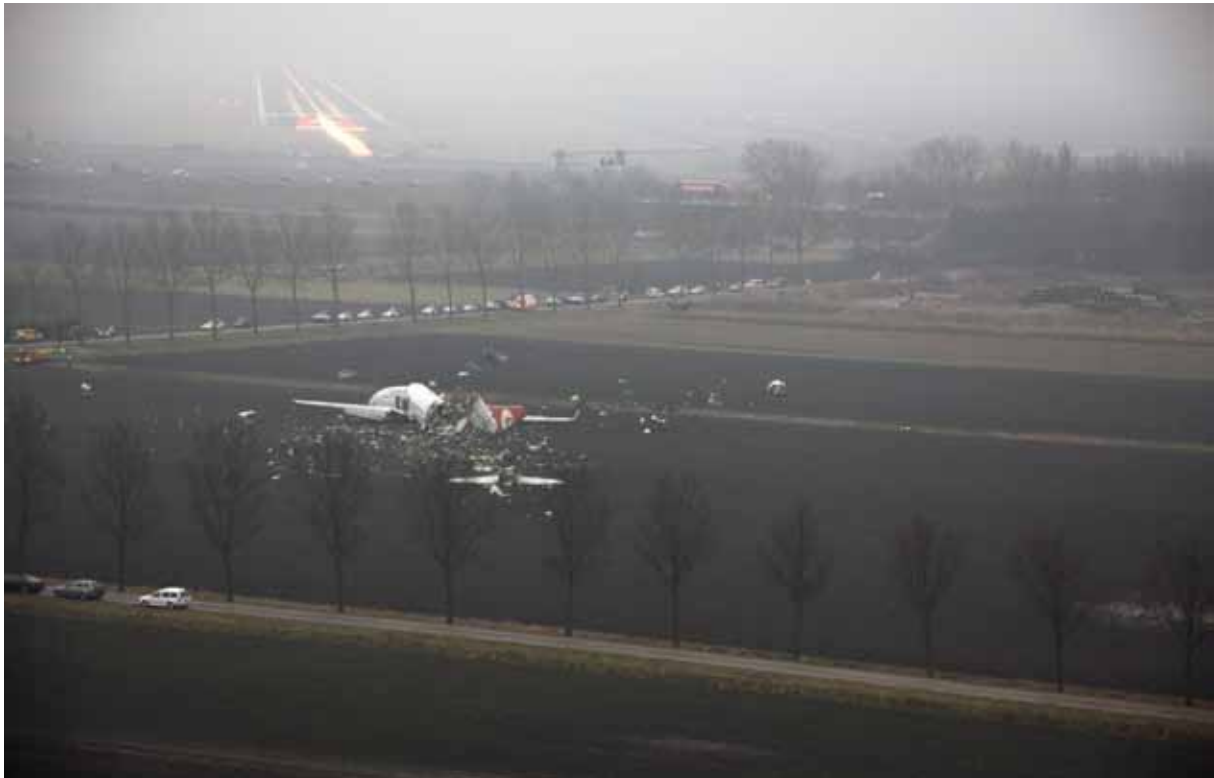
A Boeing 737-800 of Turkish Airlines made a flight from Istanbul Atatürk Airport in Turkey (LTBA) to Amsterdam Schiphol Airport (EHAM) on 25 February 2009.<sup>1</sup> The aircraft crashed while on the approach for runway 18R (the 'Polderbaan') and ended up in a field at a distance of approximately 1.5 kilometres from the runway threshold (see illustration 1). Four crew members and five passengers died and three crew members and 117 passengers were injured.<sup>2</sup>

*Illustration 1: the Boeing 737-800 that crashed with runway 18R in the background (source: KLPD)*

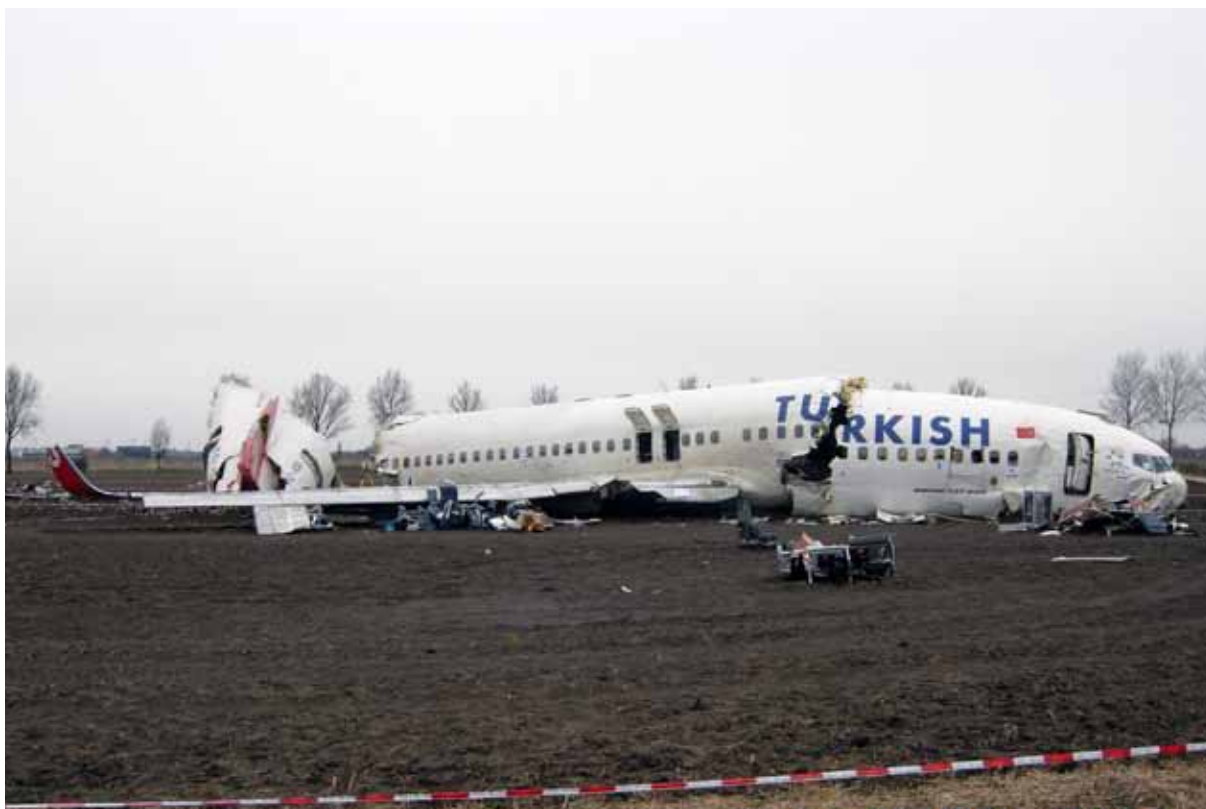
The aircraft was destroyed as a result of the impact. The fuselage of the aircraft broke into three sections; the tail section, the main section with the wings and the front section with the cockpit. The material damage to the aircraft is described in appendix K.

*Illustration 5: side view of the Boeing 737-800*

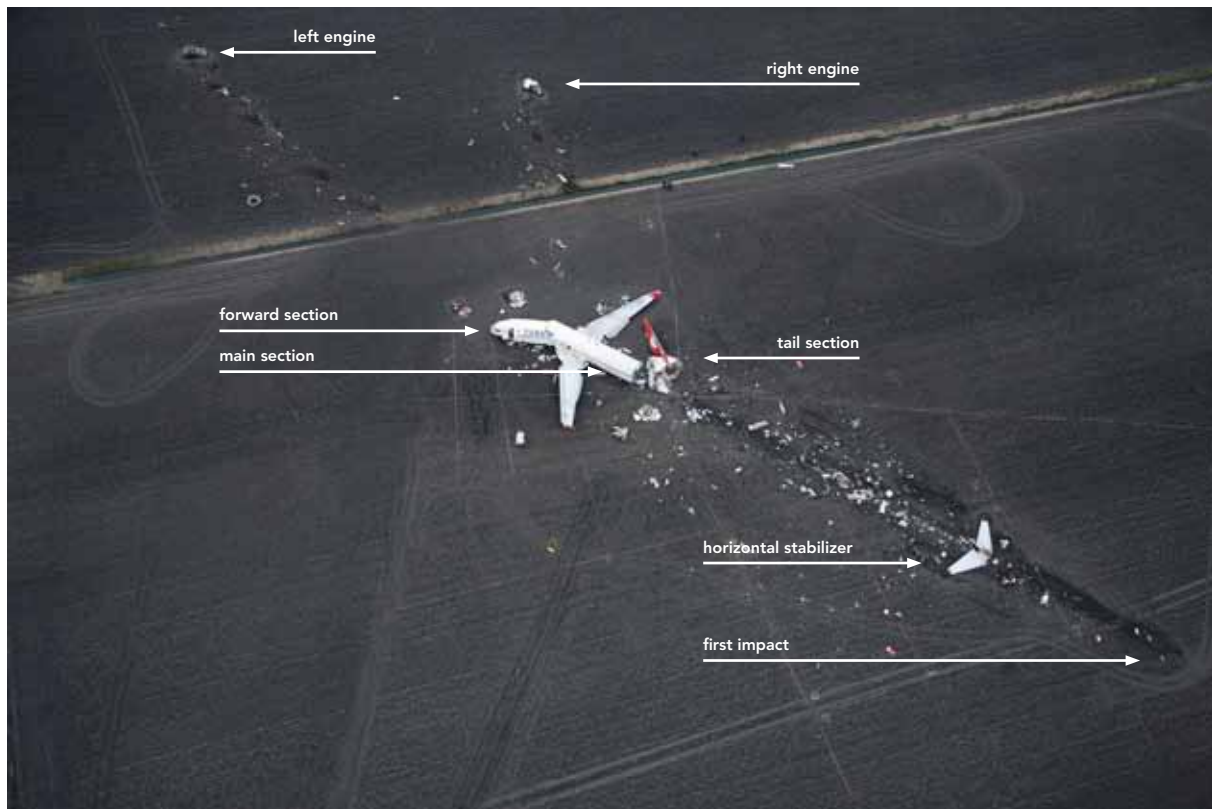
The traces of the impact revealed that the rear part of the fuselage was the first to hit the ground. The aircraft came to a standstill in a field relatively quickly due to the low forward speed that the aircraft had when impact took place. The soil conditions may possibly have had an additional braking effect.

All parts of the aircraft have been found at the location of the accident and there are no indications that something may have broken off during the flight. The flight data recorder and cockpit voice recorder data do not indicate this in any way either.

*Illustration 6: aerial photo of the aircraft that crashed (source: KLPD)*

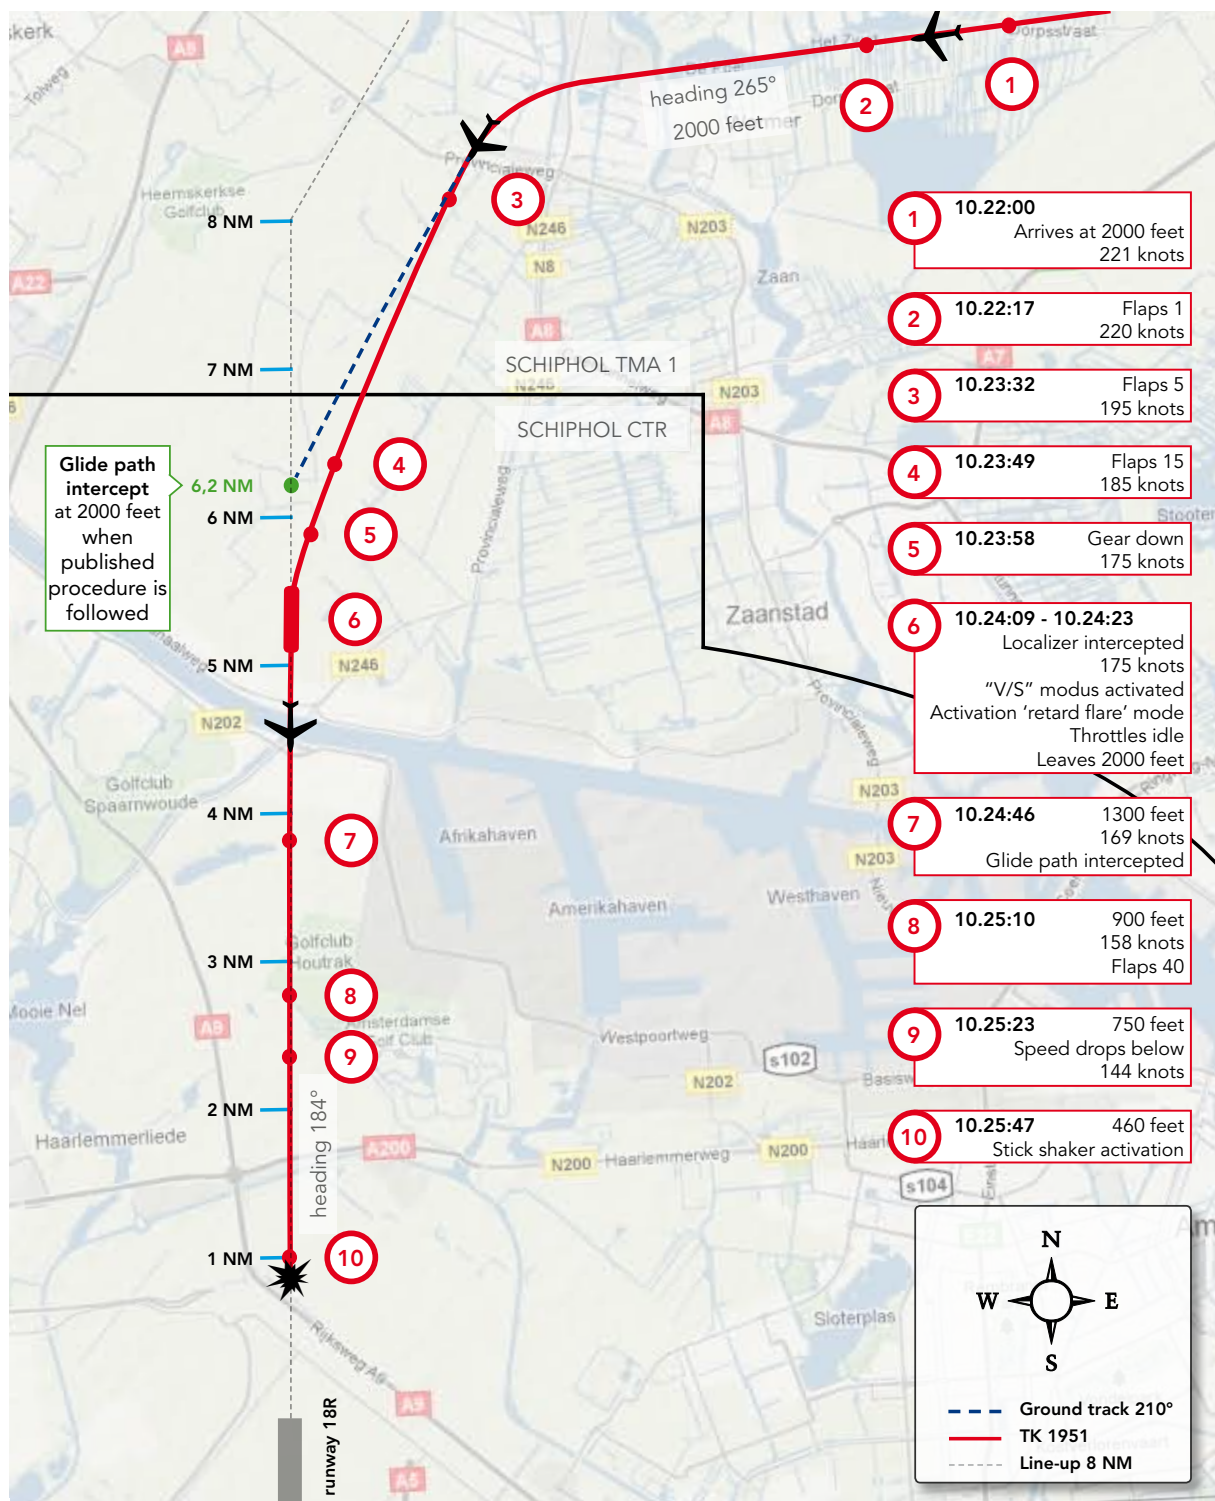
Illustration 8: top view of the ILS approach of flight TK1951 versus the intended ground track of the controller

Air Traffic Control the Netherlands has indicated that executing a turn-in manoeuvre between 5 and 8 NM for runway 18R at Schiphol airport as it occurred with regard to flight TK1951 occurs in more than 50% of all approaches for this runway. In addition, pilots sometimes ask for a short line up. LVNL is, therefore, of the opinion that aligning aircraft within the 8 NM is a normal situation. Air Traffic Control the Netherlands is also of the opinion for this same reason that aircraft crew do not have to be asked whether they can or wish to accept such a line up. Air Traffic Control the Netherlands states that air traffic controllers may broadly interpret the procedures for lining

11. IVW should monitor LVNL's compliance with national and international air traffic control procedures.

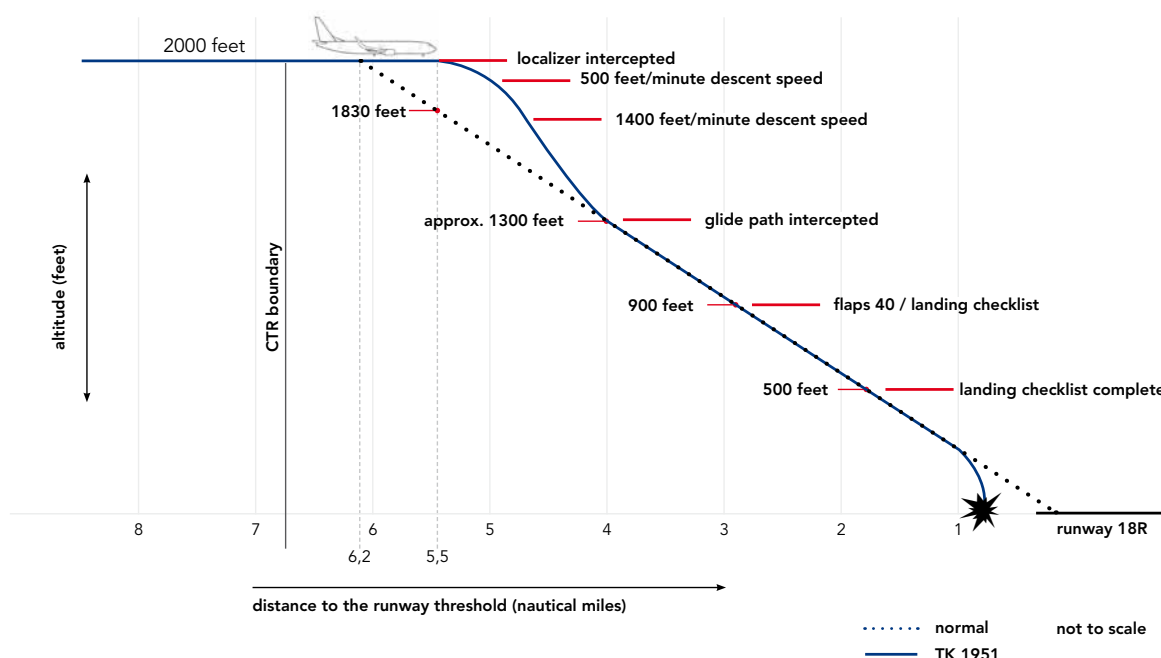
In an ILS approach the localizer and glide slope signal is normally intercepted automatically using the autopilot. The glide slope signal can normally only be intercepted after the localizer signal has been intercepted. The normal ILS procedures were not followed because the localizer signal was intercepted above the glide slope. As a result of this the glide slope signal could not be intercepted automatically. The result was that the cockpit crew had to perform a number of additional actions. The aircraft had to be put in a steeper angle of descend to obtain the required glide slope. This is shown in illustration 10 also. The actions that the crew performed in order to intercept the glide slope from above can be found in the timeline in appendix S. These actions had to be performed quickly and accurately and monitored constantly to prevent the angle of descend becoming too great to intercept the glide slope and to prevent the aircraft stopping the descend too soon to arrive at the selected altitude<sup>52</sup>. According to the cockpit voice recorder these actions were not discussed. Given the sequence and speed of these selections it is not likely that these actions were performed by the relatively inexperienced first officer, but that the captain performed these actions, which would normally be performed by the first officer as pilot flying, in addition to his own tasks. Analysis of the cockpit voice recorder, the timeline and simulator tests has confirmed this.

Illustration 10: side view of the approach of flight TK1951

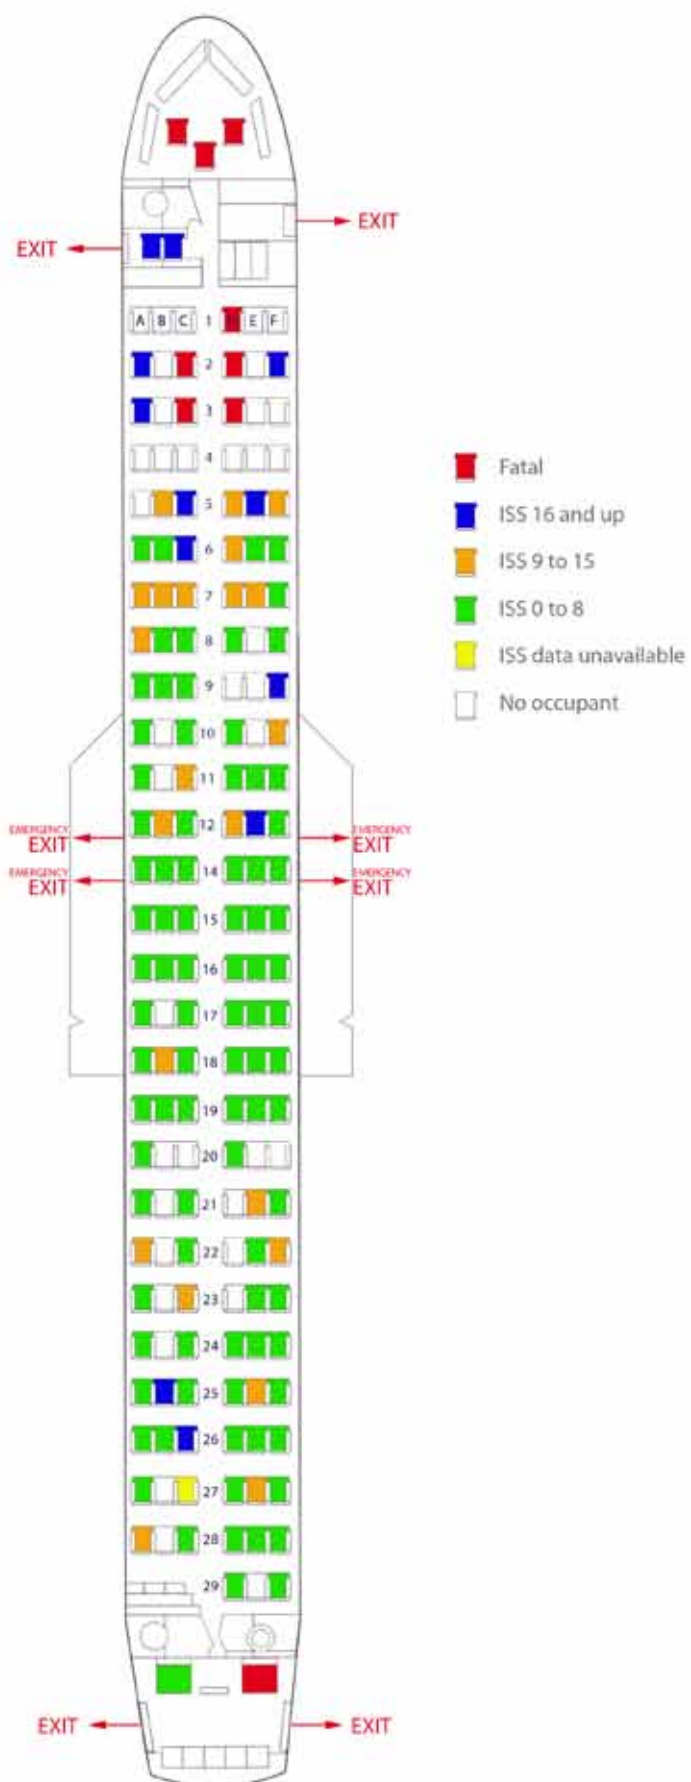
Illustration 11: gravity of injuries to occupants by seating position, according to ISS scale

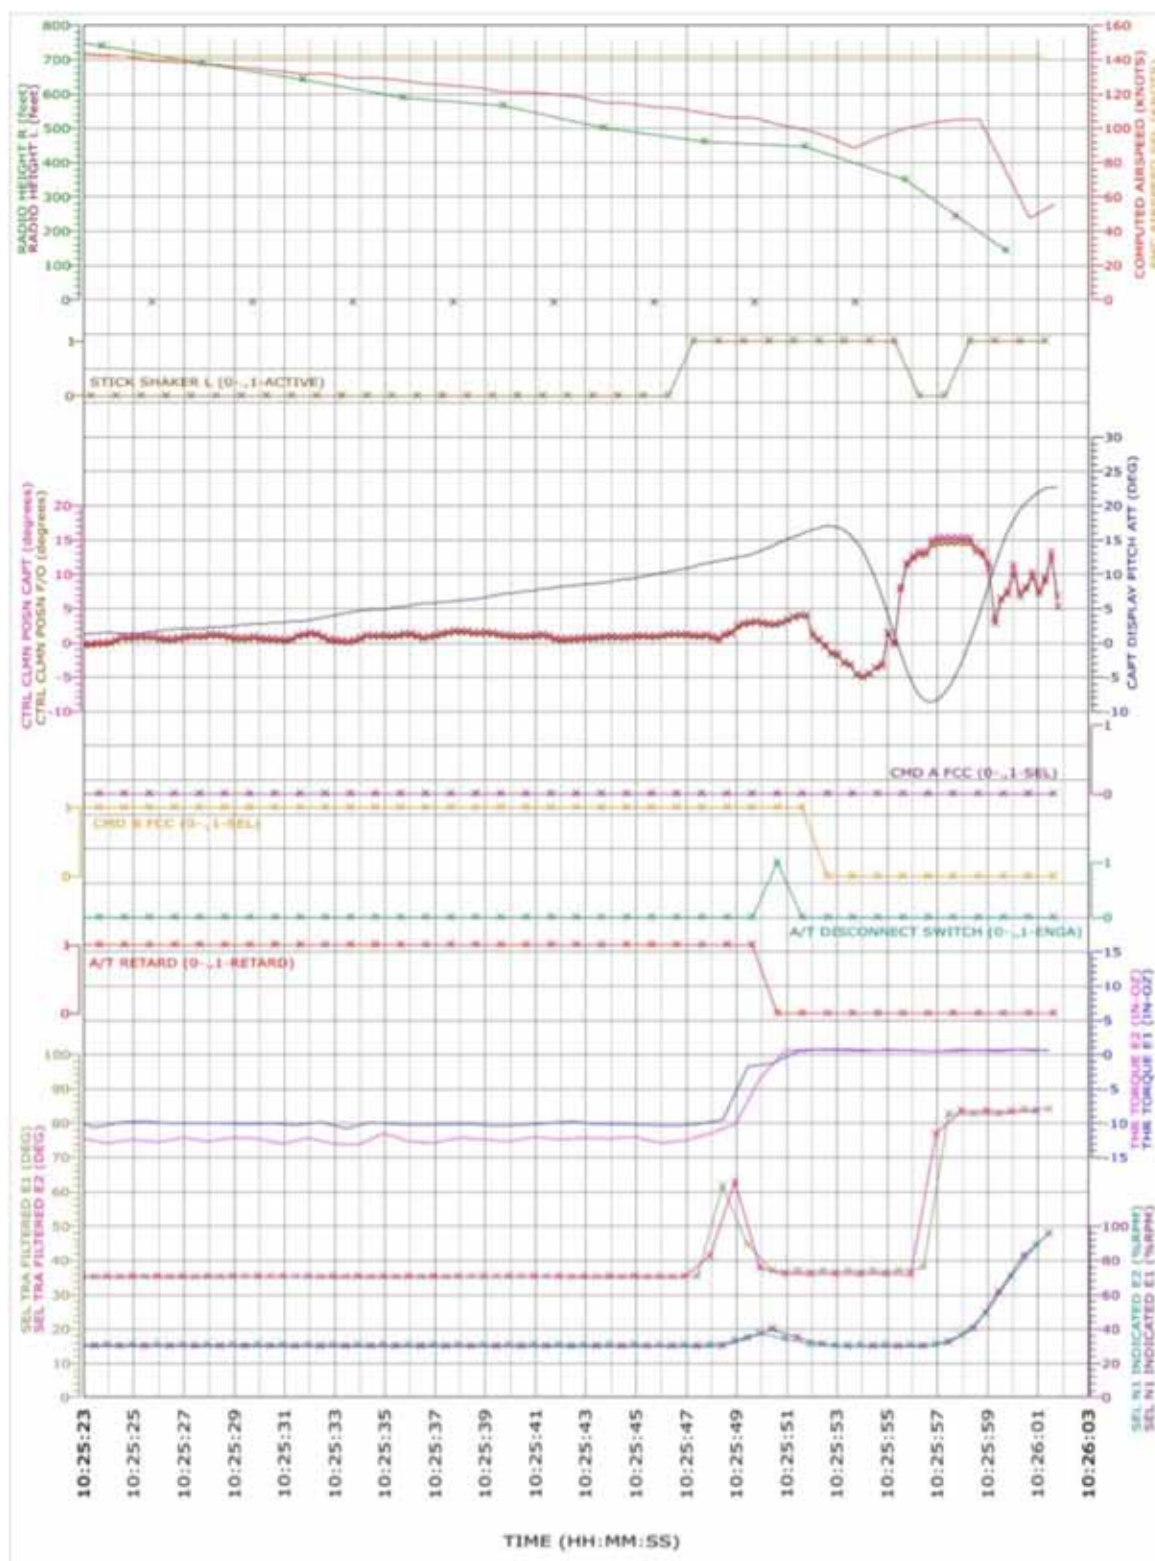
Illustration 13: parameters flight data recorder, last 40 seconds flight TK1951

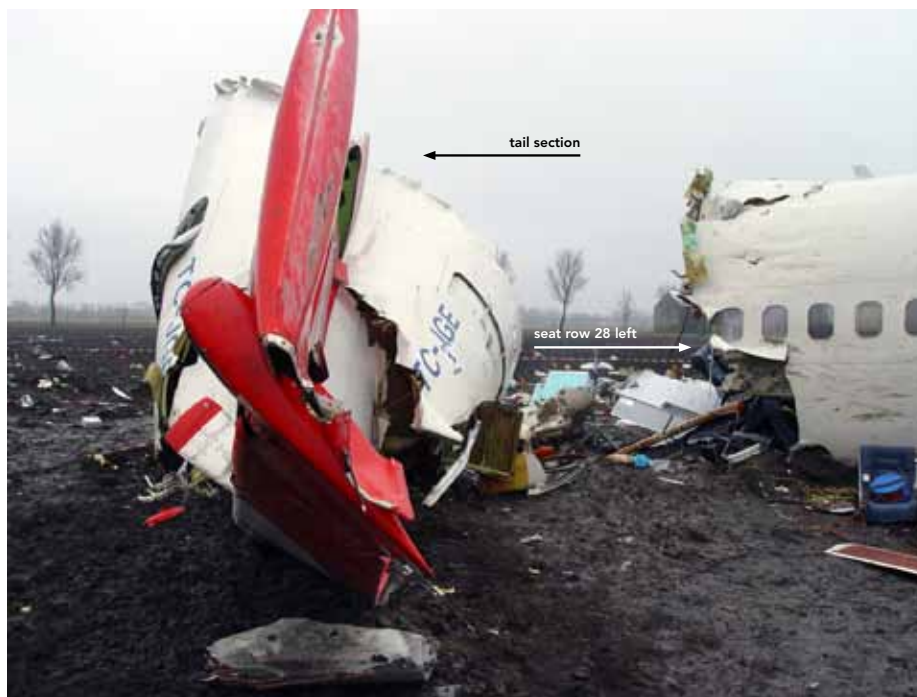
This part of the fuselage with the vertical stabiliser still attached separated in front of the rear cabin doors and sustained heavy damage. This section comprised the rear pantry and the two aft doors and was found turned 114 degrees towards the right wing. The doors of the left and right exits were partially open while the locking mechanism of both doors was still closed. Both the aft facing right and left cabin crew seats were found outside the tail section.

*Illustration 14: tail section*

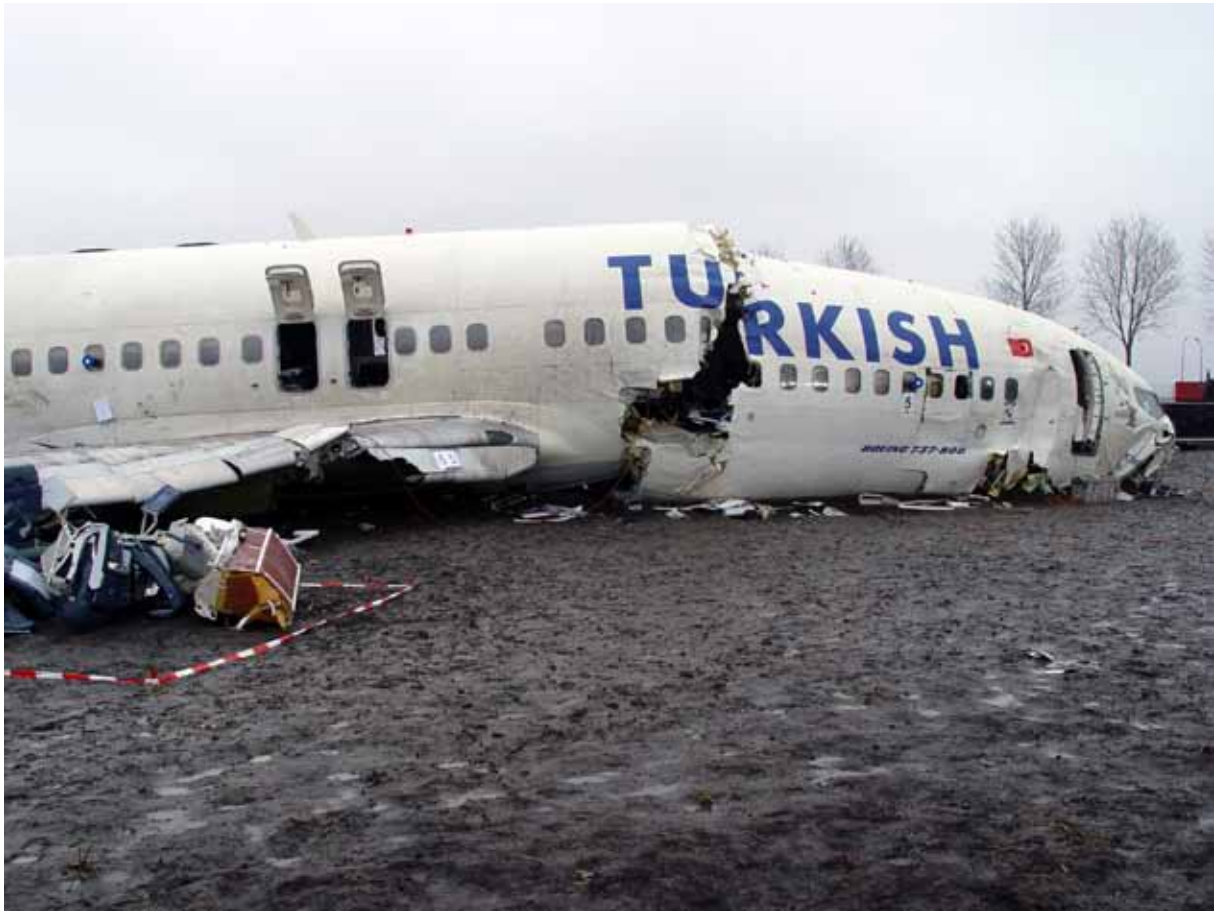
*Illustration 15: main section and front section*

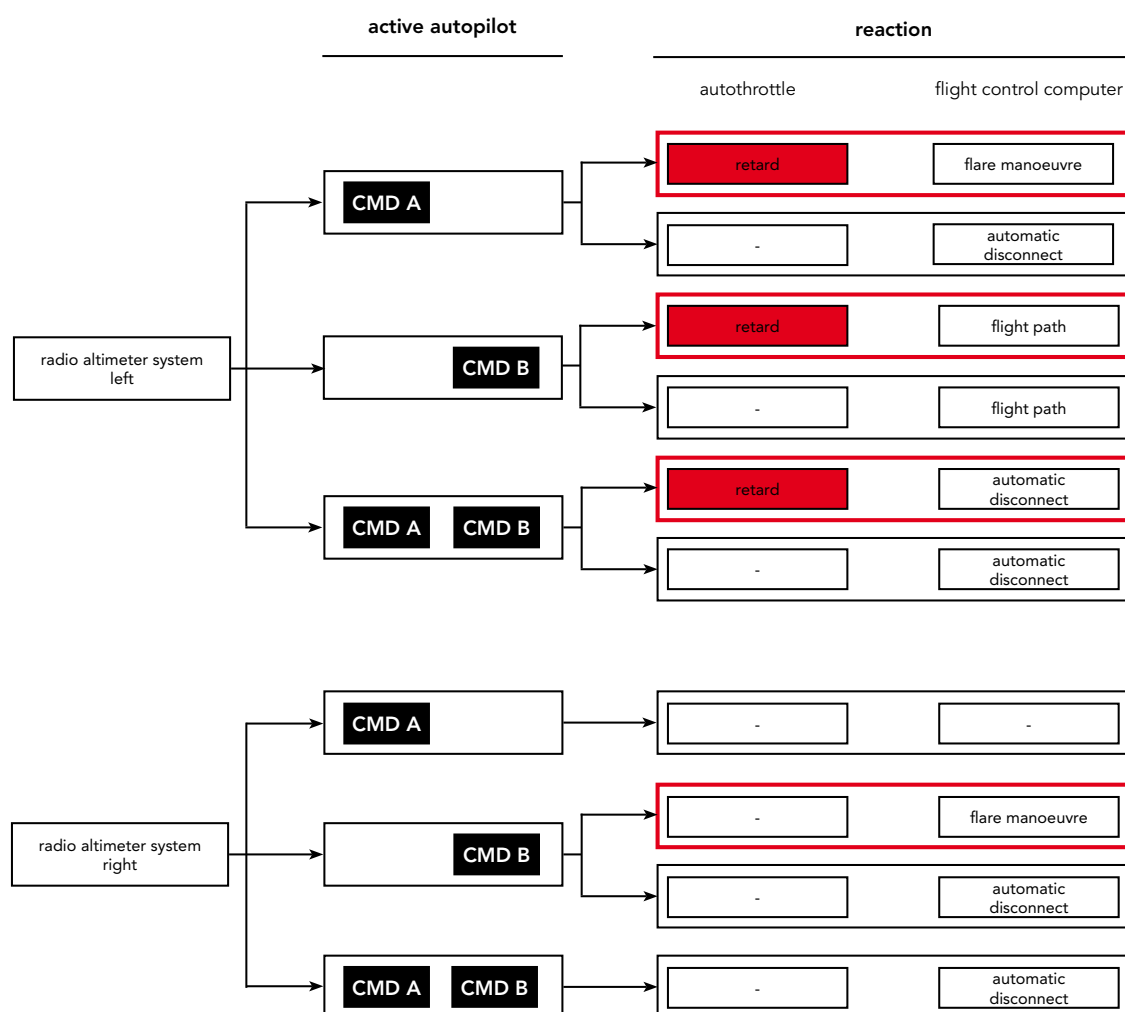
In this test, the 'retard flare' mode was activated during a 'dual channel' approach. The 'master' flight control computer activated the 'flare' command. The flight mode annunciator briefly showed 'FLARE'. The autothrottle used the 'flare' command and activated the 'retard flare' mode. The 'retard flare' mode remained active when the left-hand radio height value was less than 27 feet.

Illustration 18 shows a simplified overview of the most relevant responses to the input data for the three test configurations. Not all of the responses are included in this overview. The overview does not, for instance, include the differences between the Smiths and Collins flight control computers with radio height values characterised as 'non computed data'.

*Illustration 18: simplified schematic overview of the responses of the autothrottle and flight control computer to an erroneous radio altimeter signal (<27 feet).*

2. The FAA and EASA should ensure that the undesirable response of the autothrottle and flight management computer caused by incorrect radio altimeter values is evaluated and that the autothrottle and flight management computer is improved in accordance with the design specifications.

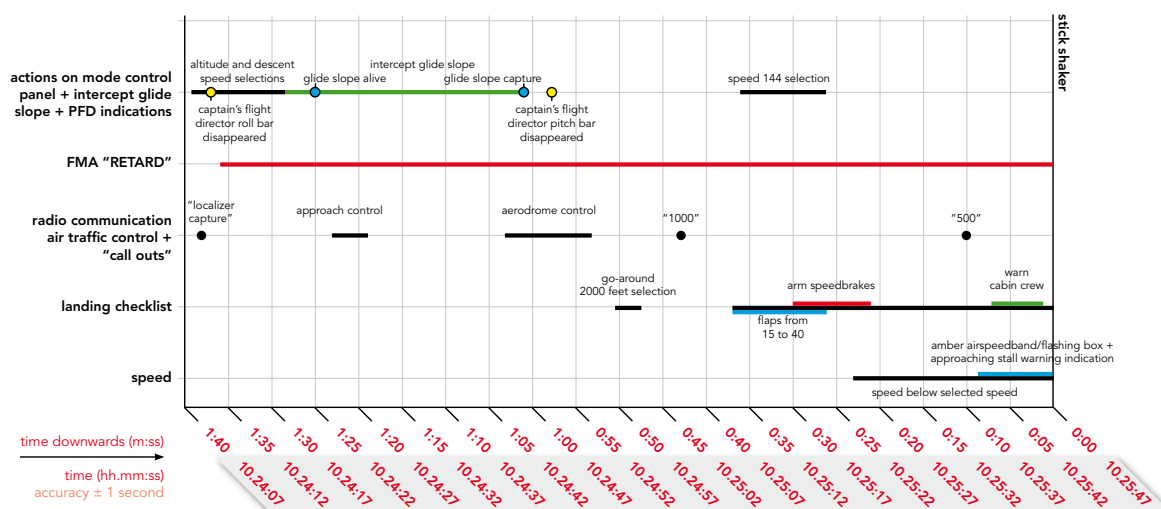
The crew must select a lower altitude<sup>118</sup> and another mode for the autopilot to ensure the aircraft descends. The flight data recorder data and the simulator tests have shown that the following actions were performed consecutively for intercepting the glide slope from above, which in total took approximately 40 seconds to accomplish (also see the timeline):

Illustration 19: timeline of actions performed by the crew between the interception of the localizer signal and the activation of the stall warning

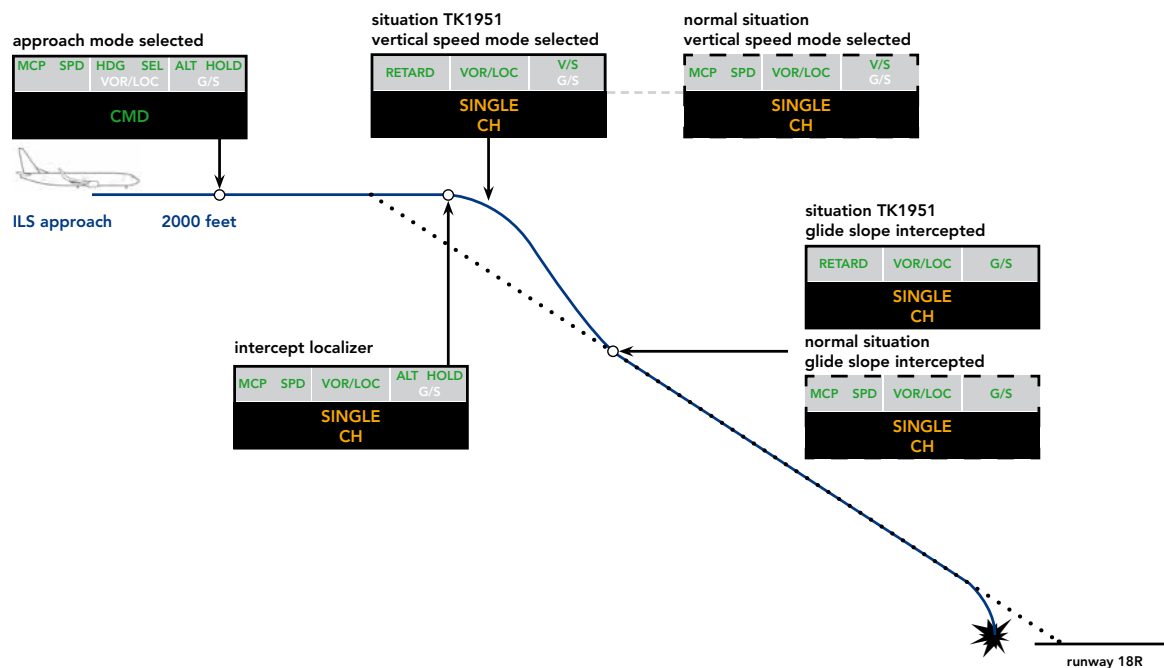
Illustration 20: flight mode annunciations during the approach of flight TK1951
