# Final Report

On the accident on **1<sup>st</sup> June 2009**  
to the **Airbus A330-203**  
registered **F-GZCP**  
operated by **Air France**  
**flight AF 447 Rio de Janeiro - Paris**

Bureau d'Enquêtes et d'Analyses  
pour la sécurité de l'aviation civile

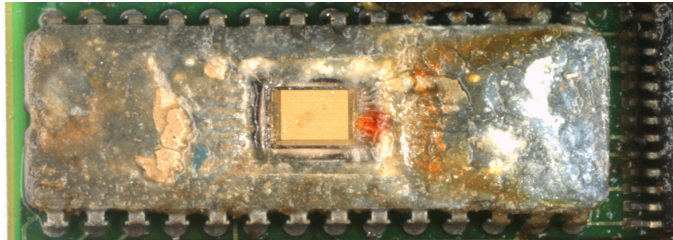
The two computers were examined. The memory components containing the data were damaged. One of the components had been torn out and the other suffered from internal short-circuits. The work was brought to a conclusion.

Figure 30: Memory component from one of the FCDC

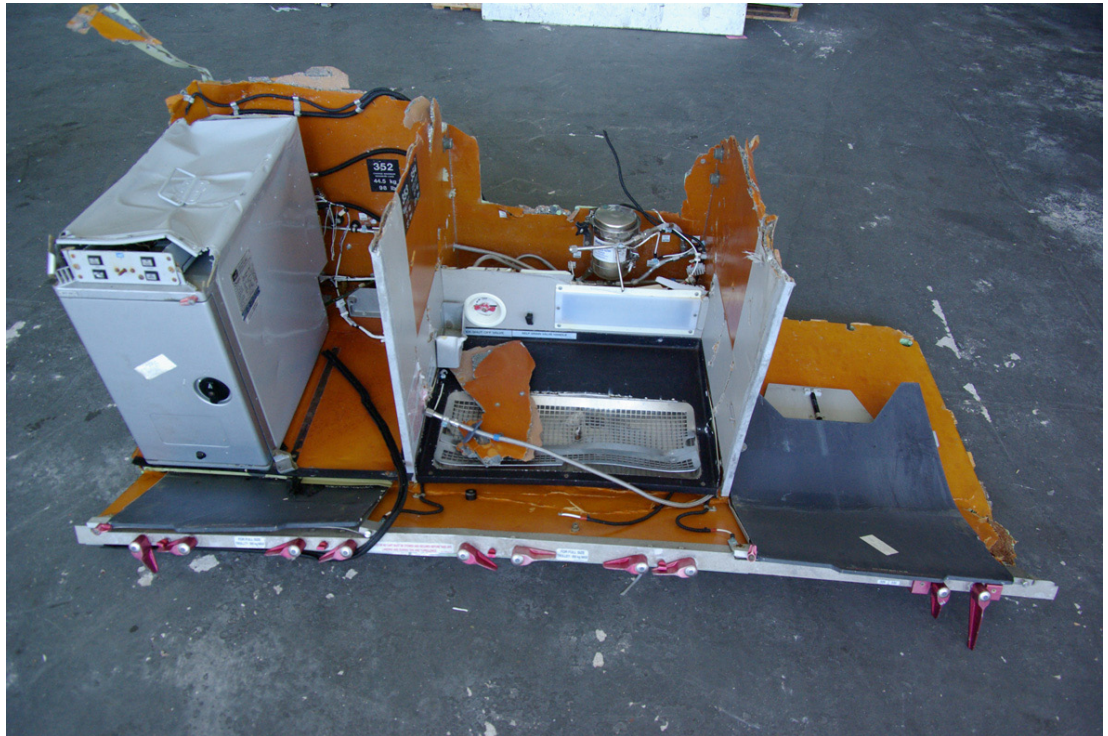
The overhead luggage rack attachment fittings had deformations that are due to vertical compression and to a forward movement of the luggage racks.

Figure 35: Part of Galley G3: downwards deformation at the level of the galley's heavy parts

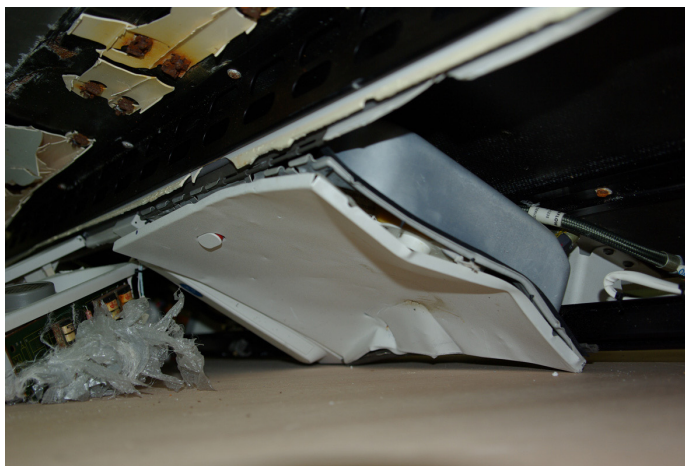
Figure 40: Passenger oxygen container recovered closed:  
the deformations on the cover matched those on the box

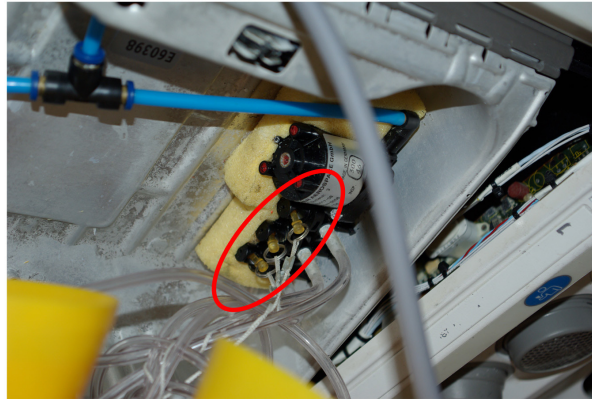
In normal operation, the oxygen is sent to the mask when the passenger releases the system's lock-pin by pulling on the mask. Several pins were found in place, closing the oxygen circuit.

Figure 41: Passenger oxygen container recovered open: the three pins are in place

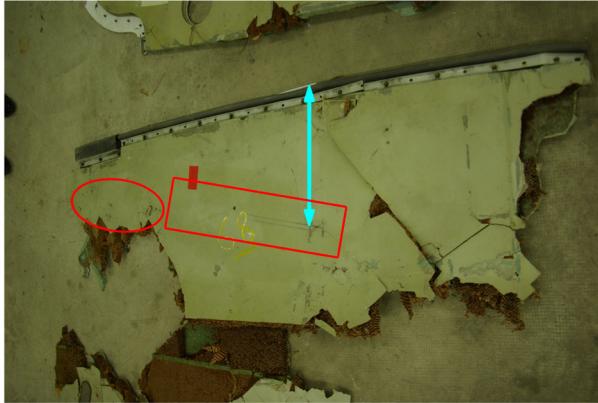
Several parts of the flap extension mechanism fairing were found. There were marks on two of them (positioned at the level of flap track N°3), made by the flap extension track on impact. Analysis of these marks (morphological and dimensional examinations) and comparison with an identical aeroplane made it possible to determine that the flaps were in the “retracted” position (see photo below) at the time of impact with the water (measurement of the distance between the track and the lower surface of the flap, position of the carriage on the track).

Figure 43: Part of the No. 3 flap track fairing on the left wing

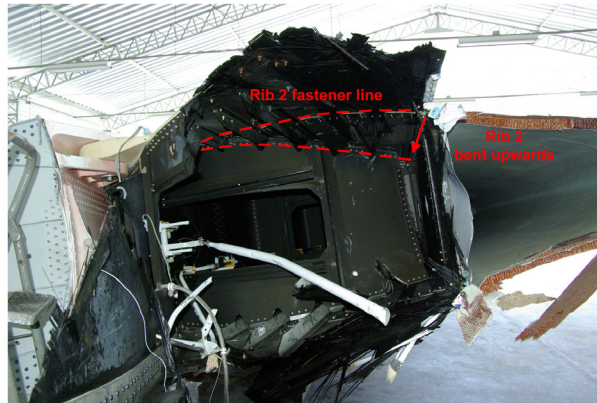
- ☐ Failure of the leading edge right- and left-hand panels
- ☐ Longitudinal cracking of the leading edge stiffener
- ☐ HF antenna support (attached to the forward spar): failure of the lower part, crumpling indicating bottom-upwards compression loads.

Figure 45: Rib 2 bent upwards as a result of bottom-upwards compression loads

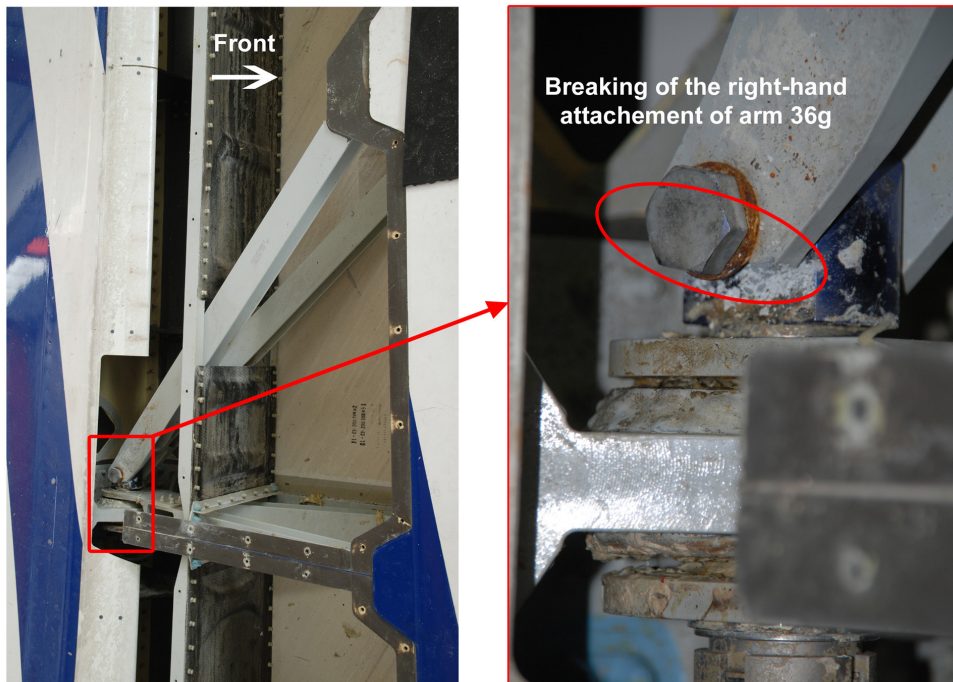
The size of this arm is calculated to withstand a maximum load of 120,000 N, corresponding to a relative acceleration of 36G of the rudder in relation to the vertical stabilizer.

Figure 47: Arm 36G, right view: failure of the rudder attachments

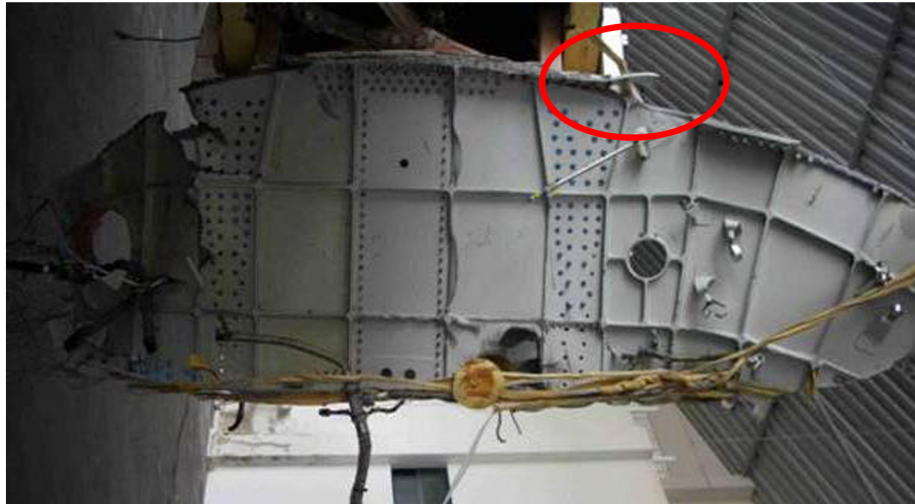
The fuselage was sheared along the frames and centre and aft attachment lugs by loads applied bottom-upwards.

Figure 48: Frame 87: shearing of the frame and fuselage skin along the frame

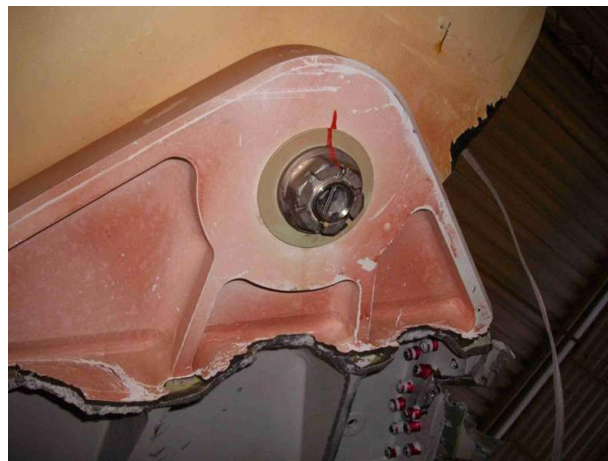
Figure 49: Right-hand aft lug: shearing of the fuselage along main frames 86-87

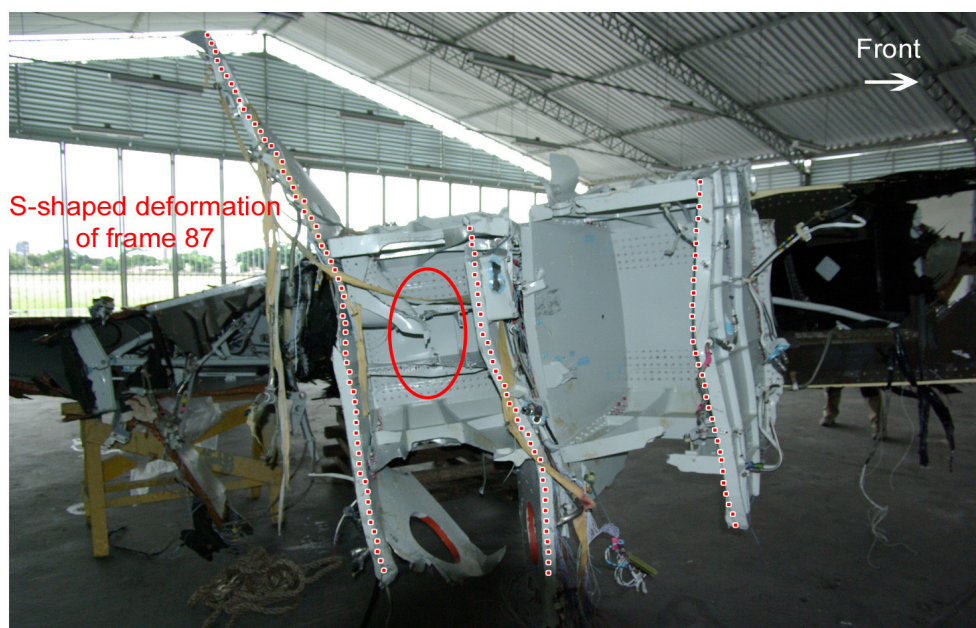
The part of frame 87 that can be seen had undergone S-shaped deformation: the left-hand side forwards, and the right-hand side backwards. The horizontal stabiliser actuator supports were deformed and broke in a backwards movement from the front. These observations indicate a backwards movement of the trimmable horizontal stabiliser.

Figure 50: Frames 84 to 87: S-shaped deformation of frame 87, with frames 84 and 85 pushed in backwards; failure of the horizontal stabiliser actuator supports between frames 86 and 87 (red circle)

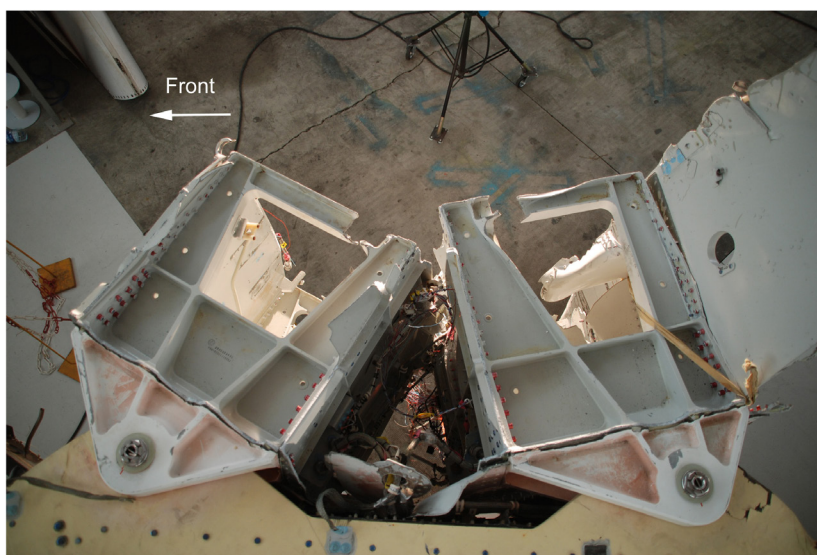
The centre attachment had pivoted backwards with the parts of the frames and web frames that were attached to it. The aft attachment had pivoted forwards with the parts of the frames and web frames that were attached to it.

Figure 51: Fin centre and aft attachments

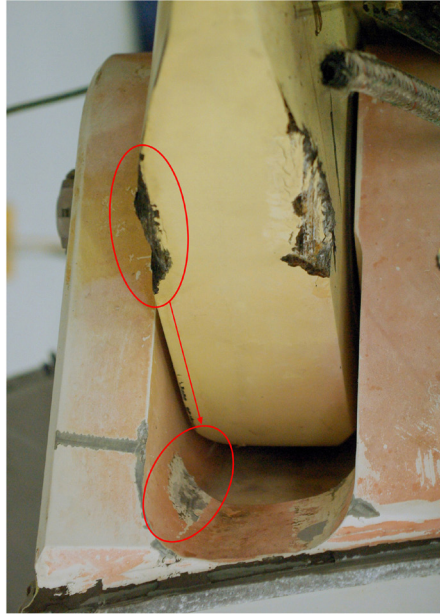
The aft attachment lugs (male on the fin and female on the airframe) had marks indicating a backwards movement of frames 86 and 87 as a whole.

Figure 52: Rear view of the left-hand aft lug: there were marks showing a backwards pivoting of frames 86 and 87

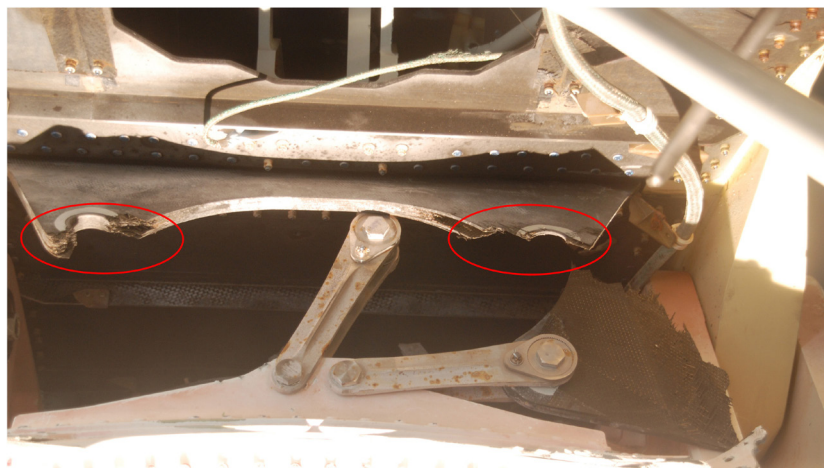
- ❑ Tensile failure of the centre spar at the level of the centre rod attachments;
- ❑ Compression failure of the aft spar at the level of the aft rod attachments and failure of the left-hand rod by buckling.

Figure 53: Tensile failure of the centre spar at the level of the attachment of the lateral load pick-up rods

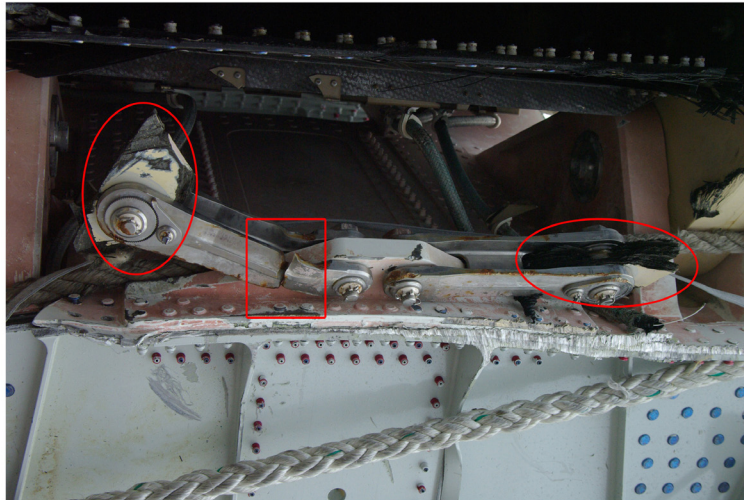
Figure 54: Compression failure of the aft spar at the level of the attachments of the lateral load pick-up rods and failure of the left-hand rod by buckling

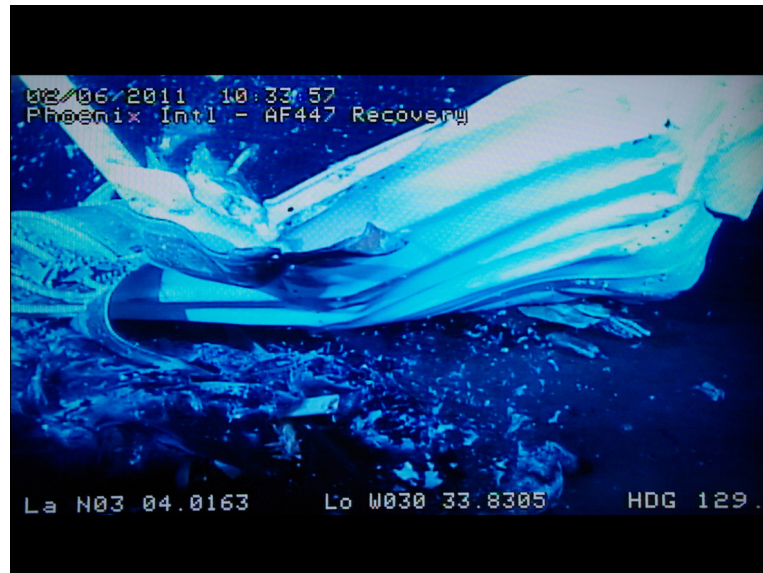
The lower elements of the fuselage were badly broken up and deformed. In these areas, crushing of the sheet-metal between the ribbing was noted, which indicates a vertical component at the time of impact.

Figure 56: Parts of the fuselage

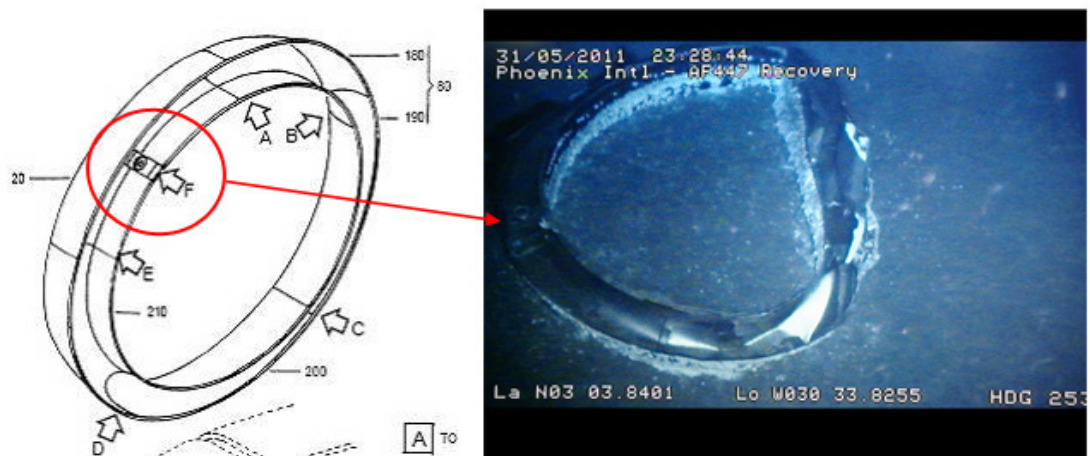
The left engine air entry leading edge had significant deformation on its lower part.

Figure 57: Left engine air intake

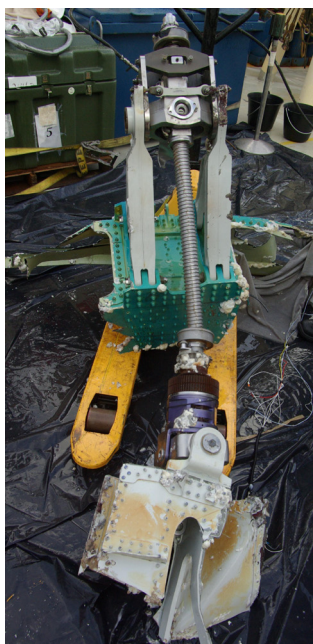
According to the manufacturer's technical documentation, the relative position of the actuator and the THS screwjack corresponded to a THS position of between 13° and 13.5° nose-up.

Figure 61: Trimmable horizontal stabiliser screwjack after being raised on board

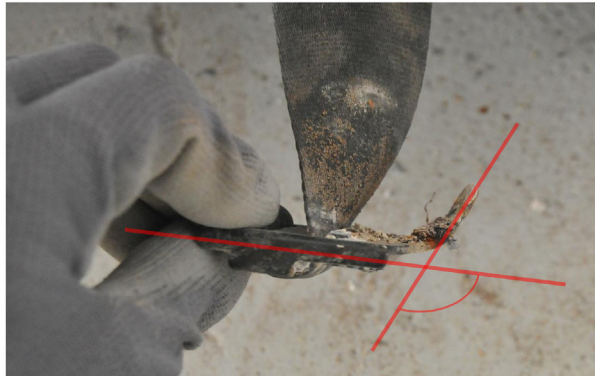
Figure 84: Malformation of the crotch belt fastening
