# FINAL REPORT AIRCRAFT SERIOUS INCIDENT

**Smoke in flight deck and cabin, engine  
shut down and an emergency landing**

**M-01409/AIG-09**

**Boeing 757-200**

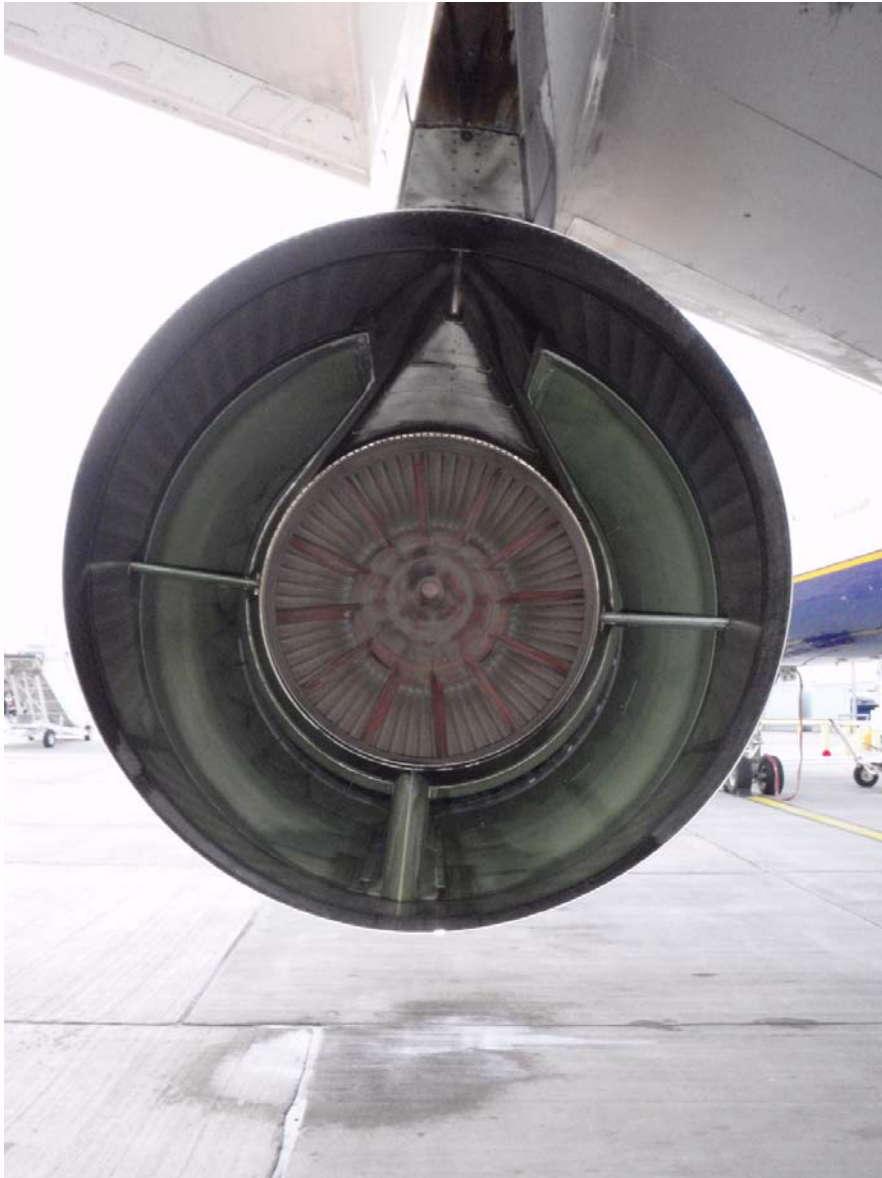
During the field investigation, fluid was found leaking onto the apron under engine #1 cowlings. See Figure 4.

**Figure 4 – Fluid seen leaking onto the apron under engine #1**

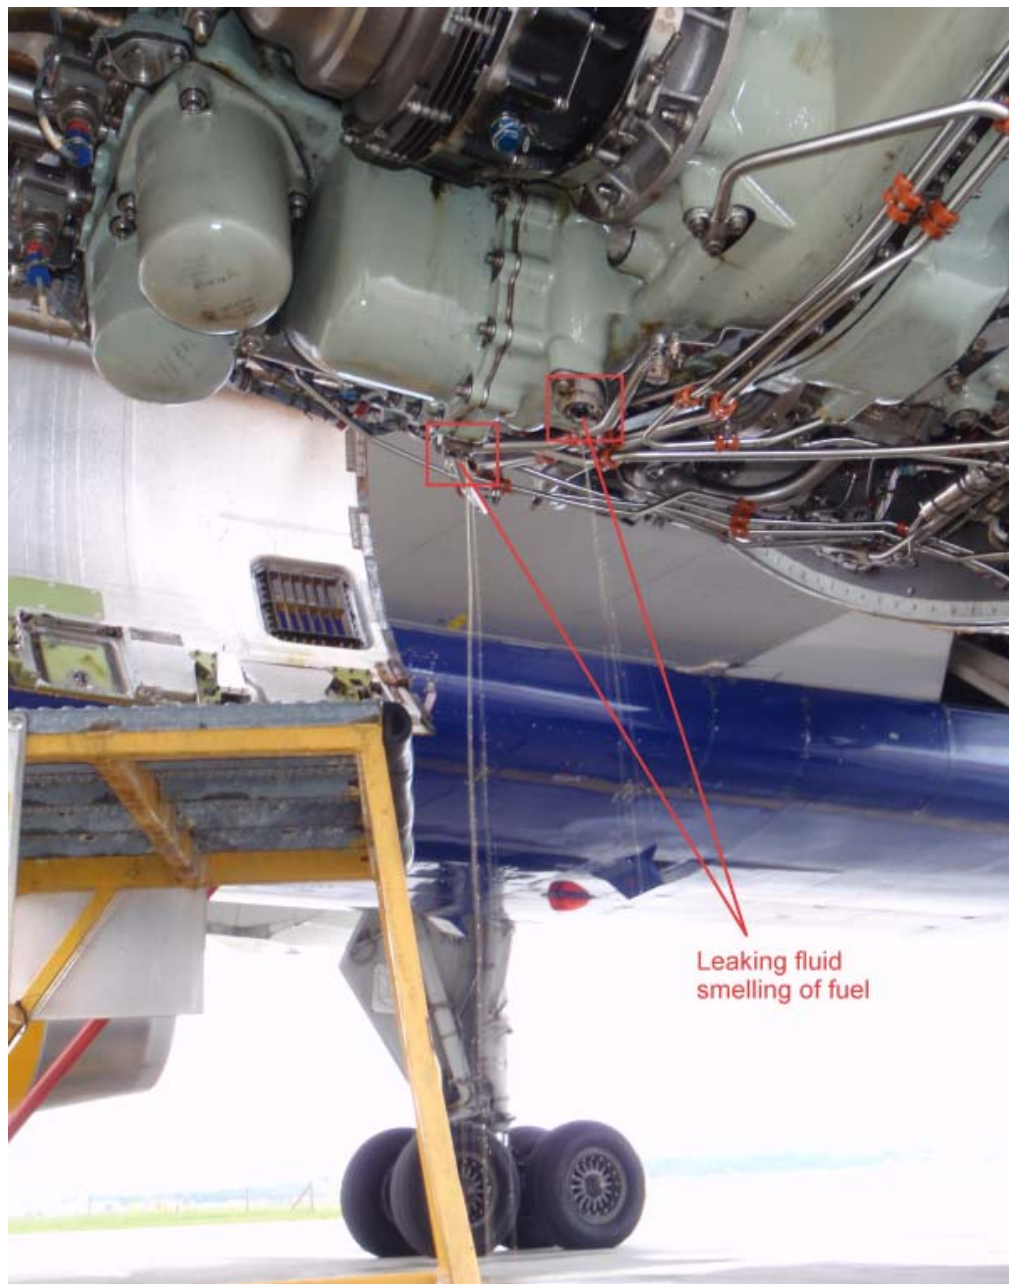
The engine cowlings were opened and fluid smelling of fuel was seen leaking from the location of two Magnetic Chip Detector (MCD)<sup>12</sup> plugs on the high speed external gearbox located in the lower part of the engine. When the MCD plugs were removed the leak continued and the MCD plugs were found to contain extensive debris. This can be seen in Figure 5 and Figure 6. The seats for the magnetic chip detectors in the high speed gearbox should be self-sealing.

Figure 5 – Fluid leaking from the MCD plug locations on the high speed external gearbox

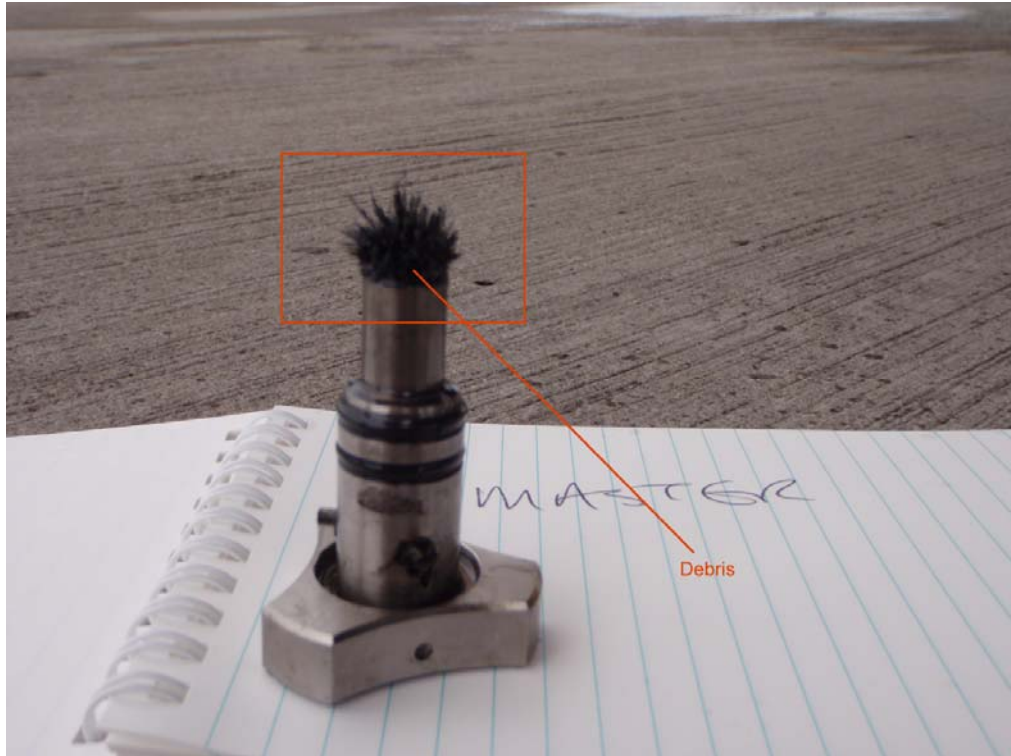
**Figure 6 – Debris found on one of the MCD plugs**

The magnetic chip detectors were removed and analysed by Rolls-Royce laboratory. The debris found on the MCDs consisted of large thin strands of debris, up to 10 mm long. The laboratory had difficulty identifying some of the material types found due to the percentage of alloy elements. According to the laboratory, the material found that could be identified on the MCDs was likely from a locking nut, a stepped sleeve, a carbon face seal and from a cup washer.

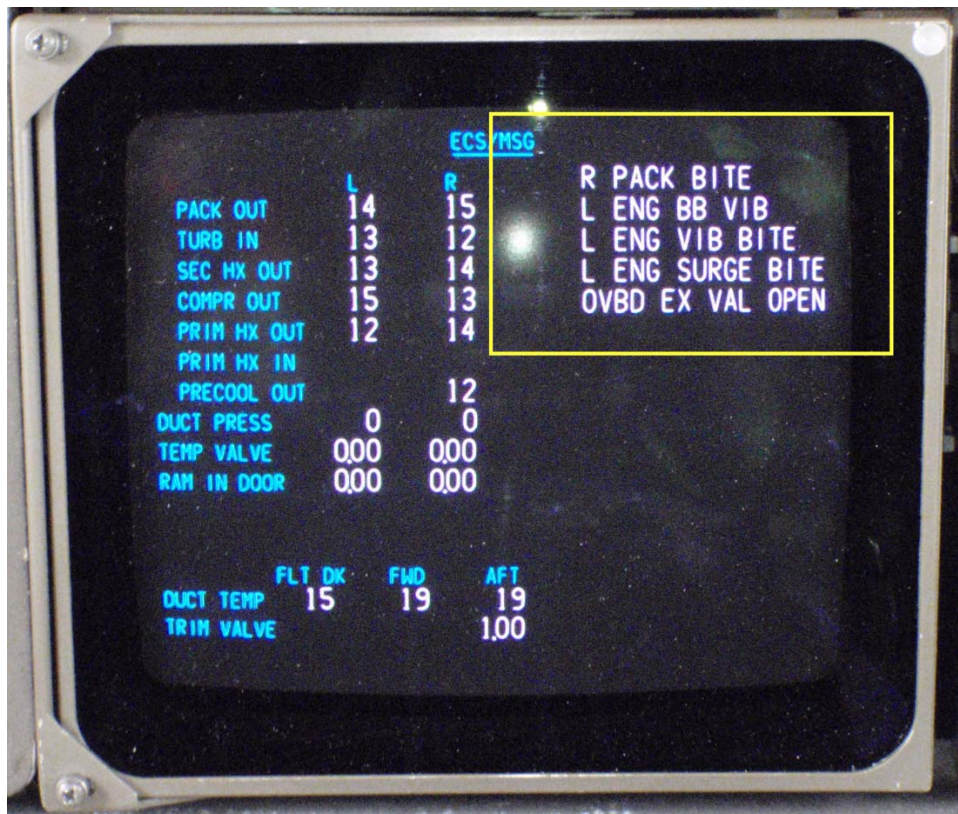
In the flight deck the field investigation revealed the following EICAS messages, as seen in Figure 7:

- R PACK BITE
- L ENG BB VIB
- L ENG VIB BITE
- L ENG SURGE BITE
- OVBD EX VAL OPEN

Figure 7 – EICAS messages

The “R PACK BITE” EICAS indicates that the Right Pack Temperature Controller had a critical controller fault or any LRU fault stored in its last flight fault memory.

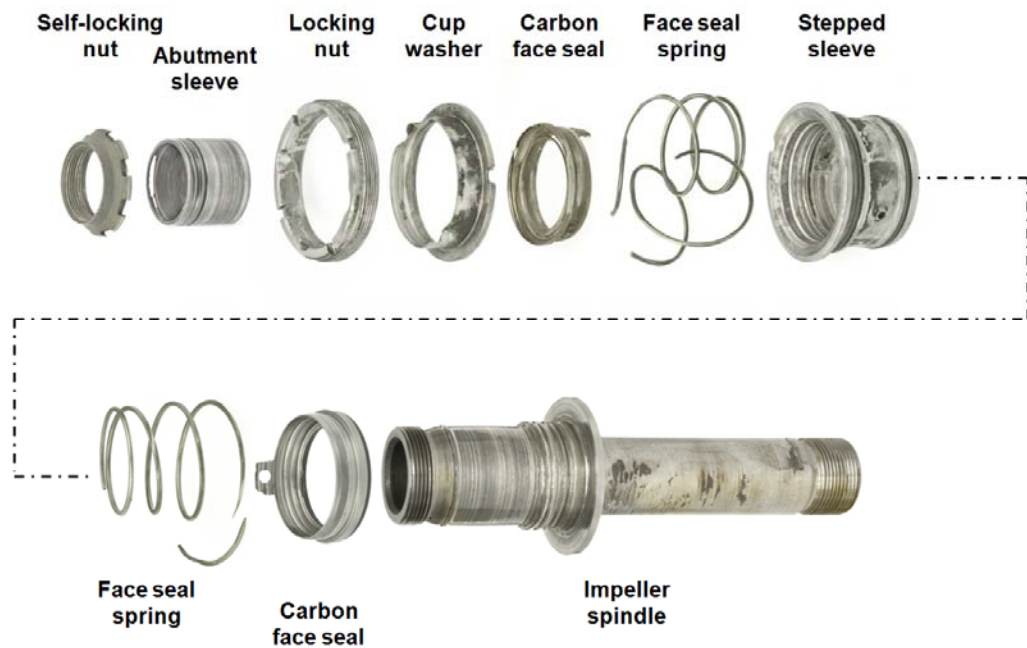
The low pressure (LP) fuel pump, P/N BPU200MK2 of S/N B1167, was sent to its manufacturer, Goodrich in Birmingham, for teardown. The low pressure fuel pump was found to have internal damage as seen in Figure 9.

**Figure 9 – Internal damage of the low pressure fuel pump**

Inside the low pressure fuel pump, the self-locking nut, abutment sleeve, cup washer, carbon face seals, face seal springs, stepped sleeve and retaining pin were all found to be damaged. It is likely that the debris which was identified on the magnetic chip detectors came from these parts. In addition, 15 cm long blockage of carbonaceous material was discovered in the fuel drain tube for the low pressure fuel pump. See Figure 10 for details on the internal parts of the low pressure fuel pump.

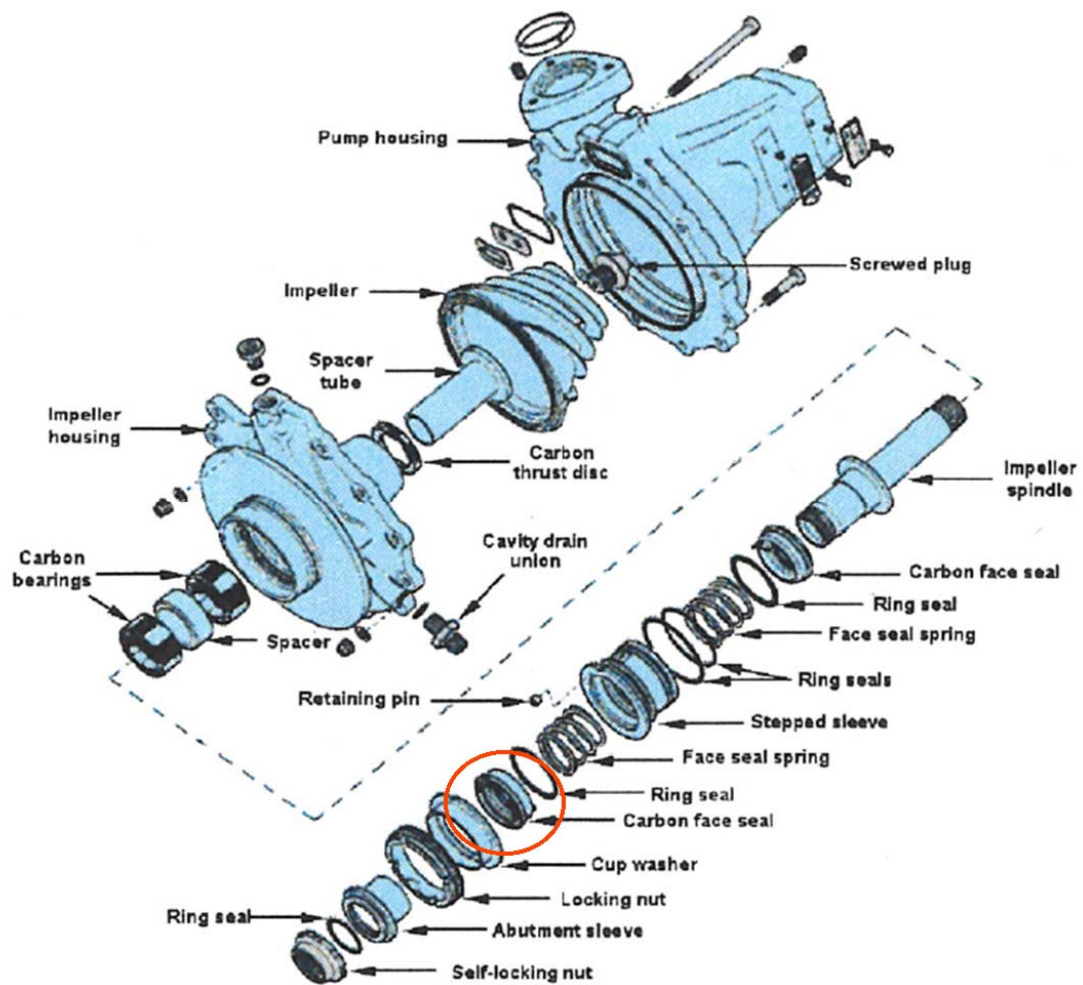
The teardown analysis of the low pressure fuel pump at the manufacturer indicated that the failure was initiated with the breakup of the carbon seal insert in the seal assembly between the low pressure fuel pump and the high speed gearbox.

Figure 10 – Component setup of the low pressure fuel pump (primary damage in red circle)

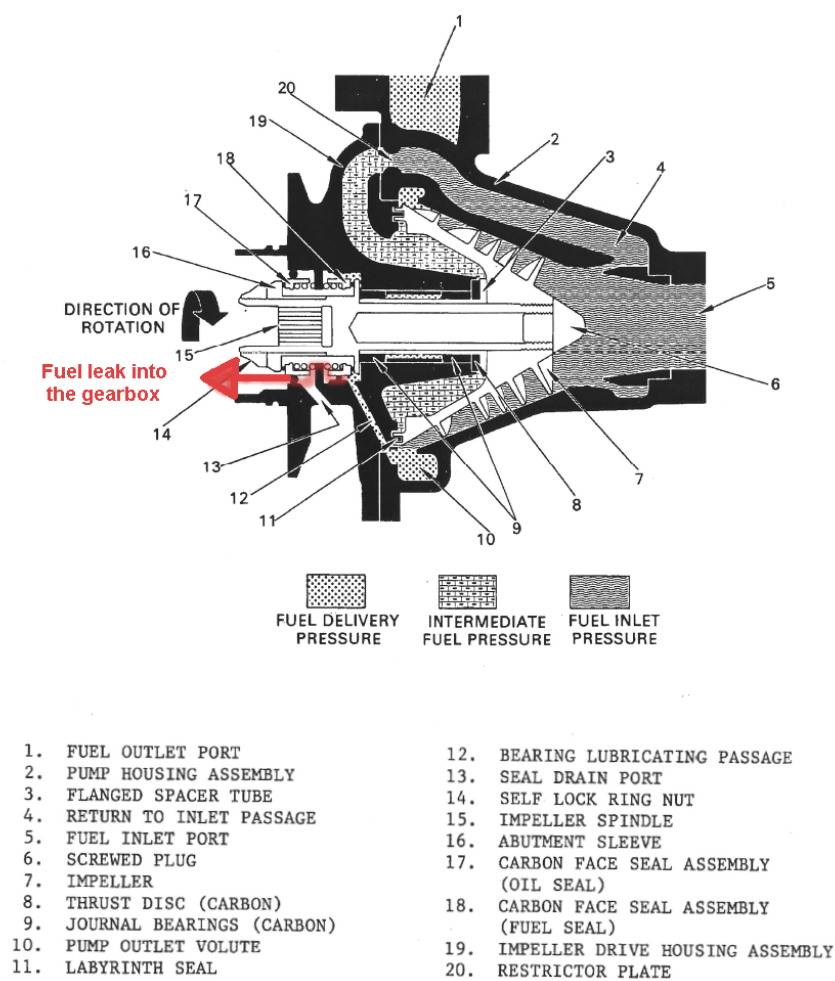
The analysis of the low pressure fuel pump indicated that the failure initiated with the breakup of the carbon seal insert in the seal assembly between the low pressure fuel pump and the high speed gearbox. It is believed that this

lead to metal-to-metal contact between the seal body and the abutment sleeve, which then due to increased friction caused torsion loading that generated rotation of the spring and the seal body. It is also believed that this lead to heavy wear in the area until the seal spring had turned to such an extent that the abutment shoulder in the stepped sleeve was passed. This caused the preload in the seal spring and the carbon seal assembly to be released, which resulted in a fuel leak into the seal cavity. As the fuel drain tube was blocked, the fuel passed from the cavity and into the high speed gearbox, contaminating the engine oil system. See Figure 11 for details.

**Figure 11 – Cross section view of the low pressure fuel pump and the leak path into the gearbox**

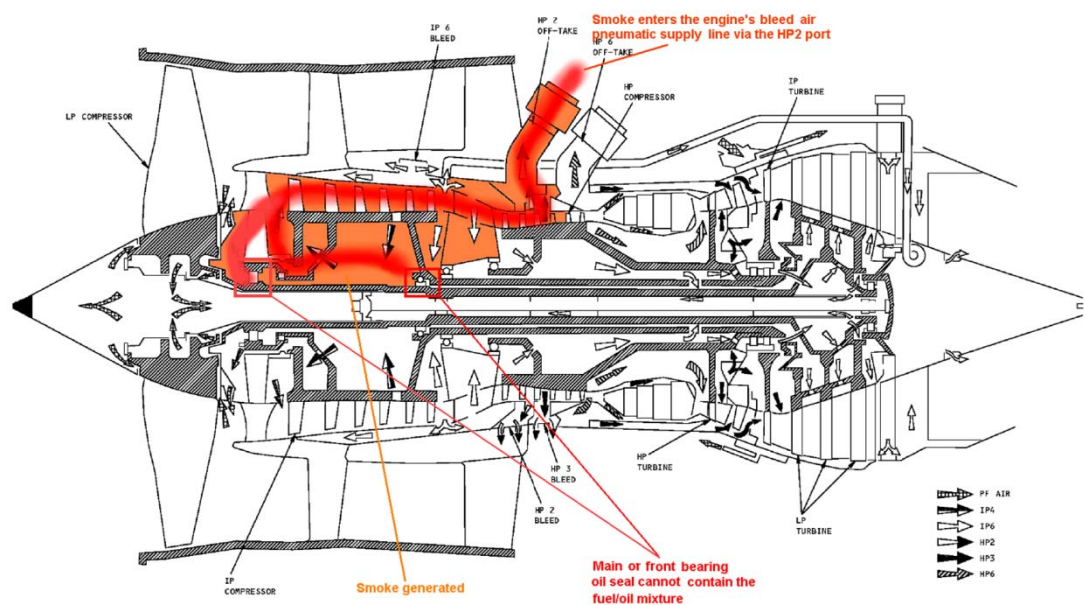
Based on this and the cooling air path of the engine<sup>21</sup>, shown in Figure 12, the probable path of the smoke can be backtracked from the HP2 port back to main bearing and/or front bearing seal in the Intermediate Pressure (IP) compressor section of the engine.

Figure 12 – Smoke propagates to the bleed air valves and enters via the HP2 port

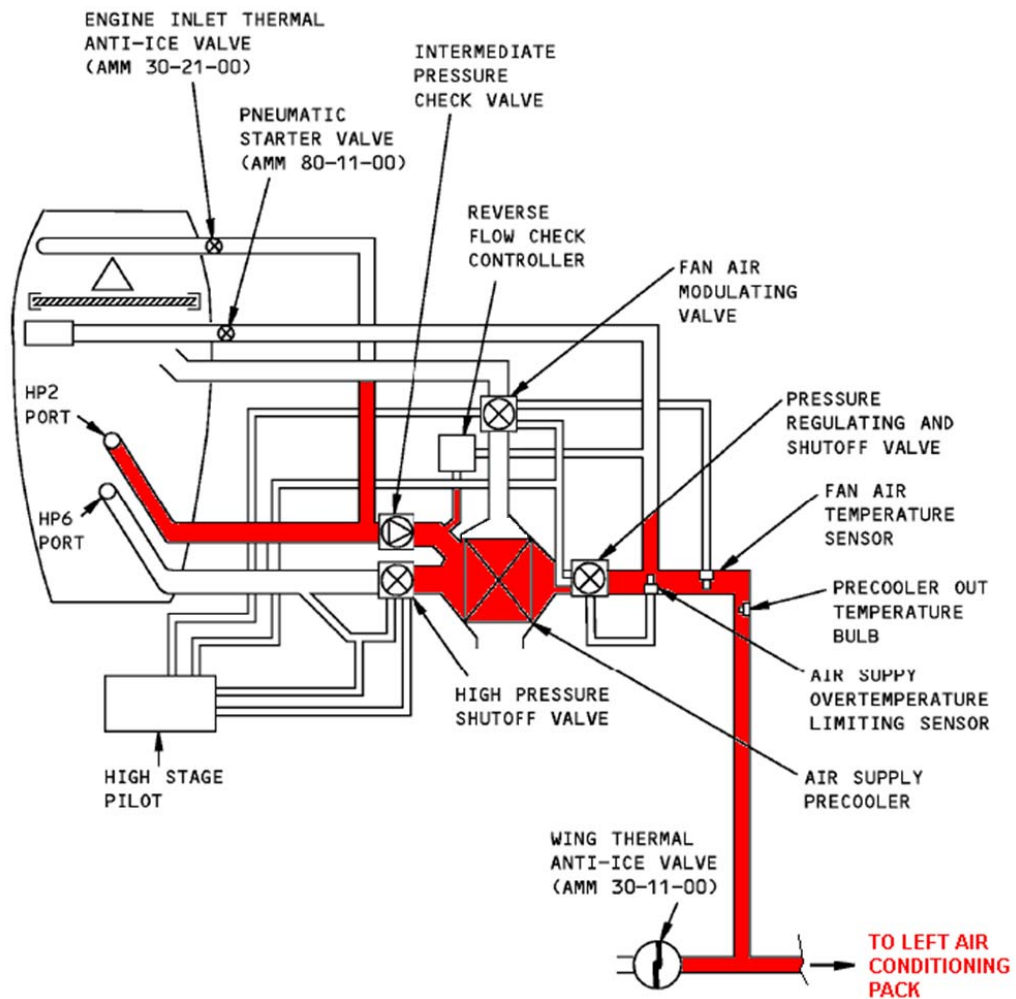
It is therefore believed that the fuel/oil mixture entered the compressor section of the engine as the main bearings and/or front bearing oil seals could not contain the contaminated fuel/oil mixture. Inside the engine's compressor, the fuel/oil mixture generated smoke. From the compressor section of the engine the smoke distributed via the air paths of the engine. Once at the HP2 port, smoke entered the bleed air system of the engine and then propagated to the airplane's left air conditioning pack. See Figure 13 for details.

Figure 13 – Smoke propagates from the HP2 port to the left air conditioning pack

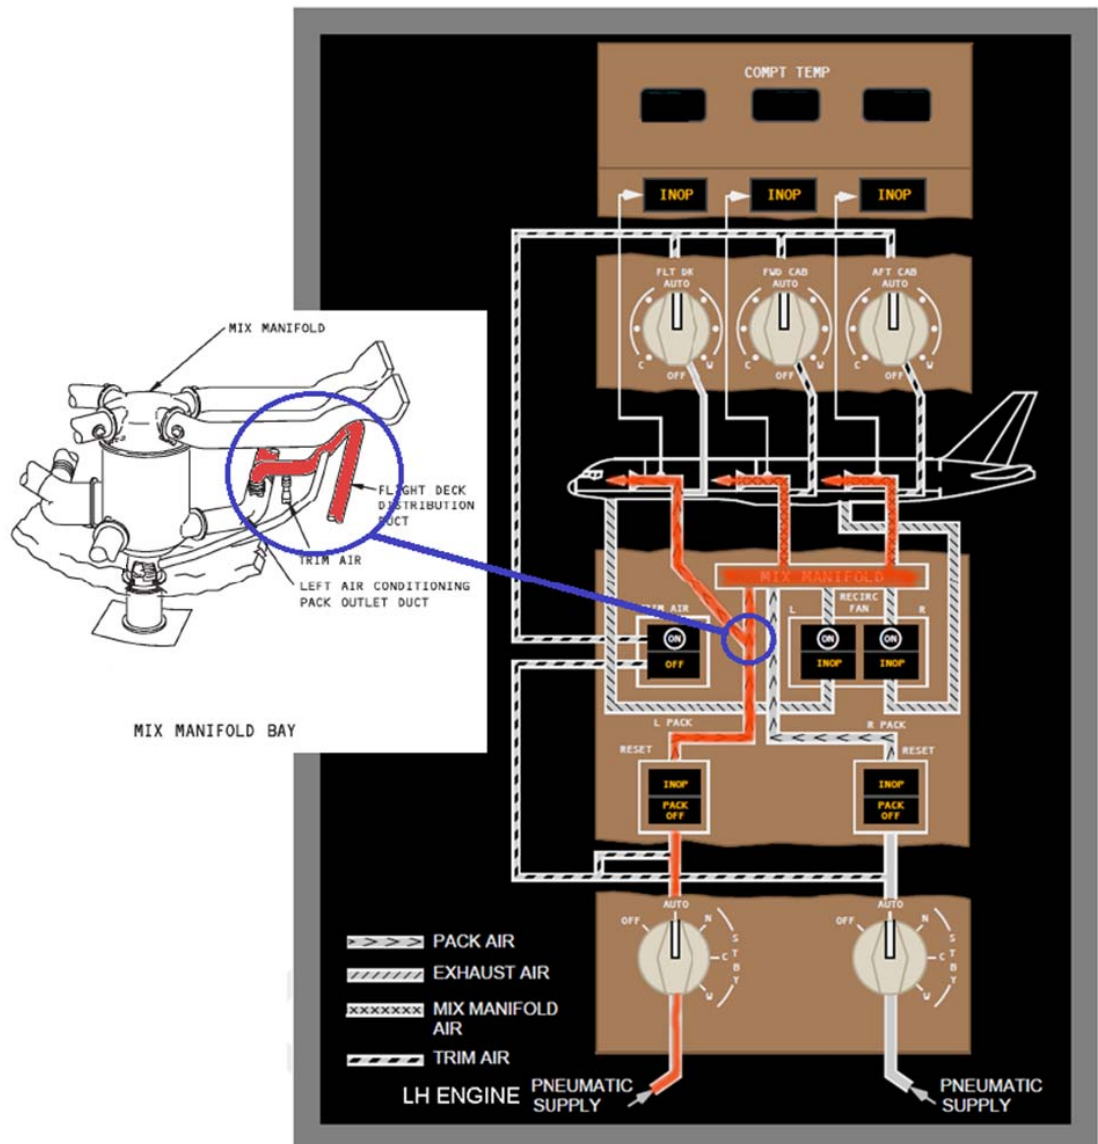
When the left air conditioning pack is inoperative the flight deck receives air from the mix manifold. Figure 14 shows this in detail.

Figure 14 – Smoke travels to the left air conditioning pack and then to the flight deck and cabin
