***Final report RL 2012:21e***

**Serious incident on 16 of January 2010 to  
aircraft EP-IBB at Stockholm/Arlanda  
Airport, Stockholm county, Sweden**

Ref.no. L-02/10

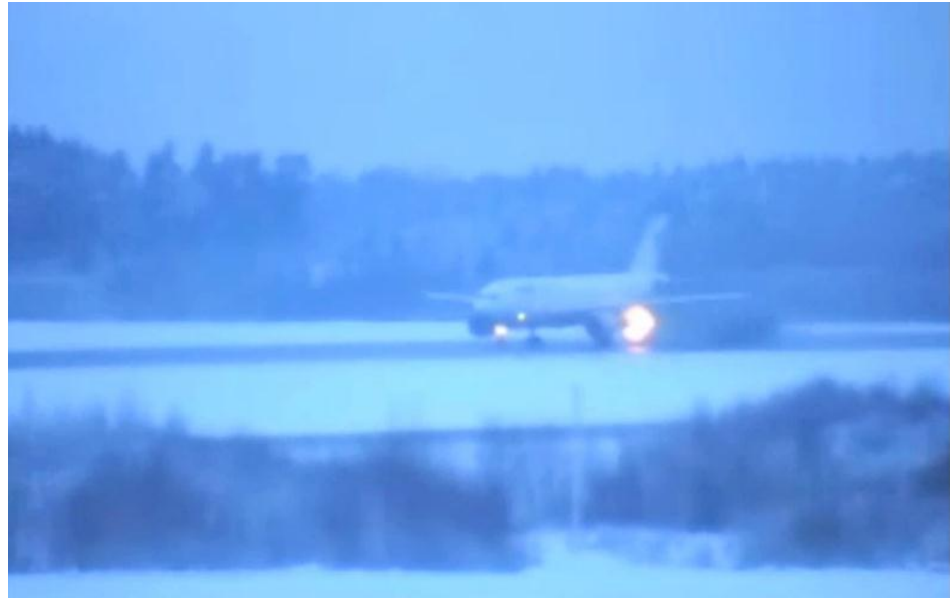
Fig. 2. Image from video. Photo: Saeid Cedighi Chafjiri.

The speed when the engine failure occurred was approximately 54 knots, but the aircraft continued to accelerate to approximately 59 knots (110 km/h). The incident occurred after rolling approximately 250 metres along the runway. The image in Figure 2 above has been obtained from a private video taken from the viewing terrace at Arlanda Airport during the sequence of events. The engine failure started with a puff of smoke and was quickly followed by three flames of varying size within the space of 0.77 seconds.

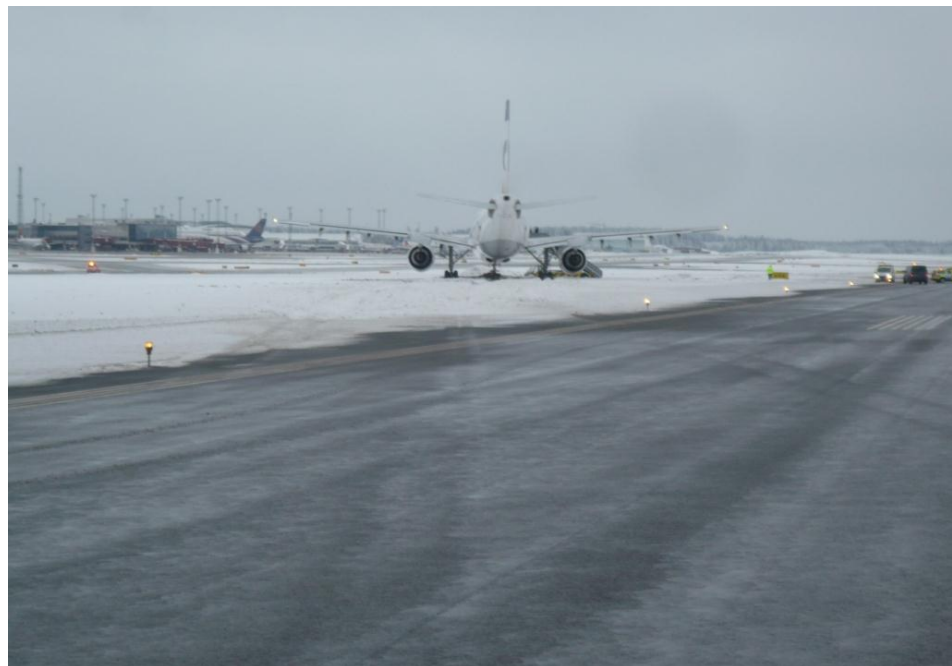
Fig. 3. The aircraft after the excursion. Photo: Swedavia.

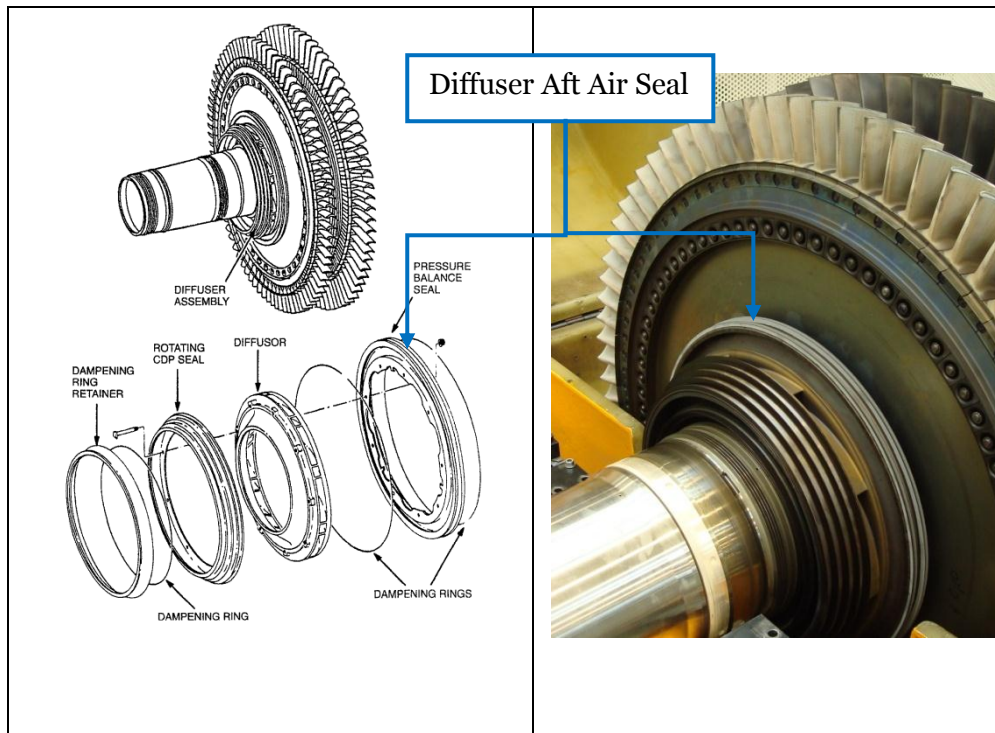
The seal teeth on the air distributor's aft seal (Diffuser Aft Air Seal), termed Pressure Balance Air Seals (see Fig. 13.), become worn and can in some cases be repaired. Engine Manual section 72-53-07, repair 003, provides a Dabber TIG Weld Repair of the aft seal teeth which adds material to the teeth edges in the form of weld beads on the flange, which are then turned down on a lathe to the correct tooth dimensions. Section 1.18.1 describes the procedure schematically.

Fig. 13. Diffuser Aft Air Seal.

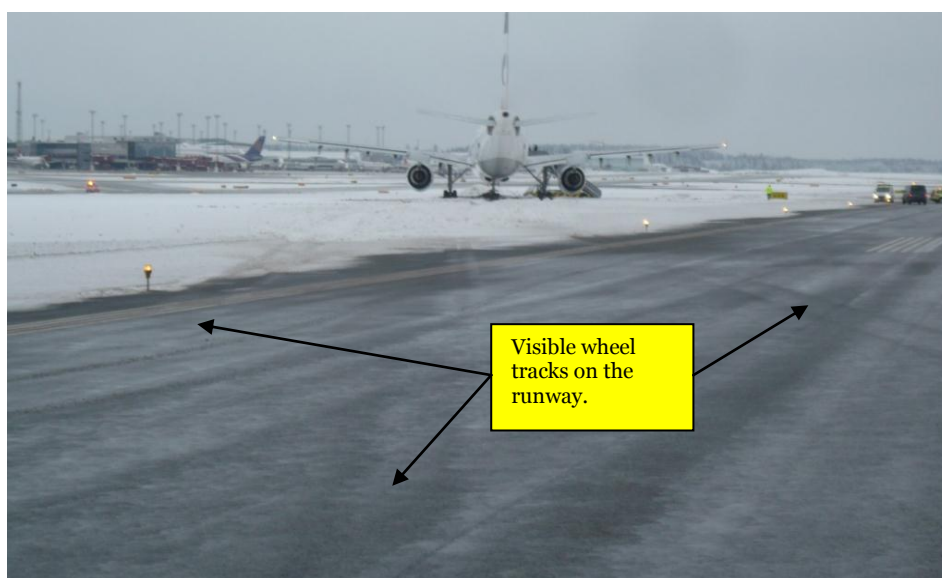
Both SHK and the airport staff have photographed the runway and the aircraft after the incident, see figs. 35b and 50. Judging by the images, the runway seems to have been covered with a grey contamination, in contrast to the appearance of the runway in the video recordings. Tracks from the aircraft's wheels are clearly seen in the contamination on the runway and in the snow outside of the runway. The landing gear is fitted with wheels mounted in pairs with a common axle and the main landing gear each has two pairs of wheels mounted in tandem. Double wheel tracks from main landing gear and nose landing gear can be seen on the runway surface in the images.

Fig. 35b. Tracks on the contaminated runway surface. Photo: Swedavia.

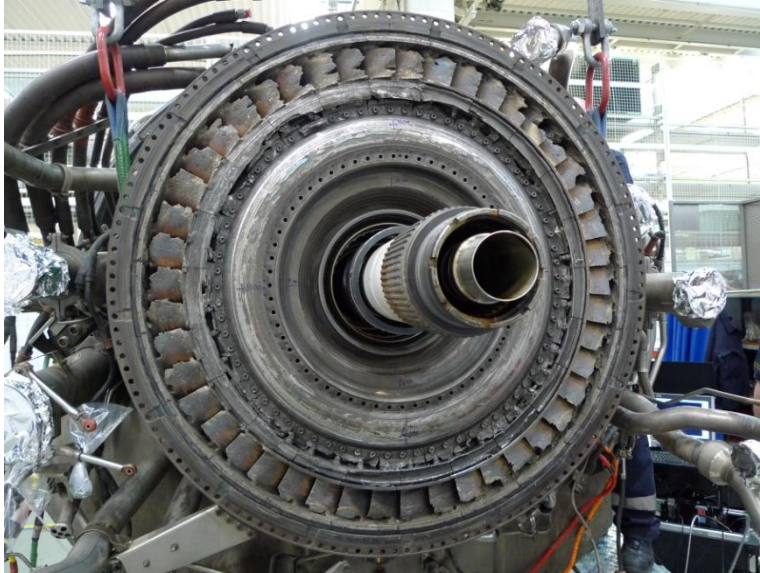
All HPT nozzle guide vanes had extensive impact damage from the “turbine side”. Its rear edges were severely mangled and partly torn away. Extensive mechanical impact damage was also found on the sheet-metal windage covers, which cover the guide vanes’ mounting bolts and hold them in place. Section 1.16b.9 discusses the parts of the diffuser aft air seal that were originally located between HPT stage one, guide vanes and turbine.

Fig. 36. HPT guide vanes stage one. Photo: SHK.

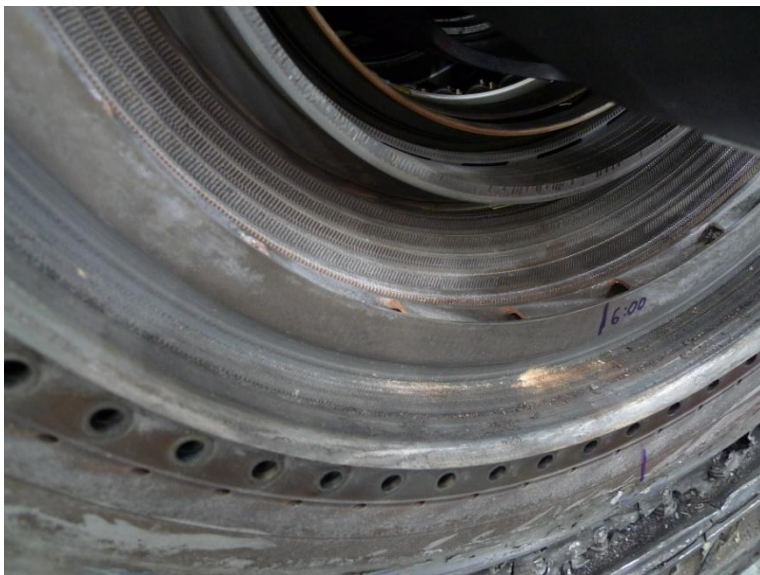
Sealing surfaces for the diffuser’s forward seal (Diffuser Front Seal) were intact and had normal wear. Sealing surfaces in the form of the stationary honeycomb for the diffuser’s aft seal (Diffuser Aft Air Seal) were torn away. The bolts which hold together the forward and aft seals against the diffuser were overstressed and sheared off. The edge of the seal normally lies parallel with the engine’s longitudinal axis, but in this case it was angled outwards at 45°. Extensive impact damage was ascertained on the parts of the module that were directed towards the HPT disc stage one.

Fig. 37. Stationary seal, forward and aft (honeycomb completely torn away). Photo: SHK.

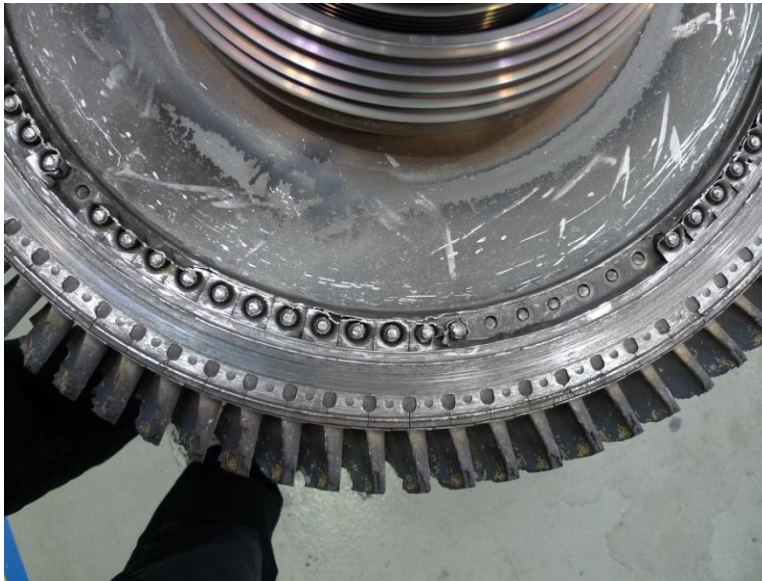
All blades were damaged through mechanical impact. The tops of the blades were entirely or partly torn away.

Fig. 38. HPT disc and turbine stage one with Diffuser Front Seal.  
Photo: SHK.

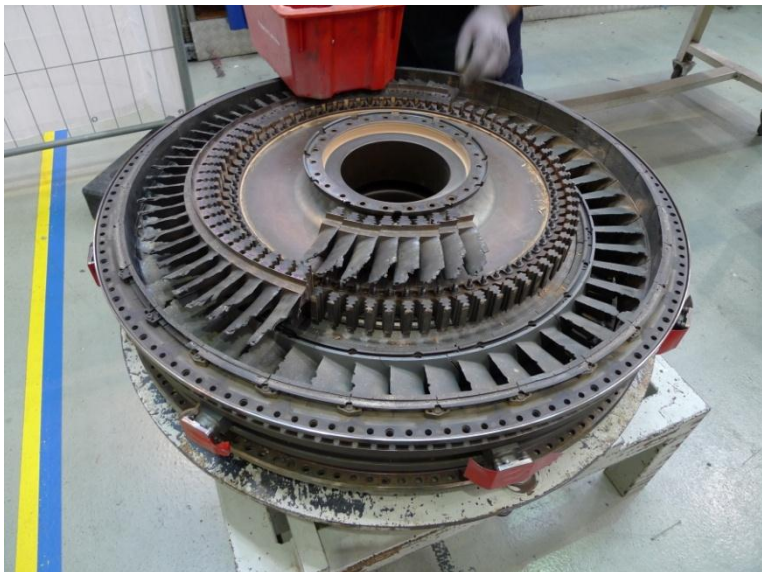
Seven of the eighty bolts which axially secures the stage 1 HPT Blade retainer to the stage 1 disk, also known as the 1st stage HPT blade retainer “Hook Bolts”, were found broken just under their windage cups. Six of these seven bolts were adjacent to each other. One broken bolt was located 12 bolt holes beyond the others.

Fig. 39. HPT stage two. Photo: SHK.

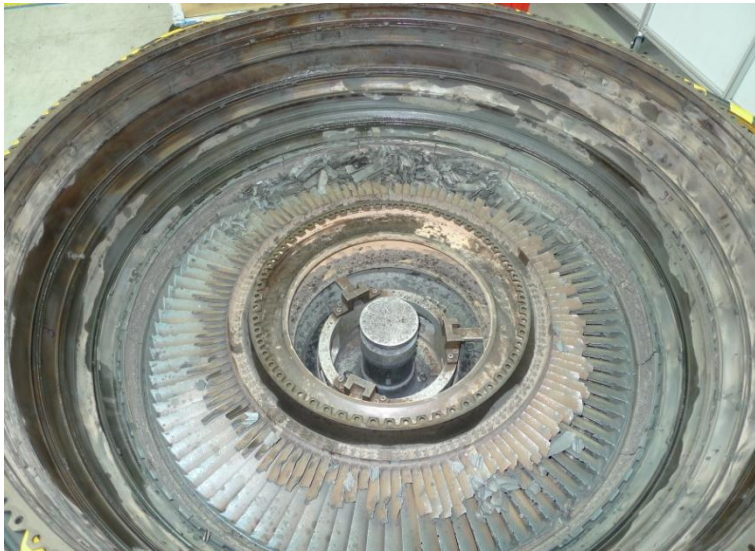
Throughout all five stages of the low pressure turbine, impact damage to both the low pressure turbine blades and guide vanes were observed. The amount of damage decreased further back in the low pressure turbine module. The low pressure turbine case was examined and found to have penetrations measuring around five by five millimeters. It has not been possible to conclude if debris passed through the holes. The LPT case was also observed with a number of case deformations in the radial direction.

Fig. 40. LPT guide vanes and turbine blades stage two. Photo: SHK.

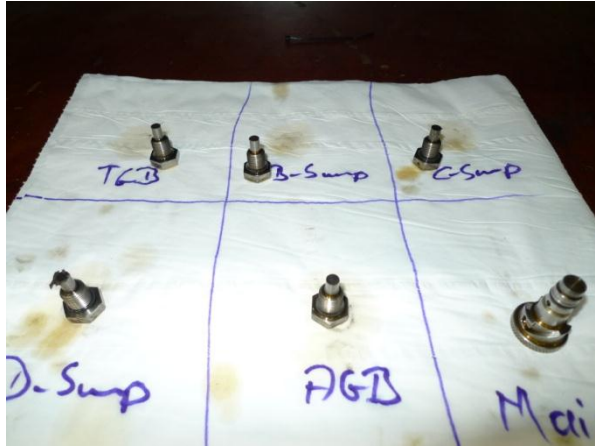
Fig. 41. The oil system's chip plugs; only the D sump (LPT) plug had traces of magnetic material. The number of chips was normal for the operating time. Photo: SHK.

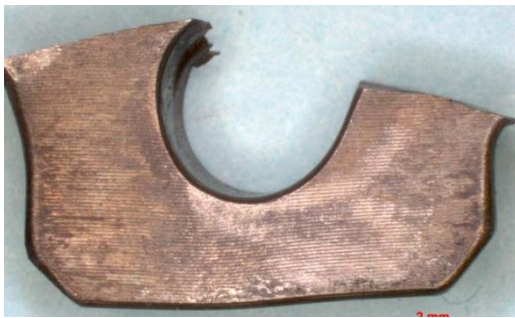
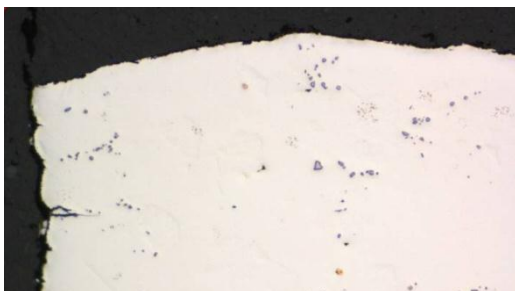
According to LHT, it is likely that the diffuser aft air seal had come loose due to micro cracks in the nine attachment lugs that hold the seal against the diffuser.

Fig. 43. Cross sections of the attachment lug with micro cracks, diffuser aft air seal. Photo: LHT.

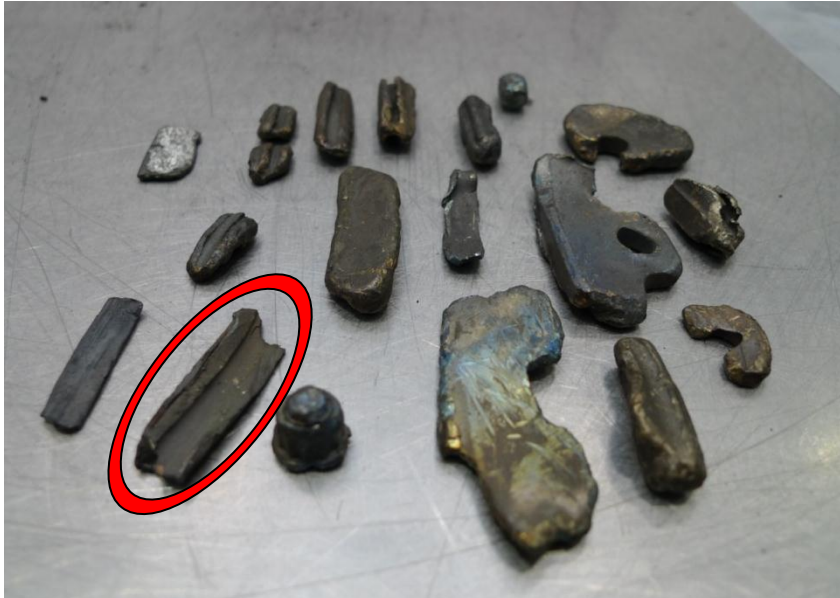
Fig. 44. Fragments analysed by Volvo Aero Corporation. The piece marked in red is a piece of the edge of the diffuser aft air seal. Photo: SHK.

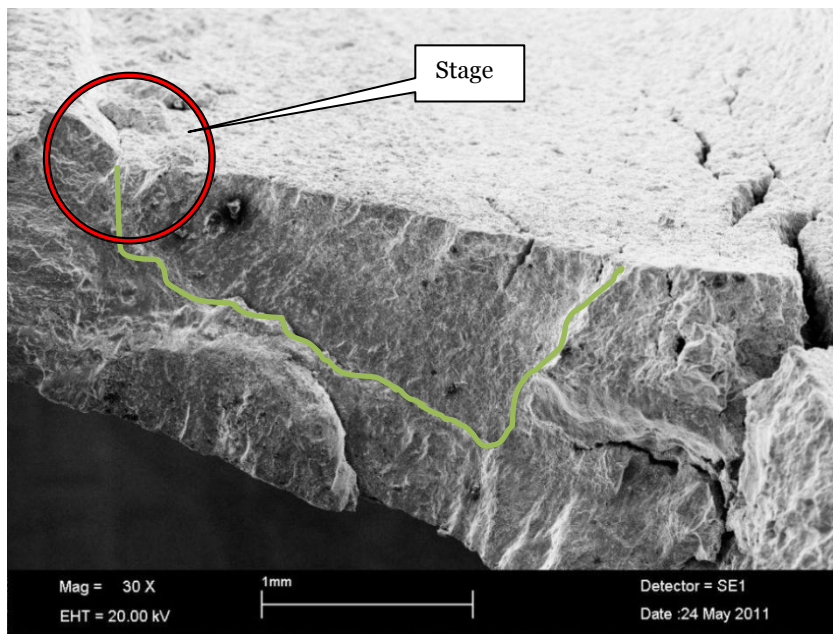
The analysis carried out by Volvo Aero Corporation indicated that the engine failure that occurred – and which was the primary reason for the incident – had probably been caused by fatigue damage in a different part of the diffuser aft air seal.

The overall assessment of the investigation results suggests that the fatigue had started in the repaired seam at the diffuser aft air seal teeth. All documented cases of CF6-80C2 diffuser aft air seal failures have been seals that had been previously repaired.

Fig. 45. Section of the knife edge in the diffuser aft air seal – one of four edges. Fatigue zone with crack initiation. Photo: VAC.

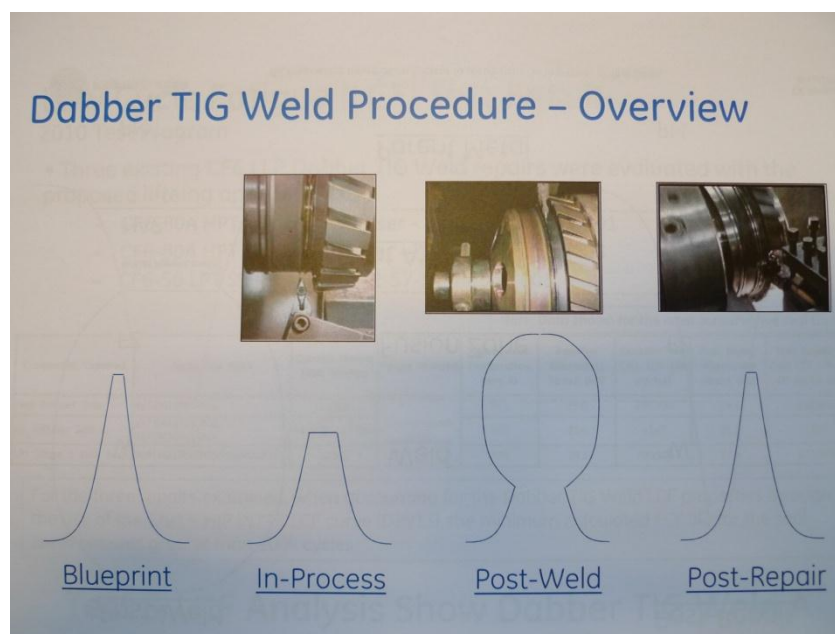
The seal material is Inconel 718. During a repair, the seal edges are dabber-welded in an age-hardened state (aged). The risk for crack formation is thereby greater in weld and heat-affected zones. For newly manufactured engine parts using TIG Weld operations, however, Inconel 718 is always welded in a solution-heated state. The material is then more ductile and has lower hardness.

Fig. 48. Repair with the GE method “Dabber<sup>55</sup> TIG Weld”.

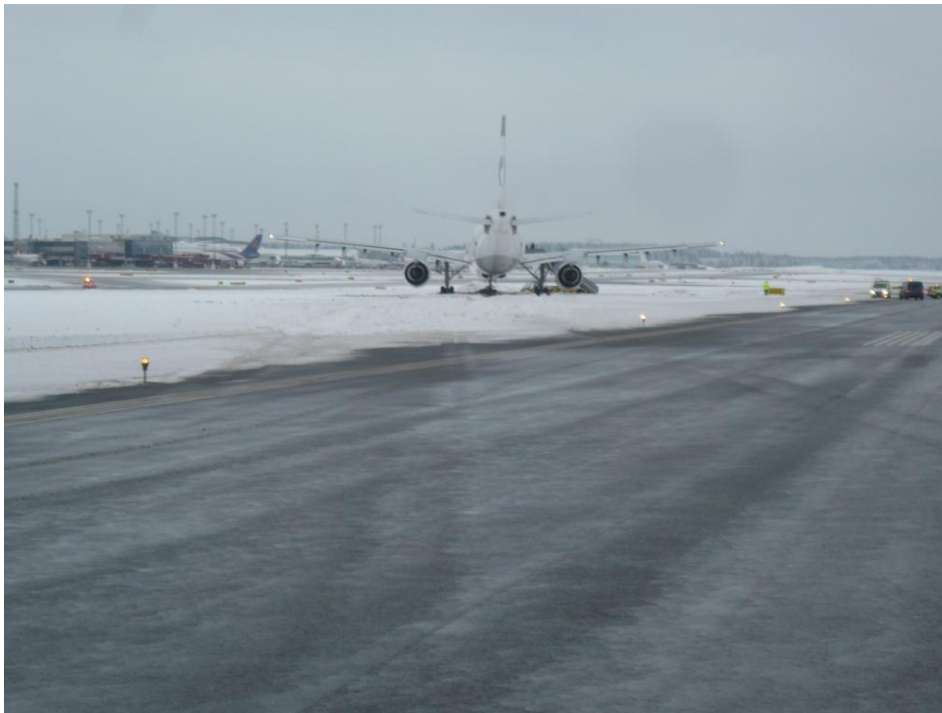
The contaminated surface must be concluded to have affected the friction negatively, however not to the extent of causing aquaplaning since the aircraft speed was too low for that.

Fig. 50. (See also fig. 35b). Tracks on the contaminated runway surface. Photo: Swedavia.

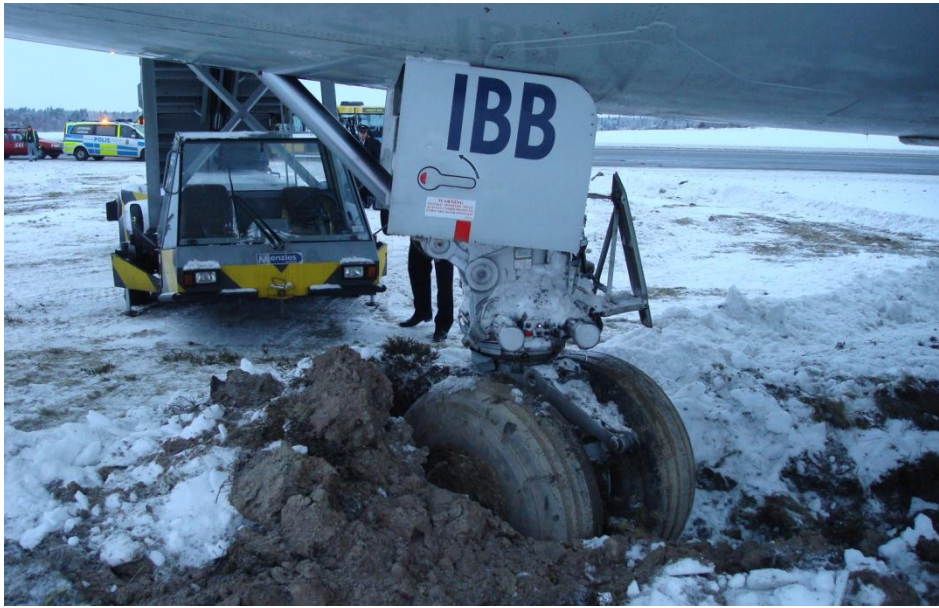
steering wheel (tiller) in the cockpit. These facts are supported by the fact that the aircraft – after having stopped – was found with the nose wheel at an angle fully to the right.

Fig. 51. The nose wheel angled to the right. Photo: Swedavia.

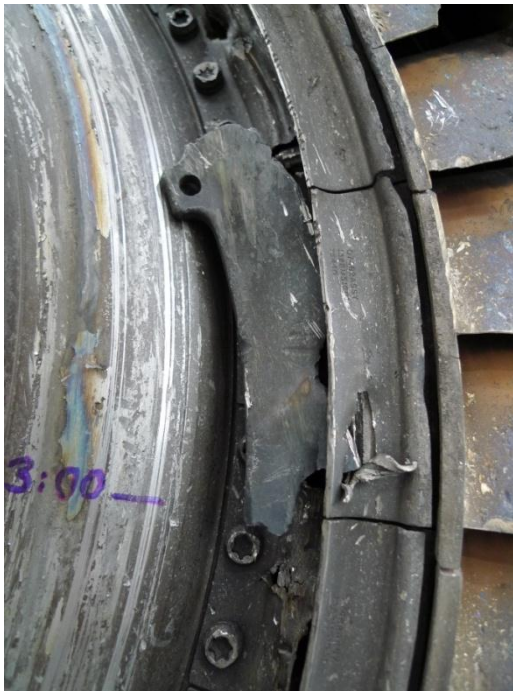
Fig. 57. HPT guide vanes stage one with fragments of the diffuser aft air seal. Photo: SHK.

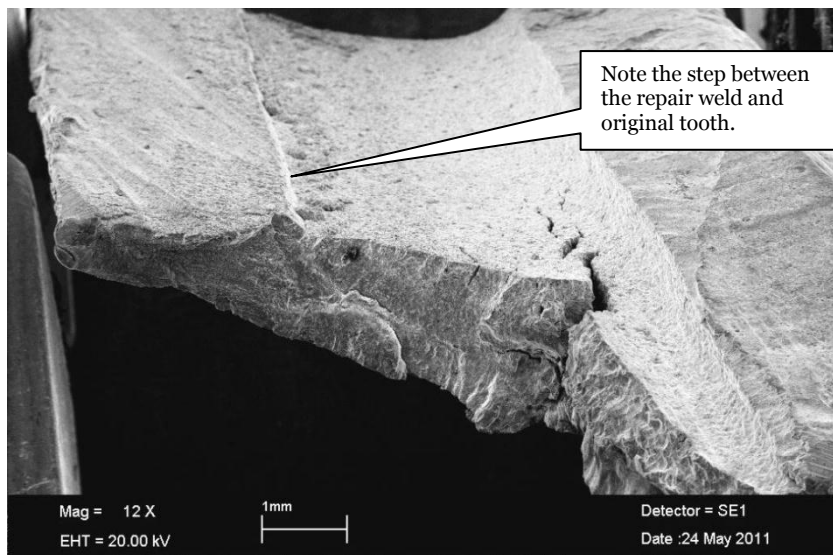
Fig. 58. Section of one of the edges in the diffuser aft air seal. See also fig. 45. Photo: VAC.

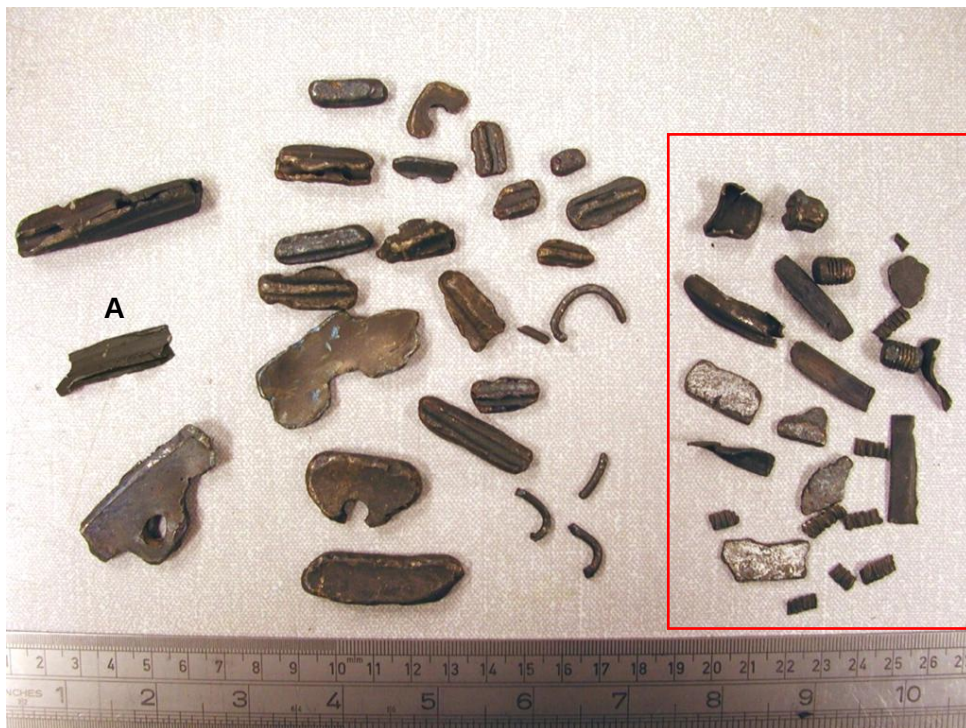
Photo No 1. Content of the plastic bag. The pieces within the red marking are not believed to be from the Diffuser Aft Seal based upon visual appearance and geometry. The piece marked “A” is from the aft tooth of the seal.

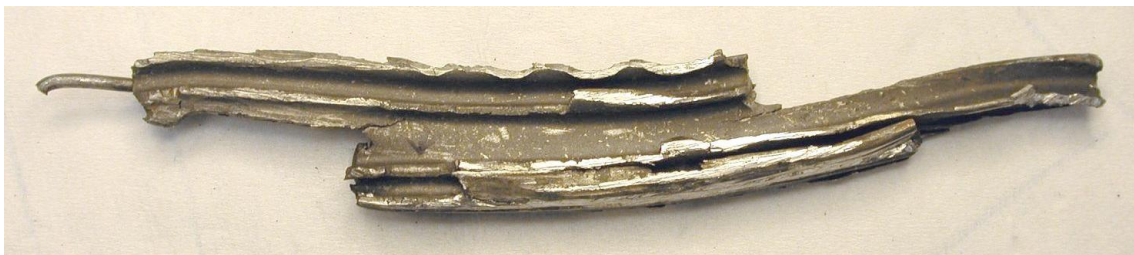
Photo No 5. Piece No 6 is the only fragment with the four seal teeth in the same piece.

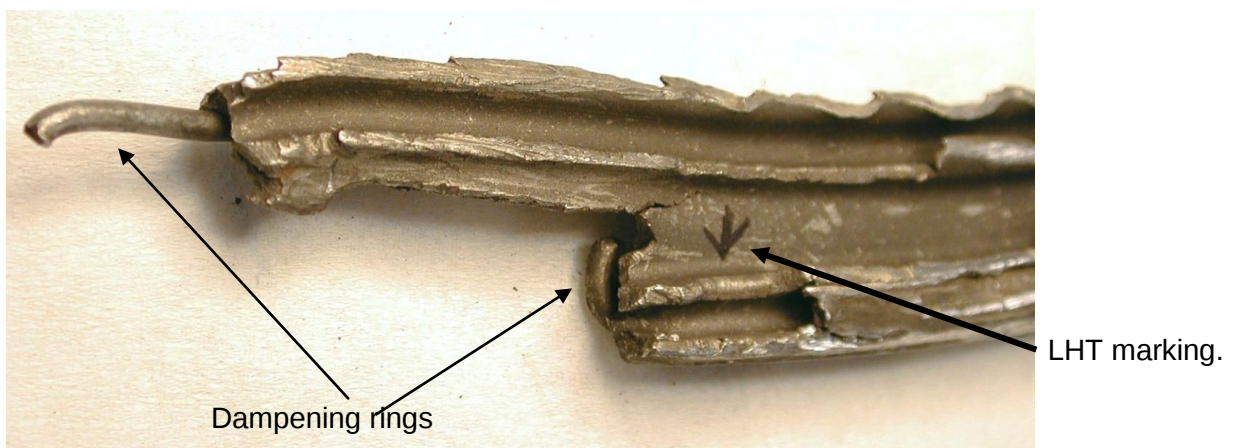
Photo No 6. Both dampening rings were in place at the failure.

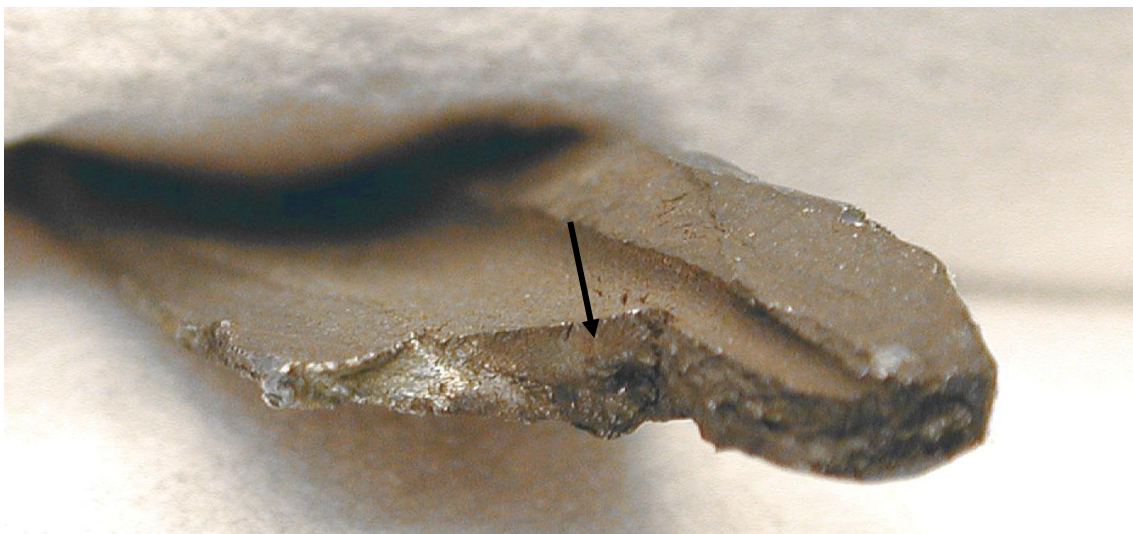
Photo No 8. The left end of the tooth in photo no 7 shows a fatigue crack (arrow). The bright appearance of the crack surface suggests it to be a secondary crack, developed during the engine break down.

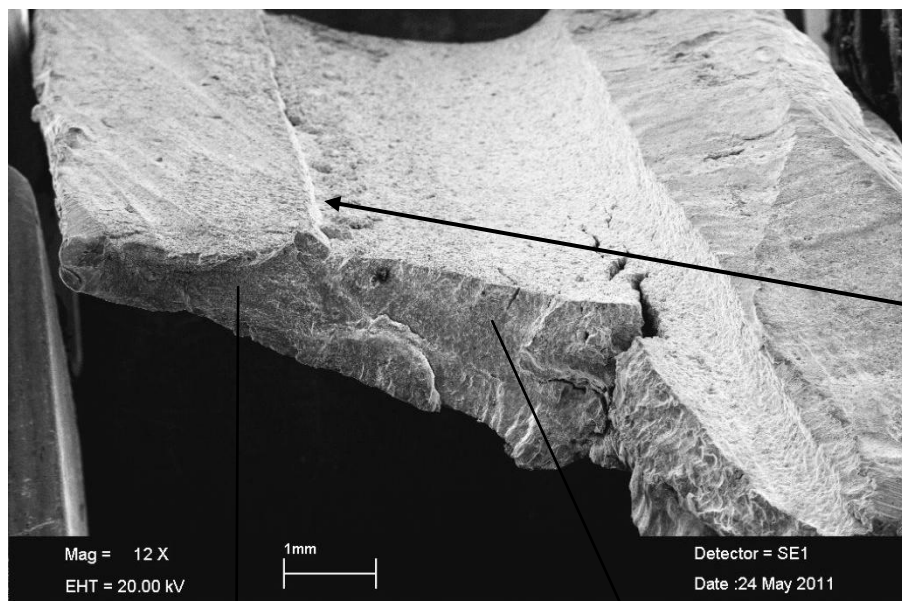
Note the step between the repair weld and original tooth.

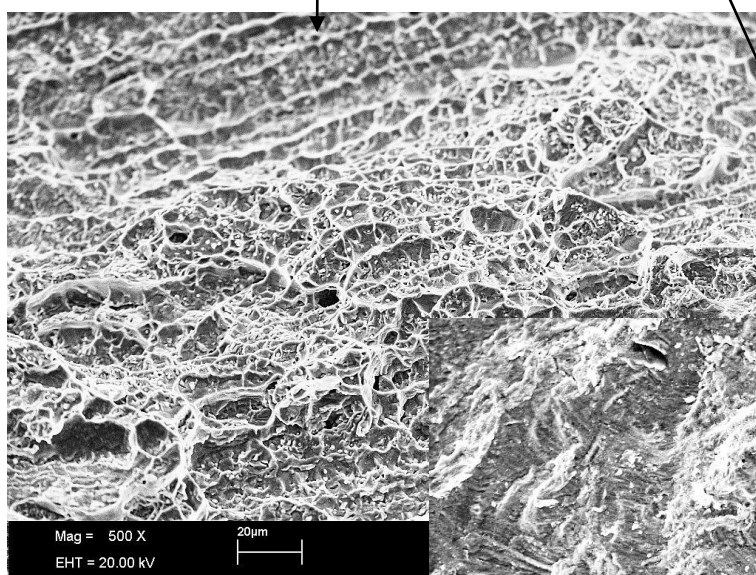
Photo No 10. Tensile overload (weld) structure.

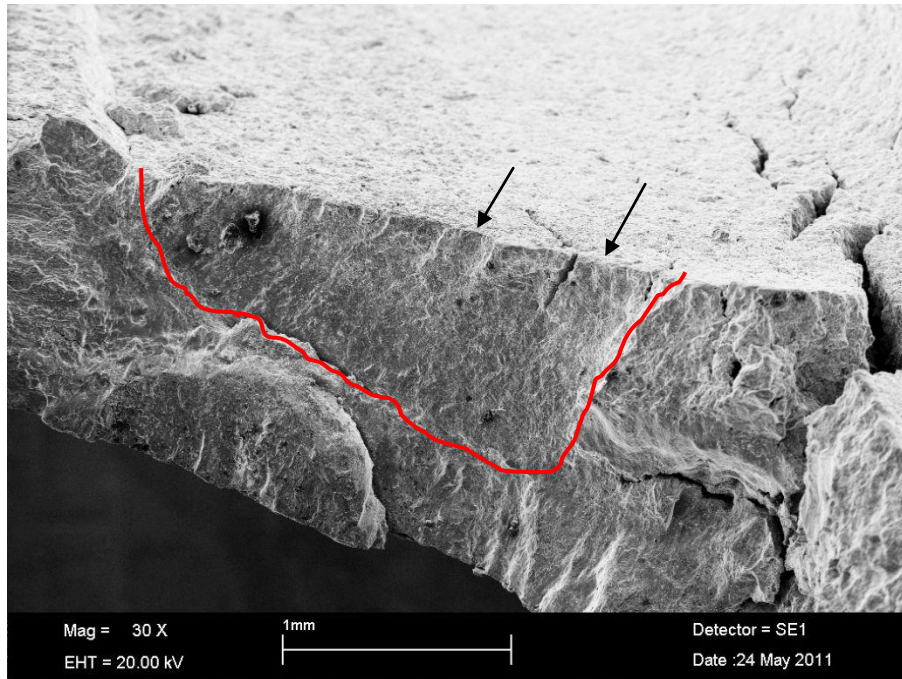
Photo No 12. Fatigue surface outlined with red. Arrows show two crack initiation points.

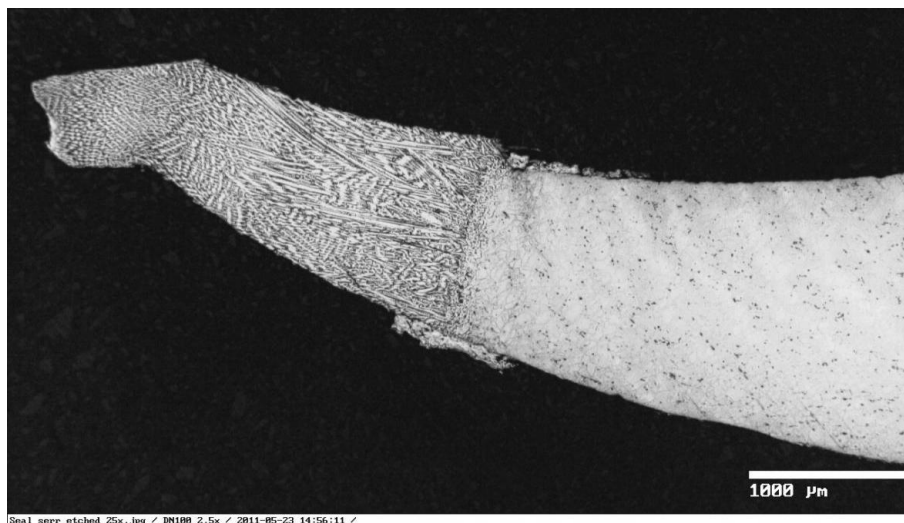
Photo No 13. Cross section, in etched condition, shows the seal tooth with the dabber weld repair.

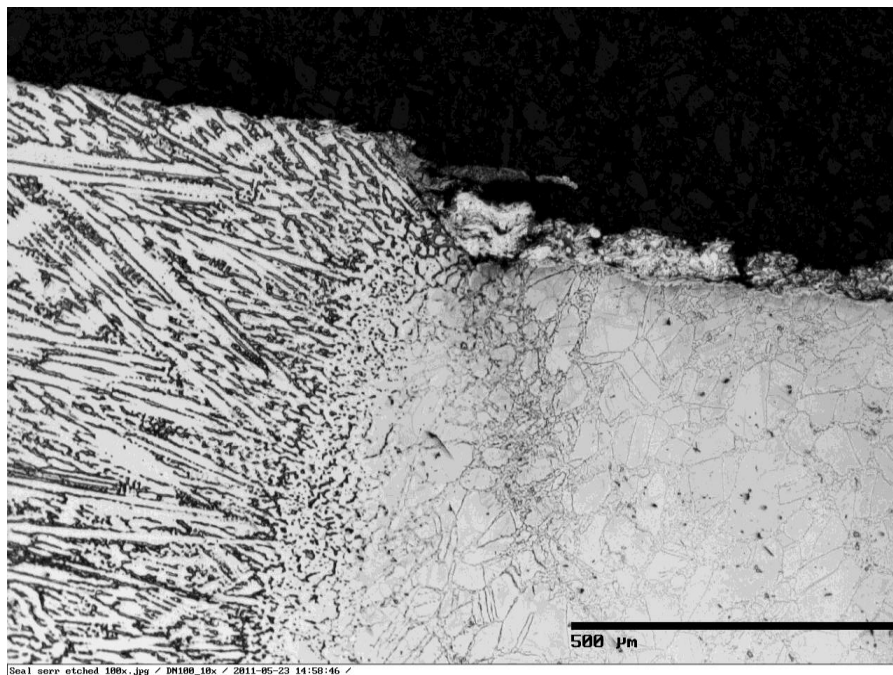
Photo No 15. Higher magnification of the area in the red rectangle in previous figure shows the machining step between the original seal and the repair weld.

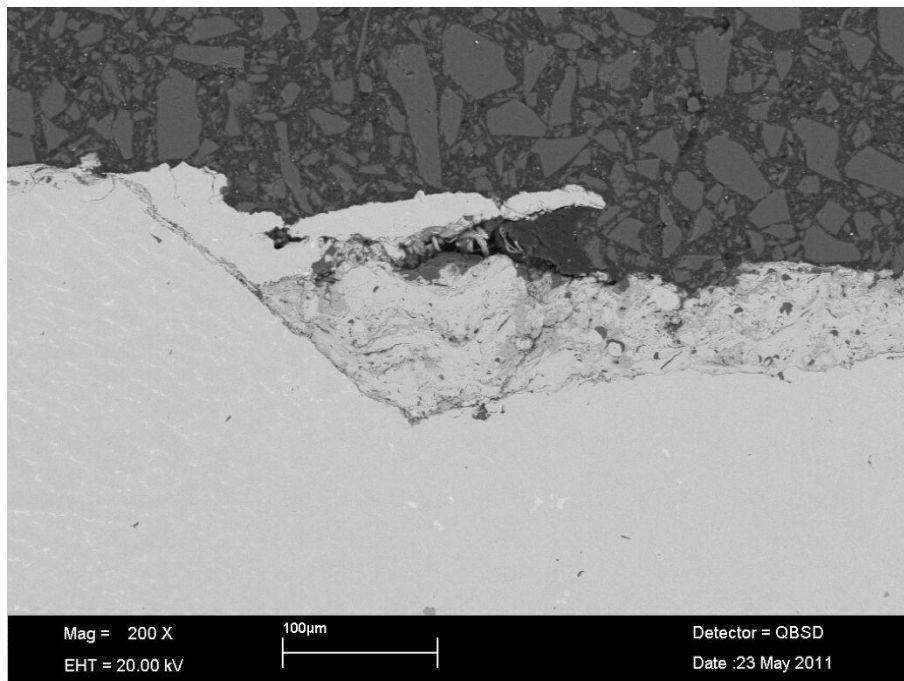
Photo No 16. SEM-photo in 200X shows that the bottom of the machining step between the original seal and the repair weld is considered to be a sharp corner.

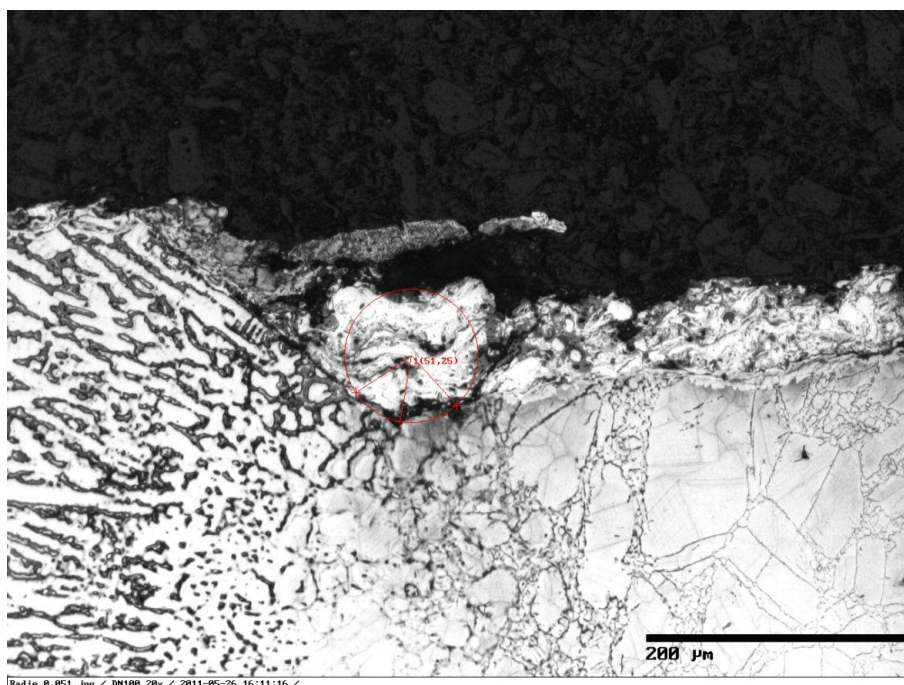
Photo No 17. The radius of the machining step is measured to be 0.05mm.

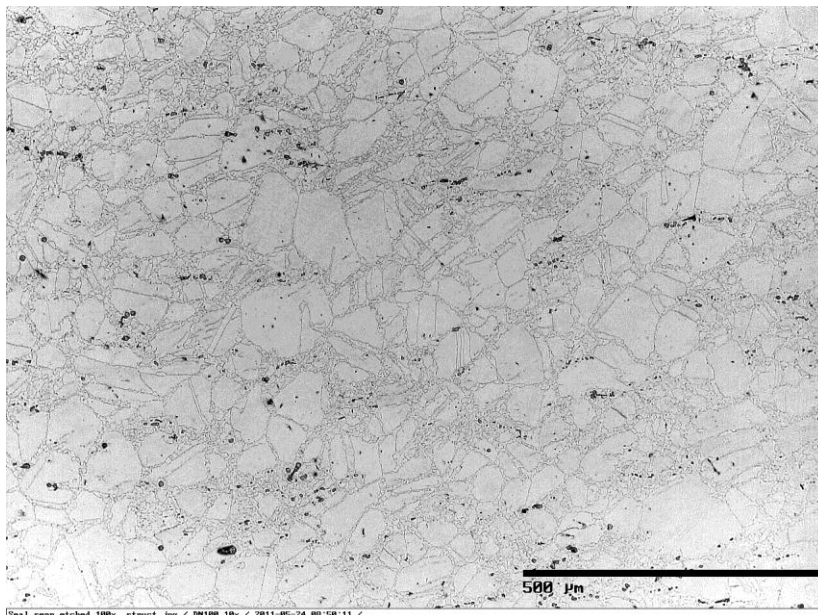
Photo No 19. Microstructure of the seal tooth, about 3 mm from the weld interface.
