# **Final Report**

**of AFRIQIYAH Airways Aircraft  
Airbus A330-202, 5A-ONG Crash  
Occurred at Tripoli (LIBYA)  
on 12/05/2010**

**Published February 2013**

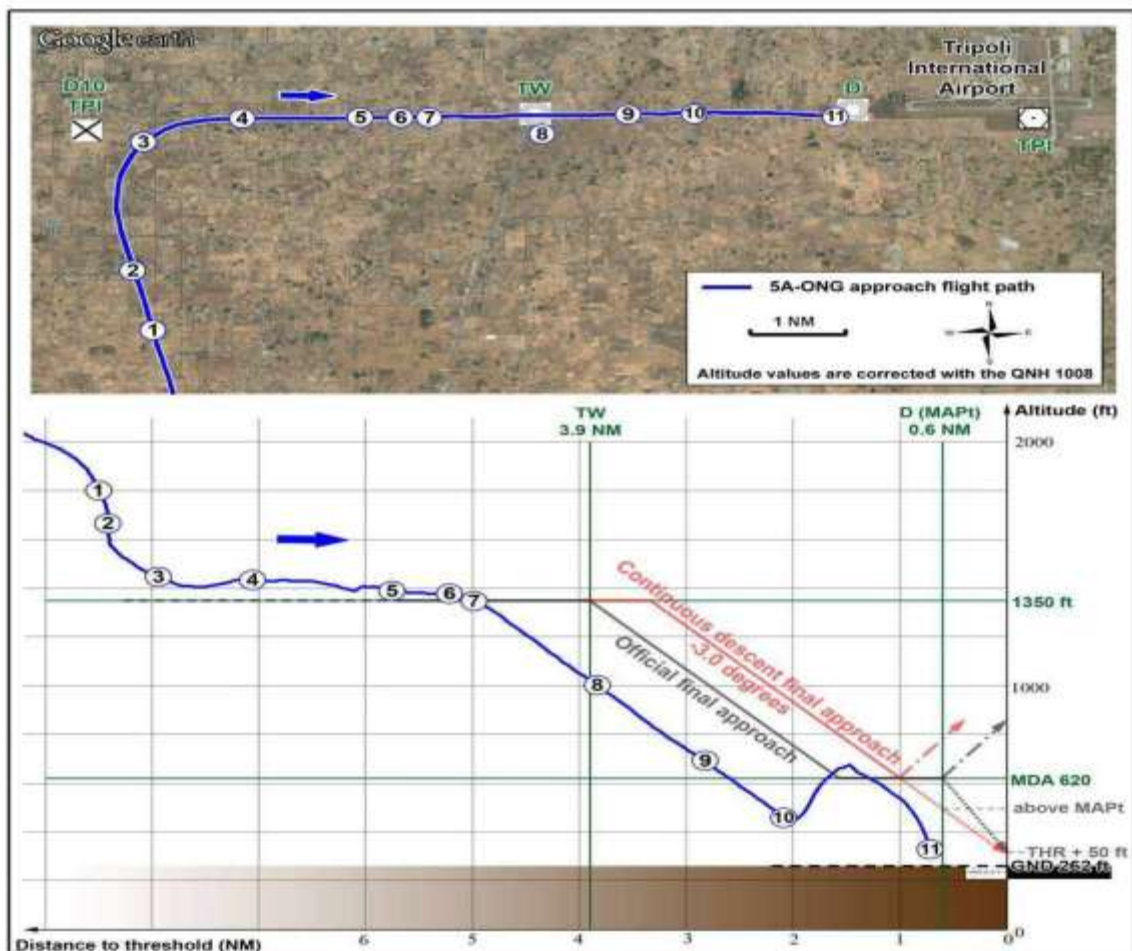
From 04 h 01 min 07 onward, the TAWS “DON’T SINK”, “TOO LOW TERRAIN” and “PULL UP” warnings respectively were recorded by the SSCVR.

The SSFDR recording ended at 04 h 01 min 13 <sup>(11)</sup>. Chronology of end of accident flight is shown in APPENDIX 11.

*End of the flight path of 5A-ONG*

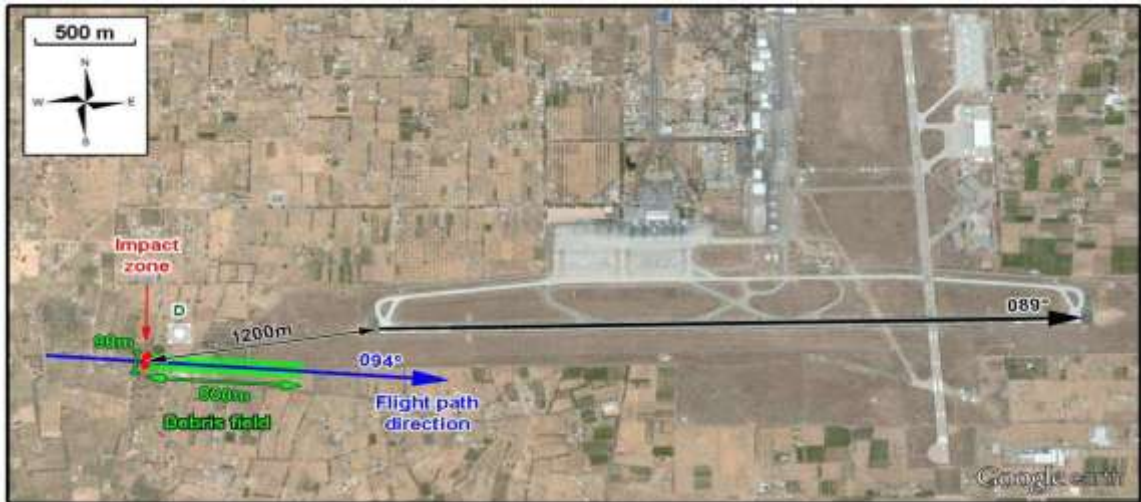
The impact site was located on a sandy plain dotted with trees, 1,200 m from the threshold of runway 09, at an altitude of about 260 feet, outside the airport. The wreckage was spread over a rectangular area of 800 m long and 90 m wide, oriented 94 degrees, and some debris was found within the airport.

*Location of crash site*

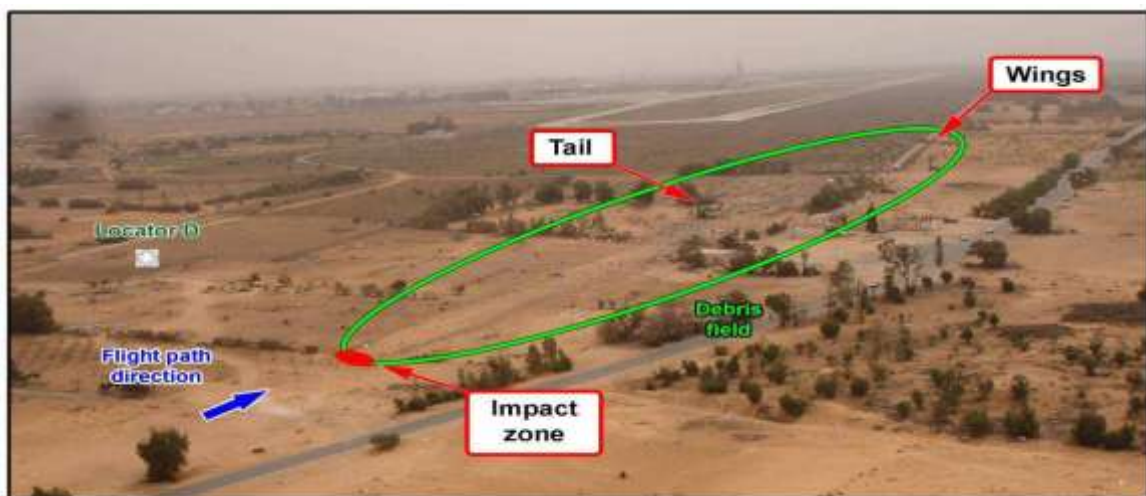
The first debris found in the impact zone comes from the soft underbelly of the aircraft, the landing gear doors and the nacelles of the two engines. It should be noted that debris from these parts of the aircraft were scattered over several hundred meters from the point of impact. No trace of the landing gear was observed at this location.

*Aerial view of the debris field*

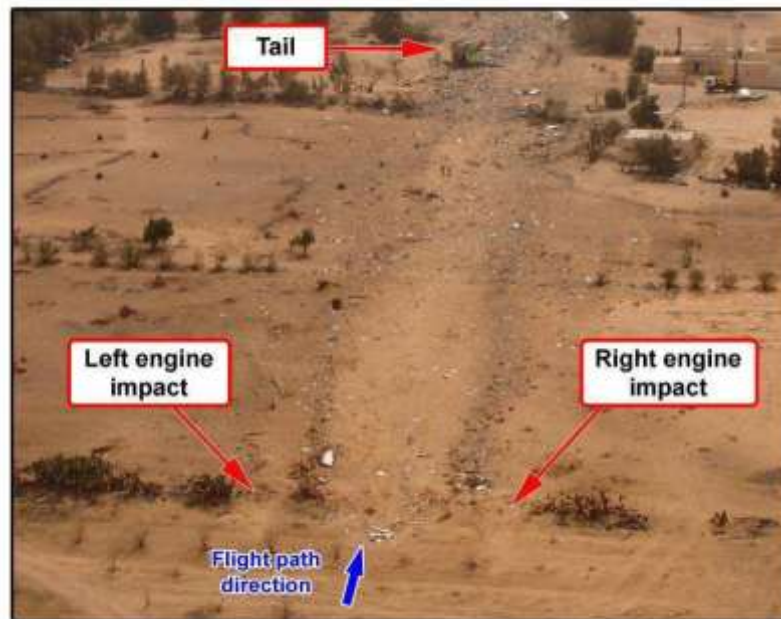
Many small fragments belonging mainly to the mid and aft sections of the fuselage were distributed eastwards from the impact zone; pieces from the front section of the fuselage were found 180 m from the impact zone.

*Aircraft ground impact*

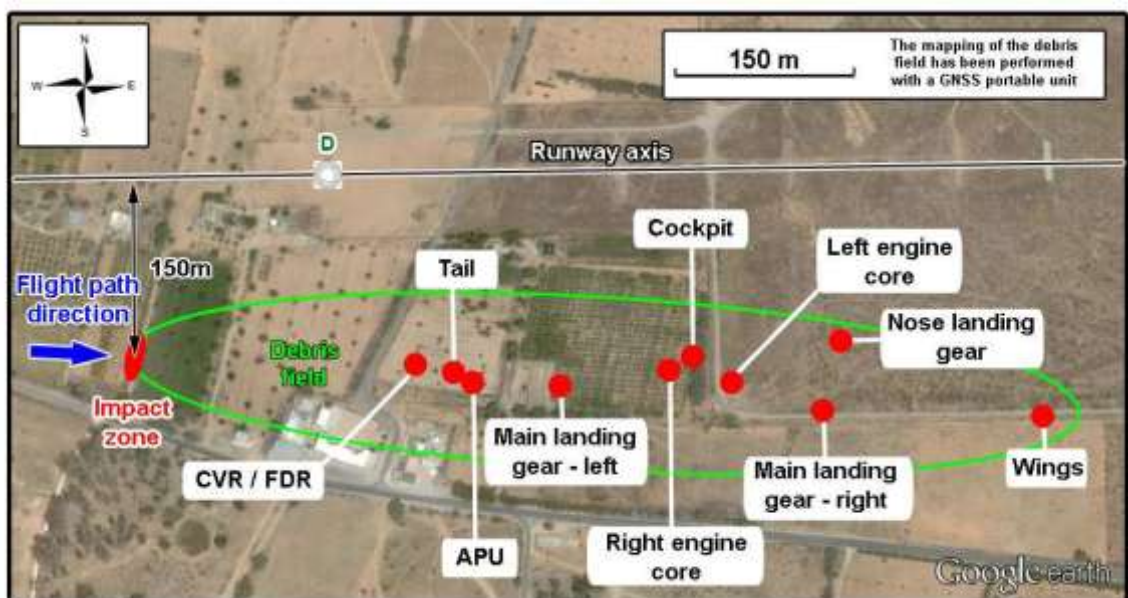
The first large items from the wreckage were distributed 270 m from the impact zone: the vertical stabilizer, the left Main Landing Gear (MLG), engine #1, the cockpit, engine #2, the right MLG, the nose gear, and finally the wings in the eastern part of the debris field. The latter bore significant fire marks.

*Distribution of the debris field*

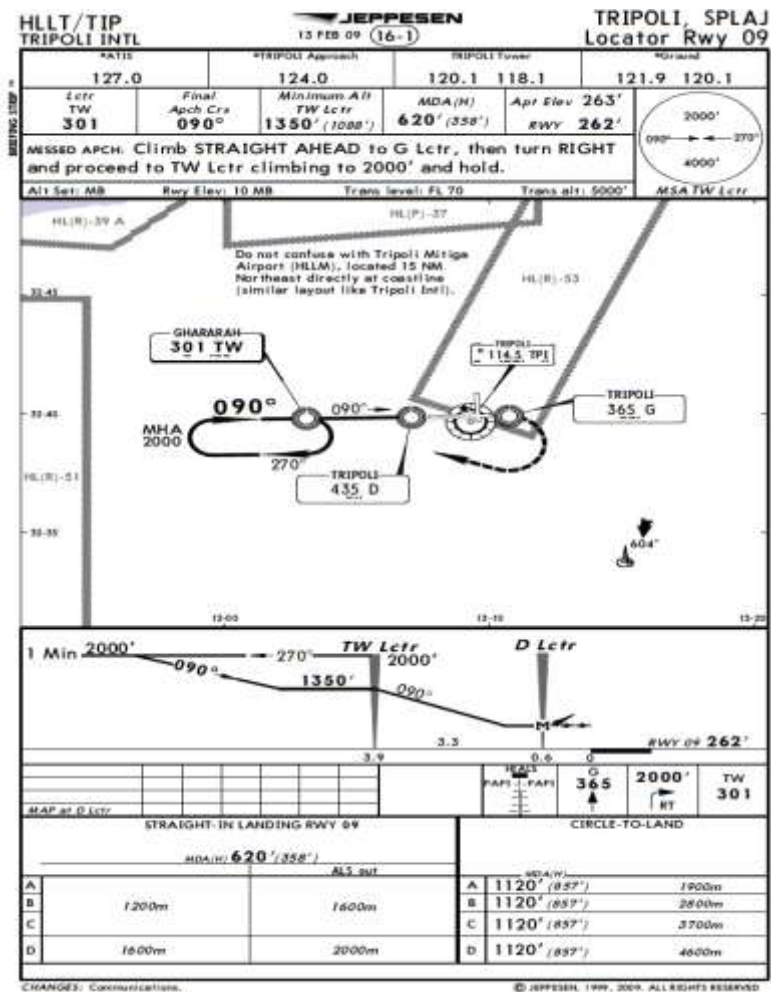
The Jeppesen chart did not provide any glide path after the FAF and did not include the table in the official map identifying crossing altitudes in relation the distance to the runway threshold 09 and rates of descent in relation the speed of the aircraft.

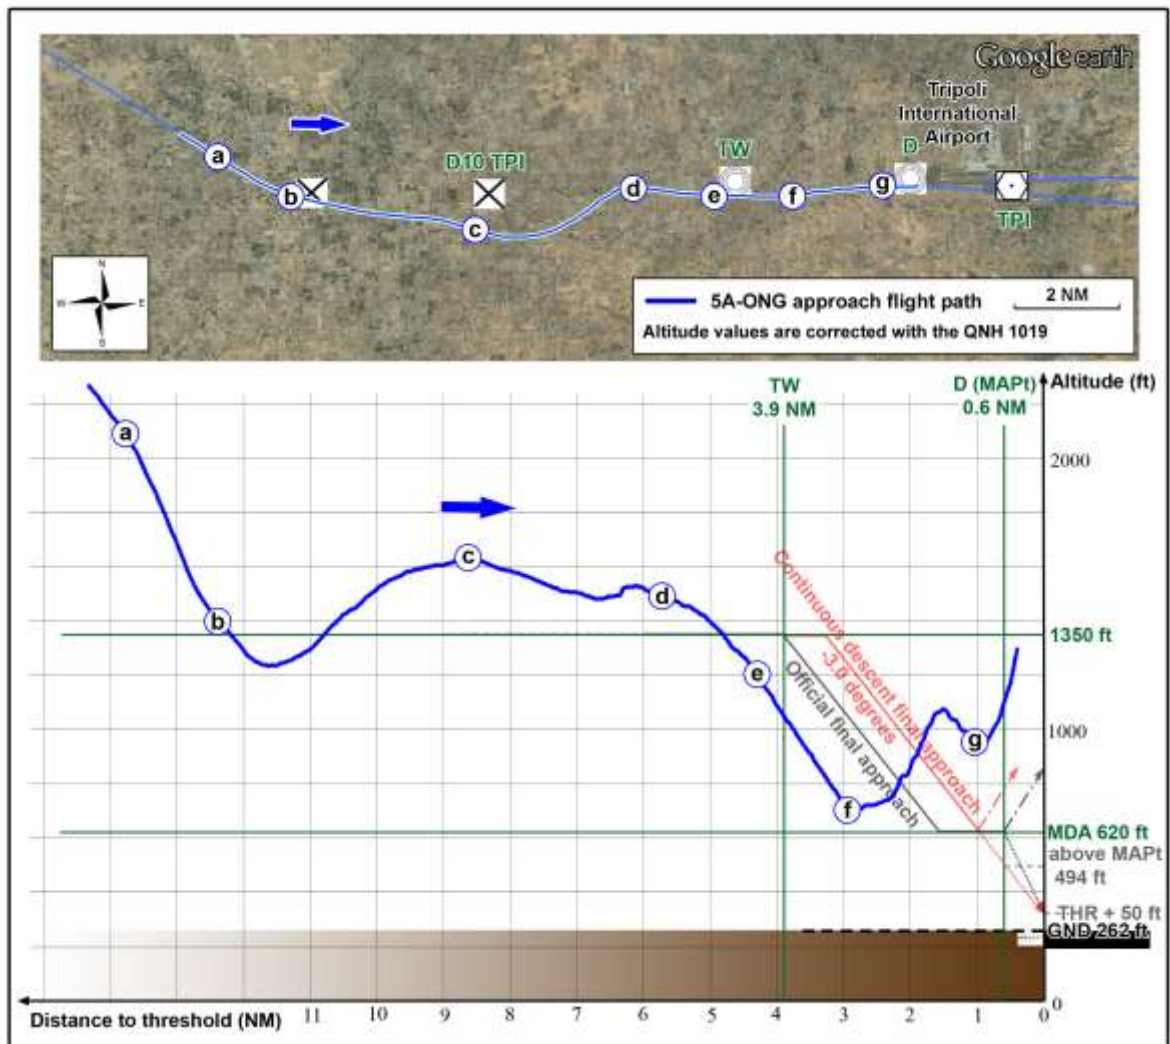
Overall, the approach was never stabilized, from the intermediate approach segment to the

missed approach. Parameters from the 28 April 2010 flight are presented in Appendix 12.
