## **Report IN-010/2010**

Incident occurred on 14 May 2010, to aircraft Boeing 737-800, registration EI-DYX, operated by Ryanair during approach to Valencia Airport (LEVC), Spain

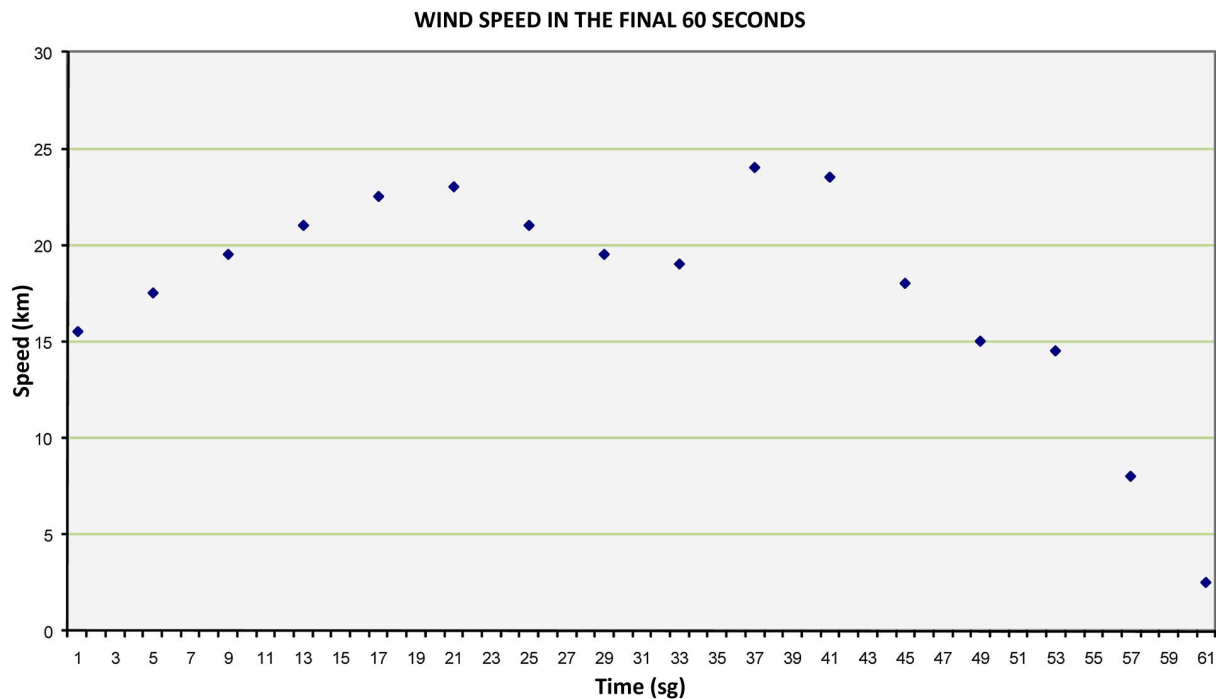
Figure 3. Change in wind speed in the final 60 seconds

Note how the CAS increased gradually over these last 20 seconds to a momentary maximum of 162 kt. The speed the pilot was trying to maintain, or Vapp, was 146.

- The first approach was made in tailwind conditions, just as the crew had anticipated.
- The indicated airspeed increased gradually in the last 180 ft, temporarily reaching a maximum of 162 kt ( $V_{ref} + 21$ ).
