**Investigation Report on the Accident to**

**Ethiopian 409 – Boeing 737-800**  
**Registration ET-ANB**  
**at**  
**Beirut - Lebanon**  
**on**  
**25<sup>th</sup> January 2010**

***Presented by the IIC on 17<sup>th</sup> January 2012***

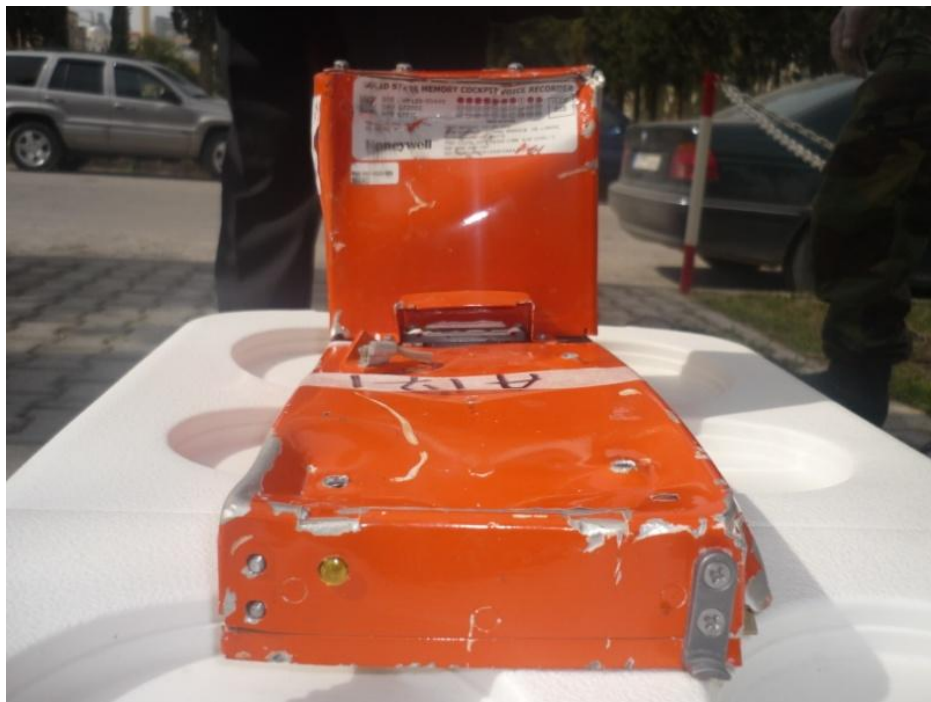
**Figure 4: CVR Chassis**

The CVR unit chassis exhibited external and internal structural damage with the CSMU detached from the chassis; the CSMU was in good condition. The opening, extraction of the double memory board from the CSMU and the read-out operations were performed following BEA procedures and Honeywell “*Reference Procedure for SSCVR Data Recovery after an*

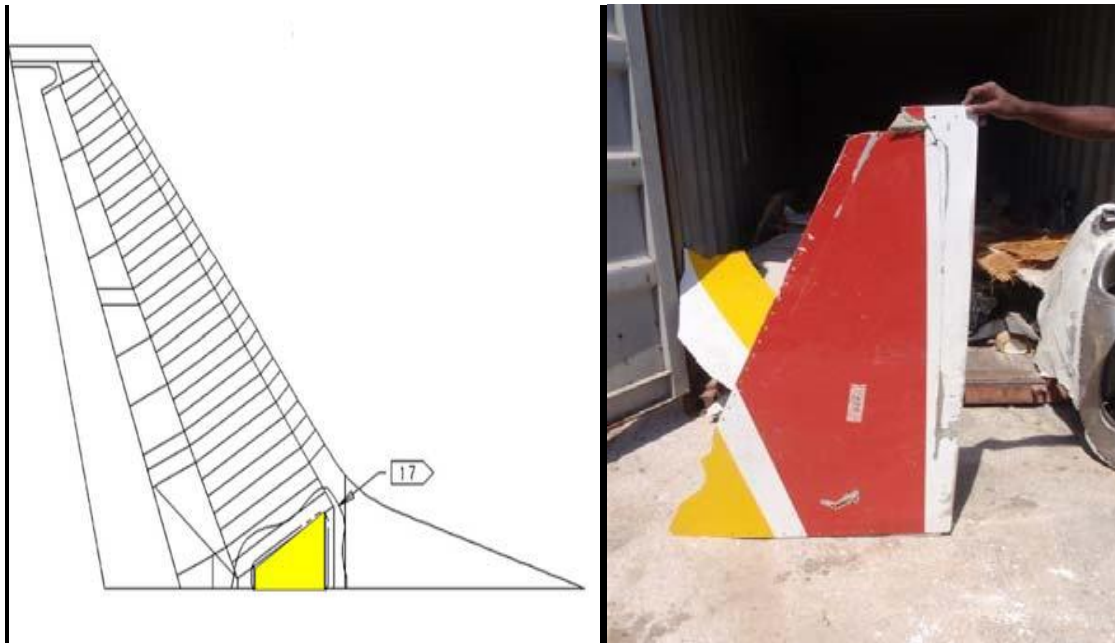
**Figure 6: Winglet Panel and its installed location**

A number of pieces of floating wreckage were recovered from the water's surface near to the last recorded radar point and to various distances north east of that point. One of these pieces was the winglet panel that was identified by the logo paint scheme and by the part number located on the interior surface. This panel was from the side lower closeout panel at the wingtip as shown in figure 6. That part is of composite material. It was found floating near the beach of Beirut, about 8 NM NE of the impact site.

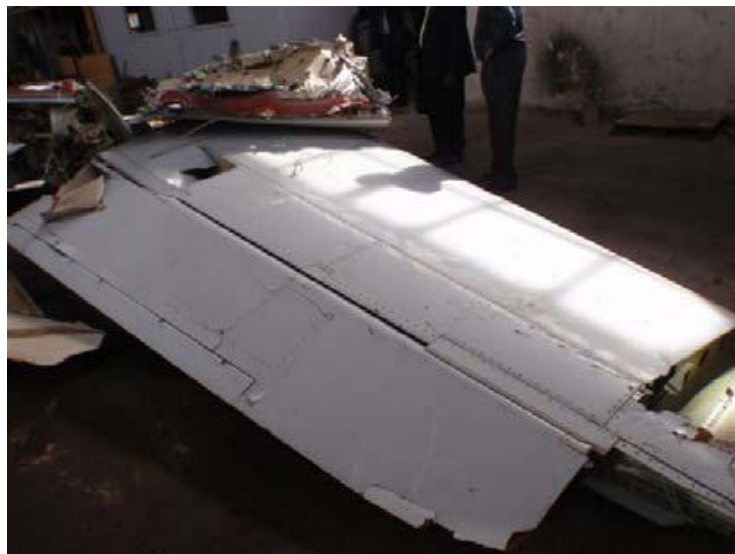
**Figure 7: Left Elevator**

Many evaluation visits to examine the wreckage were conducted by the Airworthiness Group. They included a thorough examination of the left and right elevators shown in figures 7 and 8. As a result of these visits, the Group also recommended to the IC to further evaluate the

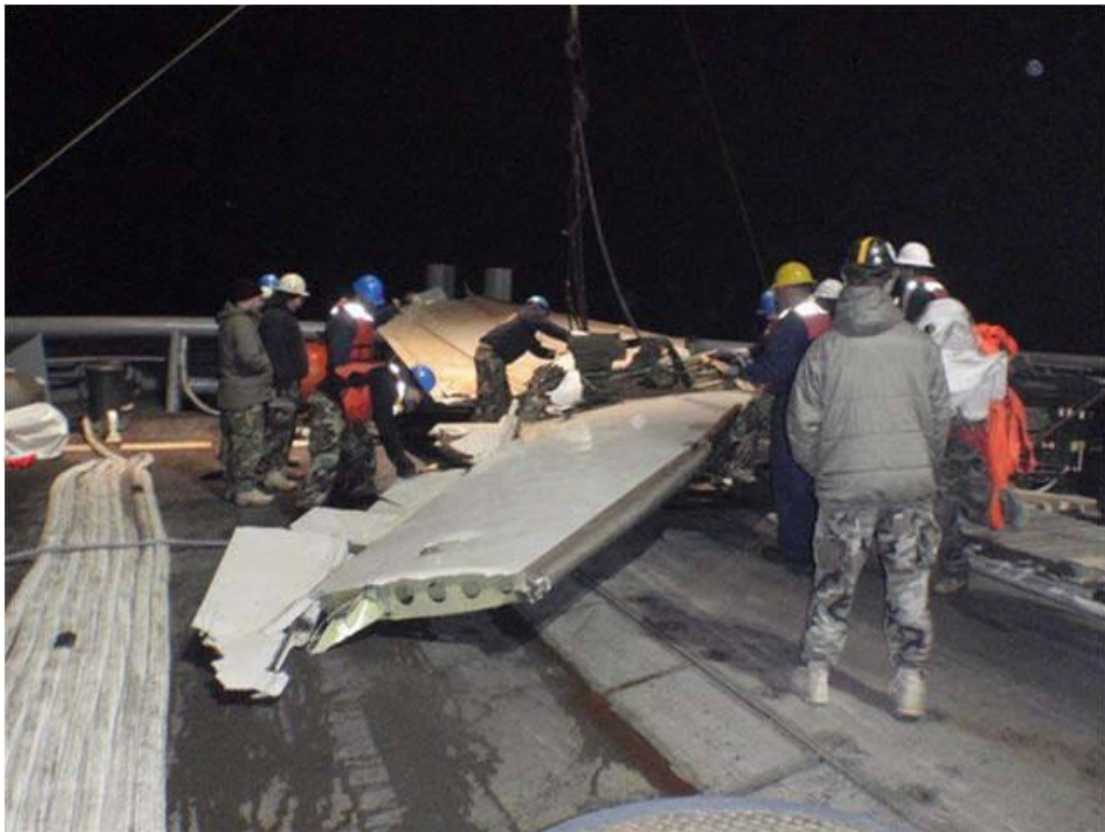
**Figure 9: Recovery of the Stabilizer Section**

The horizontal stabilizer section was recovered (during the search for the DFDR and CVR); this portion was relocated to Beirut Naval Station. The Airworthiness Group has recommended the removal of the Trim Tab section and sending it to the NTSB for further investigation. That recommendation was approved by the IC and the Trim Tab analysis is discussed in section 1.16 of this report with the full report attached as Appendix O.

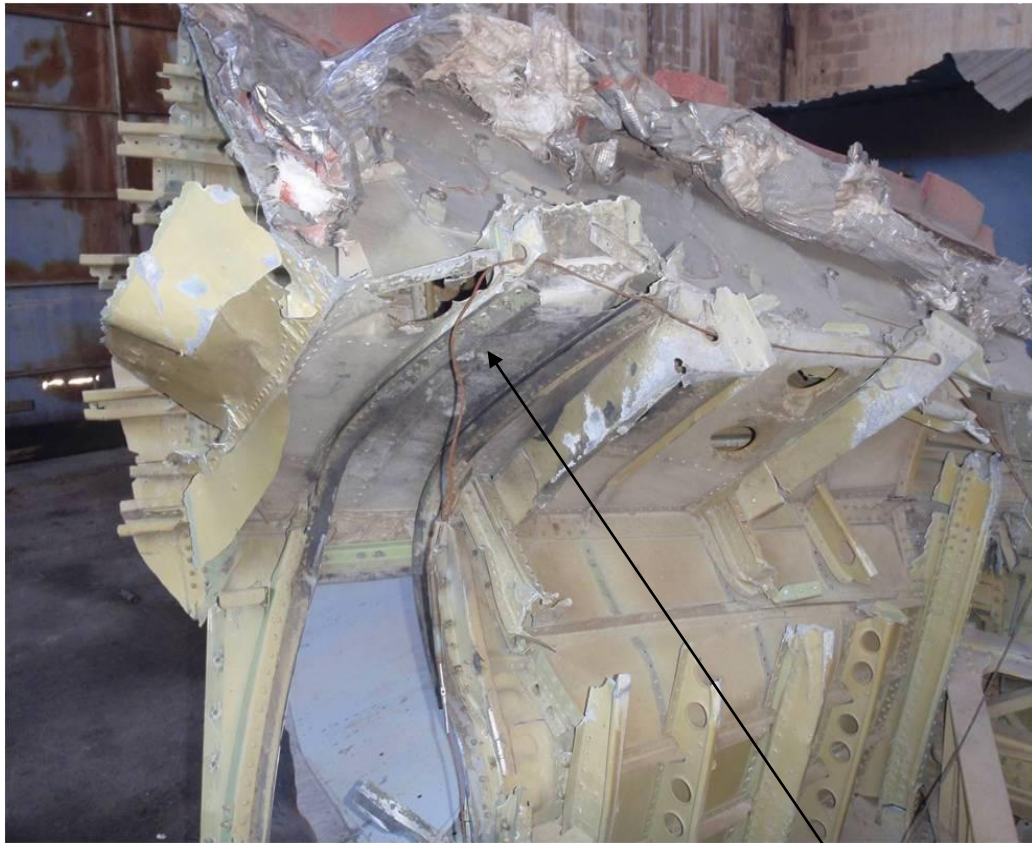
**Figure 14: The APU Exhaust area showing the Black Soot**

The NTSB report was received from the US Accredited Representative on July 29, 2011. The report specified that “*There was no discoloration to the primer paint and the surface was uniformly covered with a light coating of sand or dirt. Zinc chromate primer paint changes color when exposed to heat.*” It goes to conclude that “*Since there was no change in the color of the paint on the primer side, there was no indication that this section of fuselage was exposed to heat/high temperatures.*”

As for the origin of the black soot it determines after examining the material associated with the black soot that *“The spectrum obtained from the submitted unknown sample suggests that the material was organic as evidenced by the presence of characteristic carbon-hydrogen bonding peaks between  $\sim 3000\text{ cm}^{-1}$  and  $\sim 2800\text{ cm}^{-1}$  as well as a small group of peaks between  $2300$  and  $1400\text{ cm}^{-1}$ . This peak configuration is indicative of a straight chained, aliphatic hydrocarbon. When compared to the spectra of known materials, the unknown material most closely matched spectra from lubricating oils.”*

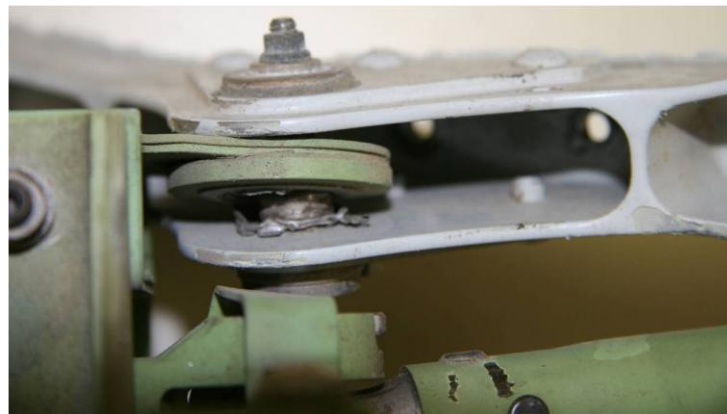
**Figure 17: Left Inner Attachment Bearing**

A few months after the accident, the FAA issued an AD not related to that accident requiring a periodic on-going inspection of the bearing retention for a secure swage on all Boeing NG airplanes. Therefore, the IC decided to send the trim tab mechanism to the NTSB for analysis, especially that inboard attach bearing of the left side tab mechanism was found with all of the bearing balls missing. Refer to Figure 17 below.

The reason behind issuing the AD was two reports of unusual airframe vibration involving Boeing 737 NG airplanes. Despite airframe vibration, neither airplane suffered from “loss of integrity” to their flight control systems; both airplanes continued safe flight and landings. Post flight examination of both airplanes revealed that the elevator tab mechanism on one side had become completely detached (both inboard and outboard lugs) from its mountings on the front spar of the elevator. Analysis attributed these fractures to the loss of the attach point bearing retention and subsequent fracture of the attach tab. However, the DFDR of the two airplanes that diverted as a result of the vibration oscillation triggering the issue of the AD showed significant oscillatory movement of the elevator following its final fracture.
