**AIRCRAFT ACCIDENT REPORT 2/2013**

**ACCIDENT INVESTIGATION DIVISION**

**Report on the accident to Airbus A330-342  
B-HLL operated by Cathay Pacific Airways Limited  
at Hong Kong International Airport, Hong Kong  
on 13 April 2010**

**Hong Kong  
July 2013**

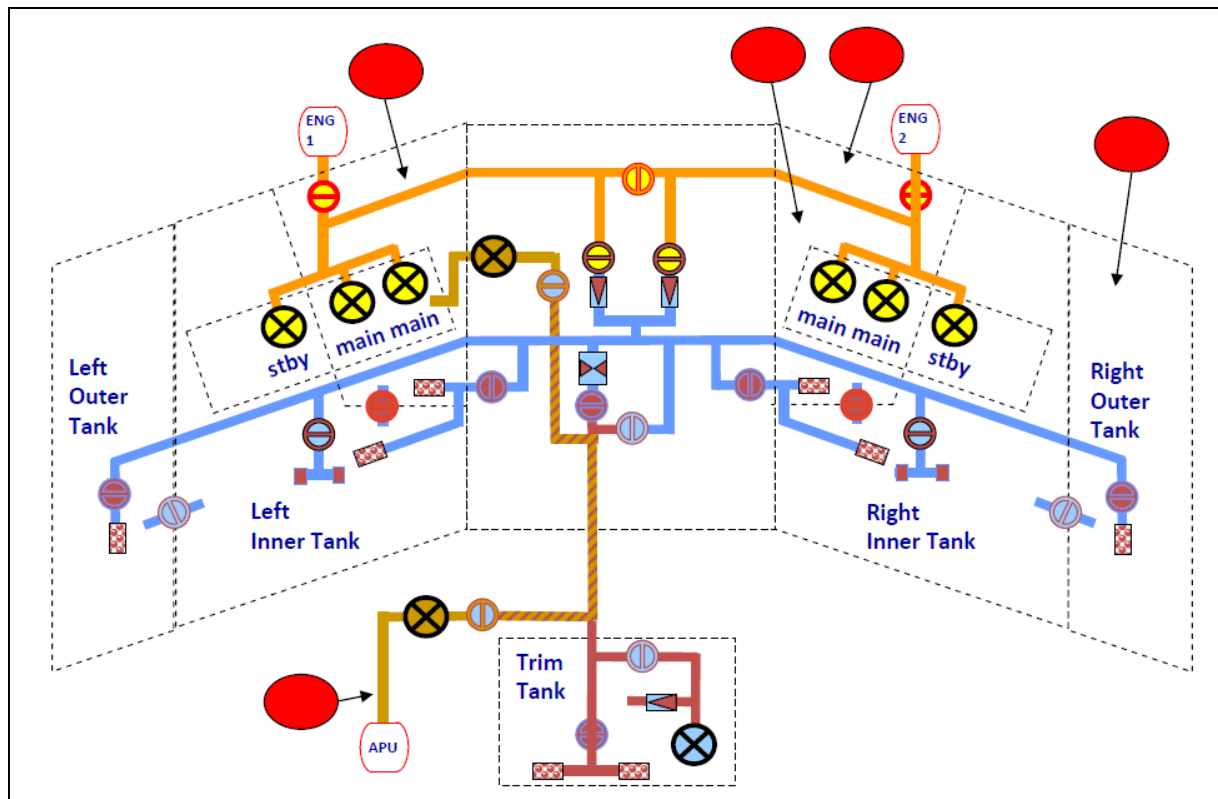
**b.** There were trace quantity of translucent spherical particulate matters in some fuel samples. As discussed later in this Sub-section, similar spherical particulate matters were also identified in other fuel samples and inside some engine components. The particulate matters were further examined and their structure and source were analysed. The results indicated that they were predominantly made up of carbon, oxygen, and sodium, with moderate amount of chlorine and sulphur, and were mainly sodium polyacrylate which was consistent with the super absorbent polymer (SAP) material used in the filter monitors installed in a fuelling dispenser. This particulate matter will be called “SAP sphere” in this Report and its structure and composition will be further discussed in this Sub-section.

**Figure 21: Aircraft fuel sampling locations.**  
**Red dots highlight those locations where the SAP spheres were present.**

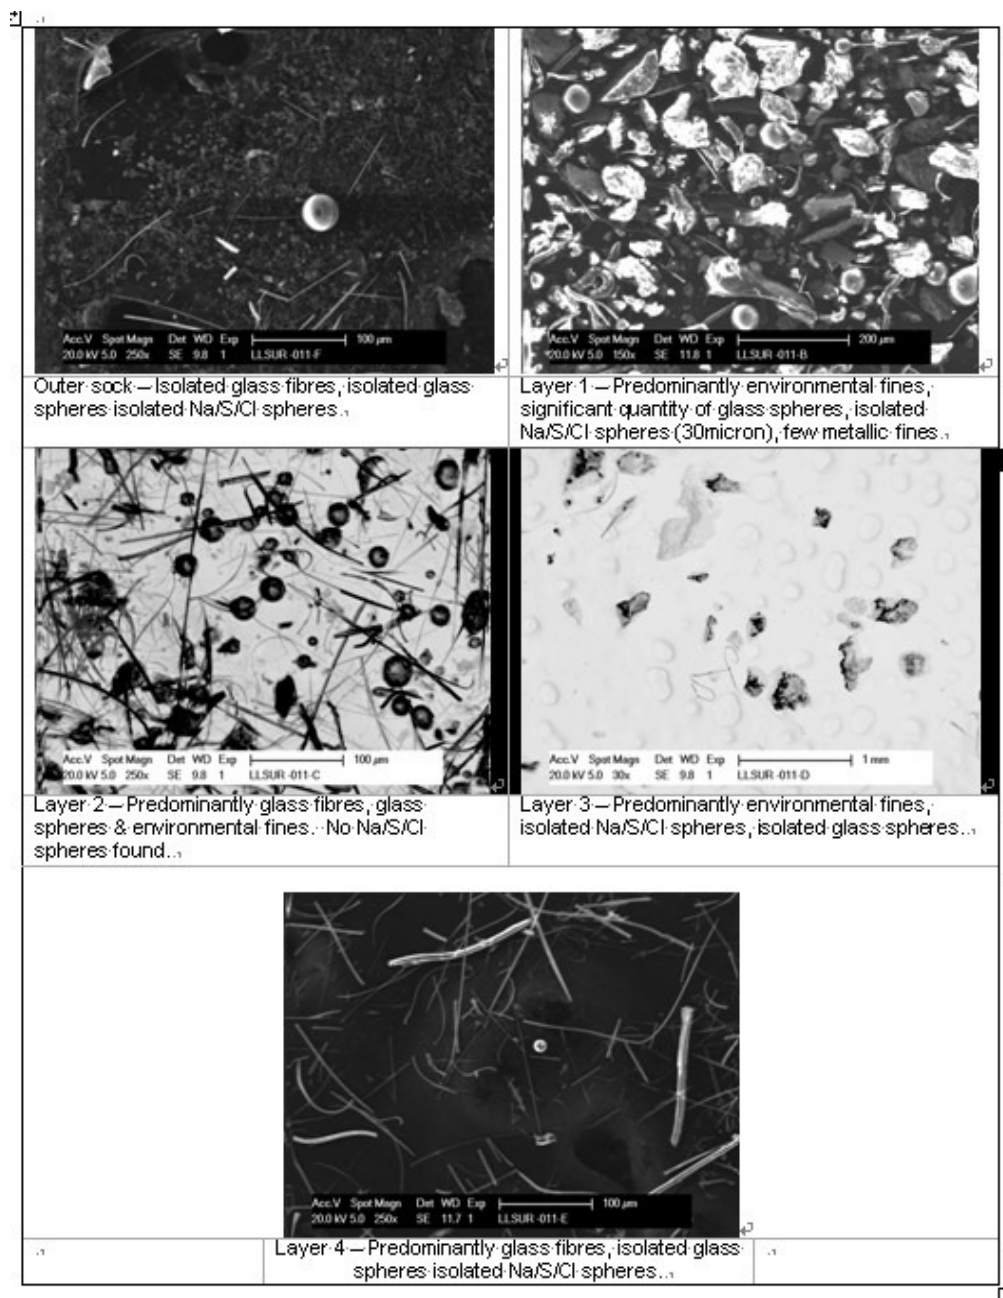
d. Examination of the dissected filter monitors revealed that the construction of the accident filter monitors was identical in terms of media type to a recently manufactured element, and that the SAP layers had been exposed to water. There was very little evidence of dirt trapped in the media layers. Isolated SAP spheres were found in one filter monitor (see Figure 33). No SAP sphere was identified in the new pristine filter monitor when it was dissected and examined by using similar technique.

**Figure 33: Isolated SAP spheres (Na/S/Cl spheres) found in the media layers of the filter monitor.**
