## **AIR ACCIDENT INVESTIGATION SECTOR**

## **AIR ACCIDENT INVESTIGATION REPORT**

**Uncontained Cargo Fire Leading to Loss of Control  
Inflight and Uncontrolled Descent Into Terrain**

Boeing 747-44AF  
N571UP  
Dubai  
United Arab Emirates  
03 September 2010

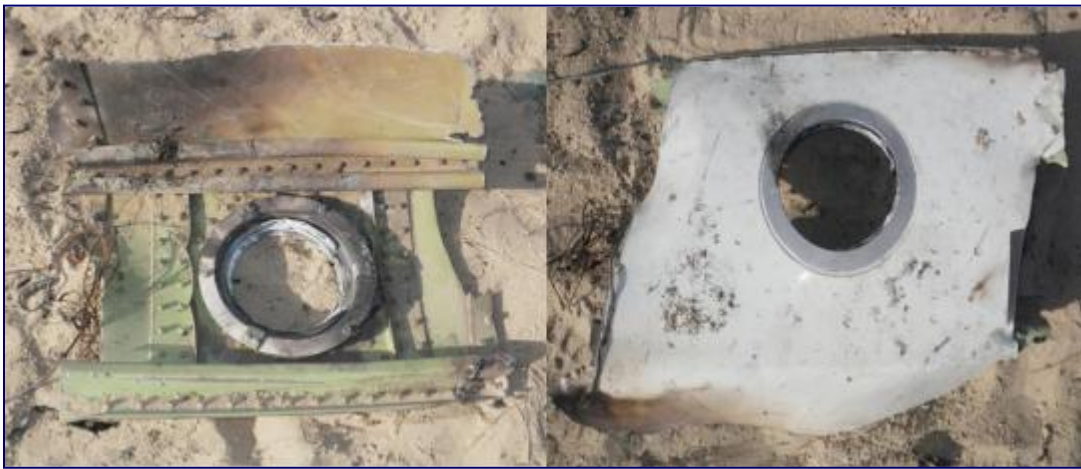
The piece of the fuselage observation window, or viewport, had sooting around the viewport opening and the viewport seal was charred and reduced to a white powder. An area of the green primer had evidence of thermal degradation of the primer paint. The level of damage sustained by the viewport window and seal in contrast to the level of damage to the surrounding material and primer paint is consistent with the thermal exposure having occurred while the viewport was covered by the bezel leaving only the window portion exposed to the interior of the main deck cargo compartment. This viewport was located on the right side of the aircraft at approximate station number 840, which is also cargo position 6R

Photo 4 Fuselage Viewport

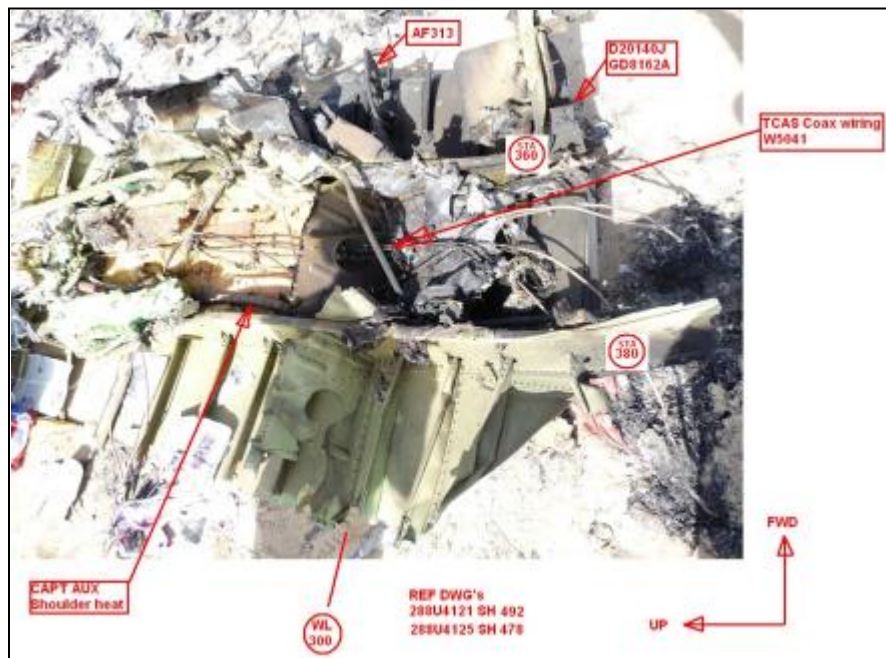
This recovered assembly of structure and fuselage skin originated from the left hand side, upper section 41, Station 360 – 420. There was heavy fire damage in the form of charred insulation and primer paint between stations 360 and 380 stopping at the level of the upper deck floor. The fire-damaged area contained TCAS coax cables and an air vent hose.

Photo 15 Recovered assembly of structure and fuselage skin

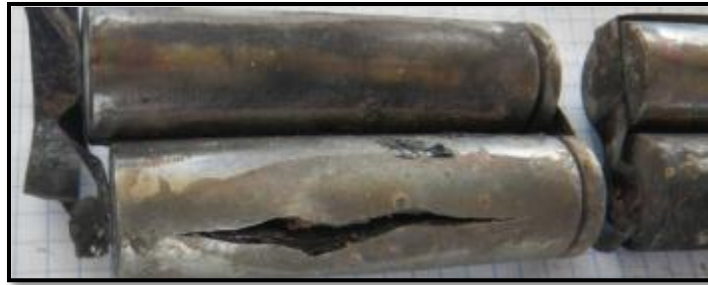
Fire damaged remains of battery pack with a fractured cell

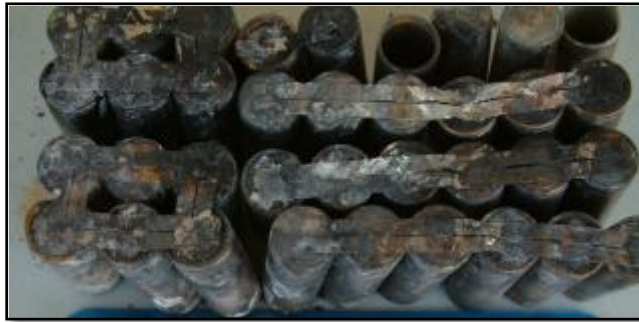
36-cell lithium-ion battery pack with multiple vented cells

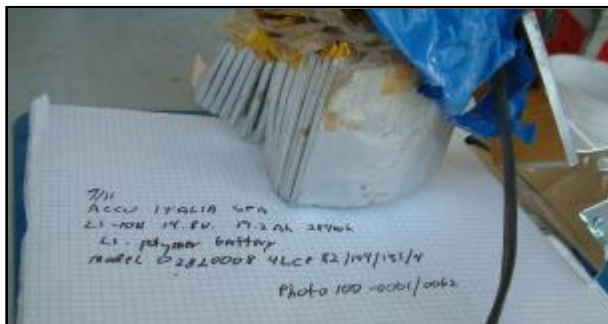
Lithium-ion polymer type battery pack [LH]/ Lithium-ion polymer type battery pack with thermal damage [RH]

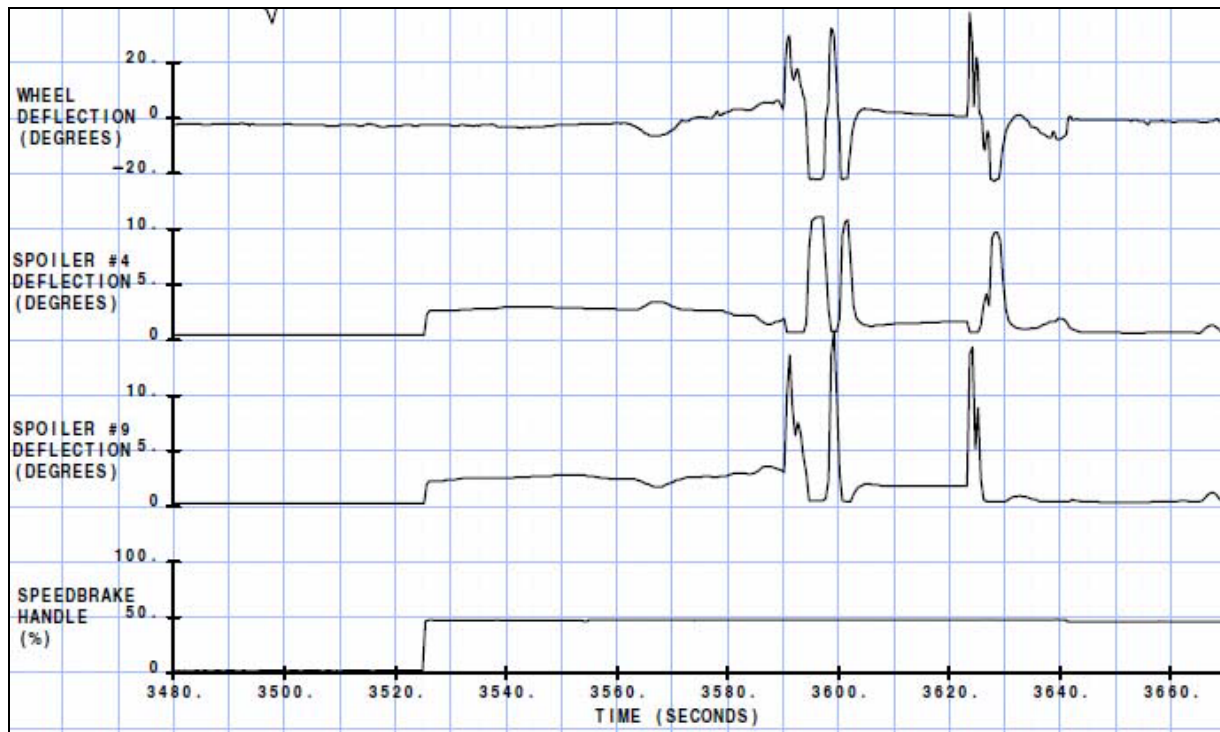
The Figure below demonstrates the inconsistency between speed brake handle and spoiler deflection – At 15:38:09 to end of flight the spoiler response to speed brake handle when moved to flight detent position was only 3 to 4 surface degrees for flight spoilers #4 and #9 Normal response to speed brake flight detent for these spoiler surfaces would be greater than 25 degrees at the flight conditions. The spoiler panels responded normally to wheel inputs during this time period which demonstrates that these spoiler surfaces had capability to move further. Spoiler deflections are consistent with the flight path of the aircraft.

Figure 53 - Spoiler deflection from speed brake handle and wheel deflection

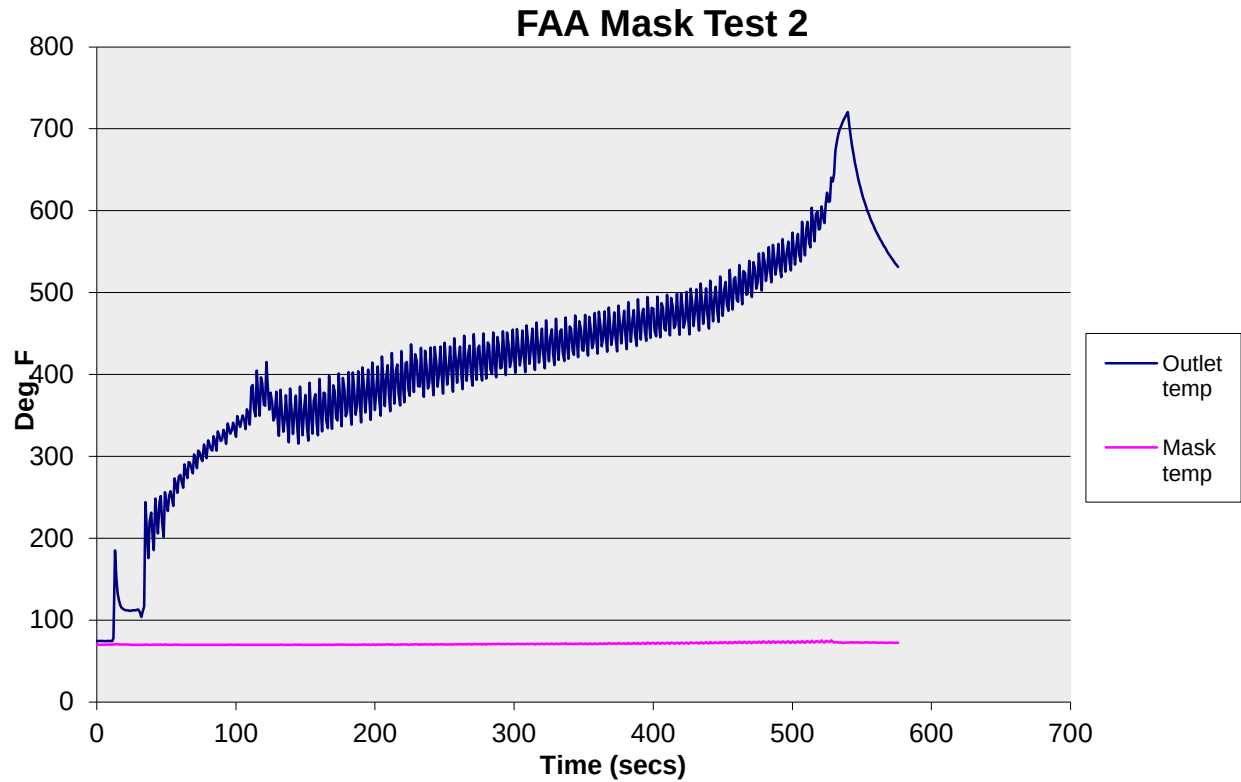
Mask Test #2 Flex Hose 60B50059 hose failure

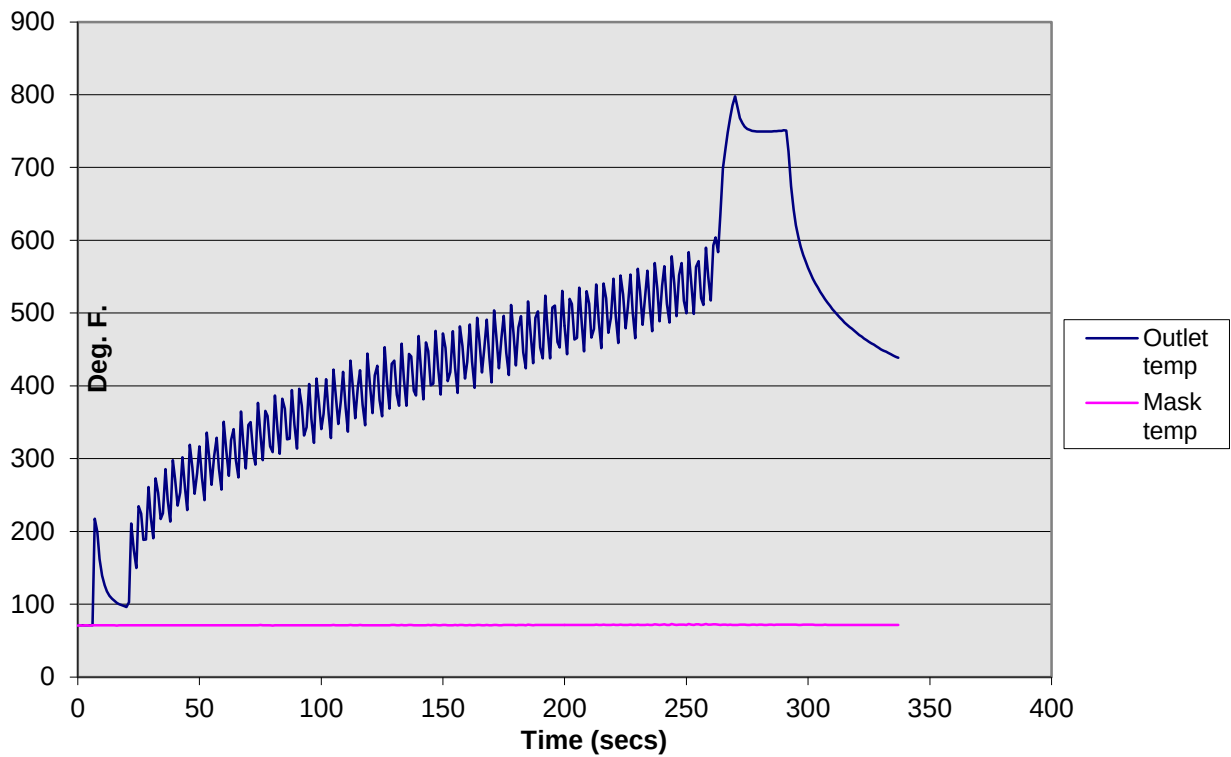
Mask Test #3 Flex Hose 60B50059 hose failure
