Air Accident Investigation Unit Ireland

SYNOPTIC REPORT

**Boeing, 737-8AS, EI-EMH/EI-EKK
LINK 2, Dublin Airport, Ireland**

7 October 2014

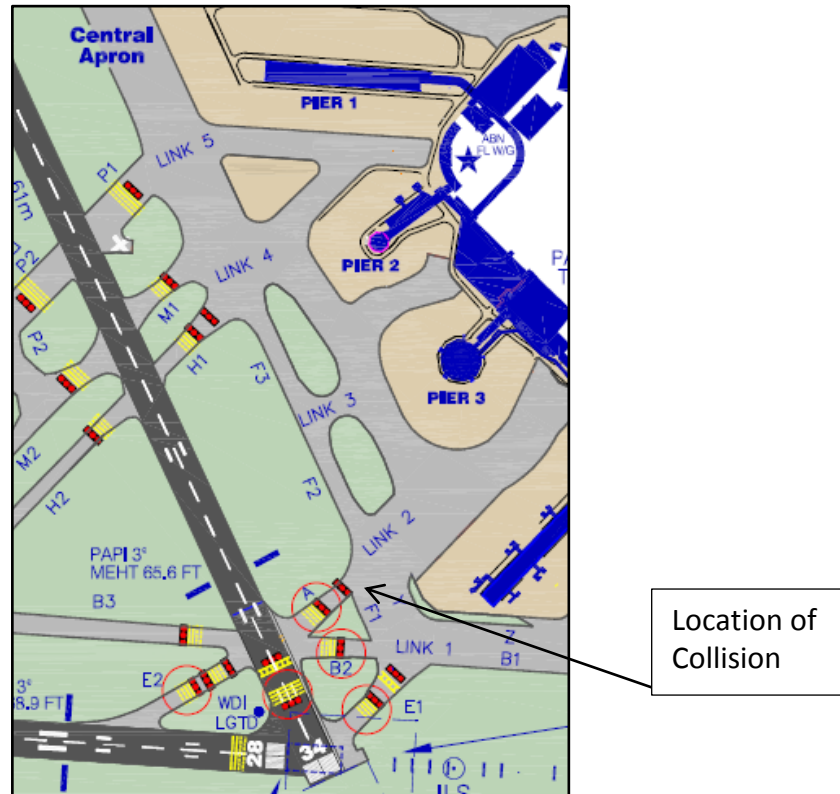
Graphic No. 1: Close-up of Aerodrome chart/Collision area

The second aircraft (EI-EMH), with a planned destination of Edinburgh (EGPH), was following behind EI-EKK in sequence but was due to depart from RWY 34. EI-EMH had been cleared to taxi, LINK 5 onto the Foxtrots and TWY A to hold short RWY 34. When the aircraft was approaching LINK 2, the SMC advised EI-EMH to continue onto TWY A, hold short RWY 34, and monitor TWR 118.6 MHz. As EI-EMH turned right onto LINK 2 and taxied towards TWY A, the tip of the port side winglet struck the outer portion of the starboard elevator of the stationary aircraft, EI-EKK.

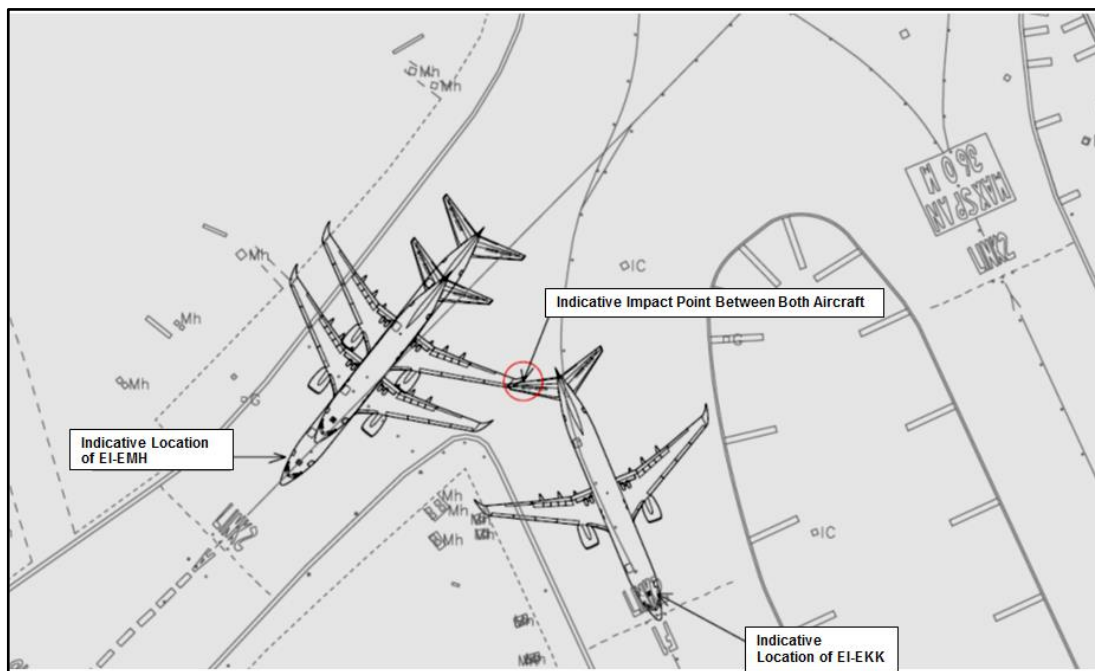
Graphic No. 2: Approximate position of both aircraft at impact and the final parked position of EI-EMH

Two Inspectors of Air Accidents arrived on site approximately one hour after the occurrence. The first aircraft, EI-EKK, was found in its original parked position with its nose tip just over the demarcation line between LINK 2 and TWY F1 and with the nose wheels slightly left of the taxiway centreline. The main undercarriage wheels were predominantly to the left side of the taxiway centreline as the aircraft tracked to complete the turn onto the centreline. The rearmost section of the starboard elevator was in line with the southern edge of TWY A/LINK 2 (**Graphic No. 2**).

The second aircraft, EI-EMH, stopped a short distance (approximately five metres) from its first point of contact with EI-EKK, approximately 15 metres (m) short of the demarcation line between LINK 2 and TWY A. The nose wheels were slightly right of the taxiway centreline and the main undercarriage wheels were predominantly to the right side of the taxiway centreline as the aircraft tracked to complete the turn onto the centreline. **Graphic No. 2** depicts, for indicative purposes only, the approximate positions of both aircraft at the time of impact and the final parked position of EI-EMH following impact.

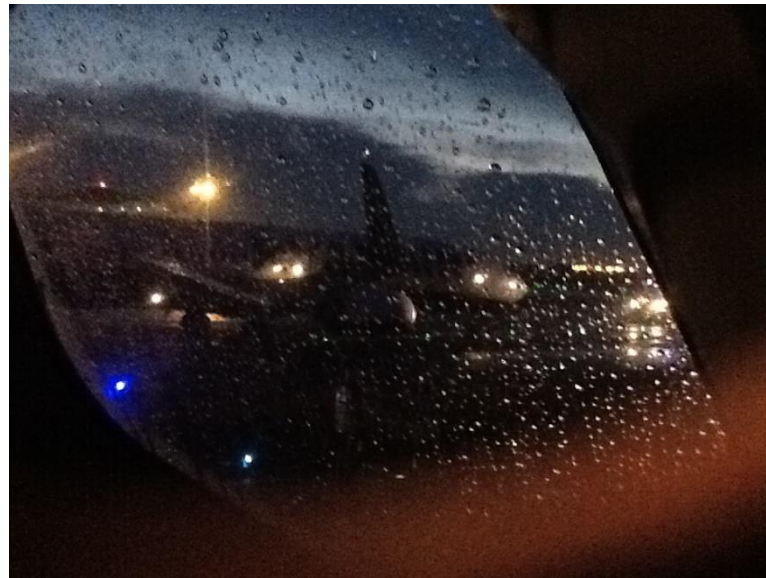
Photo No. 1: Post collision view of EI-EKK from side cockpit window of EI-EMH

Shortly after the occurrence, the Commander of EI-EMH took a photograph of EI-EKK from his rear portside cockpit window and on request the Commander provided the photograph to the Investigation (**Photo No. 1**). This photograph shows EI-EKK in the foreground. The side cockpit window is covered in rain drops and diffused ramp lighting can be seen in the background. Light conditions are early morning darkness. However, it was not raining at the time of the collision.

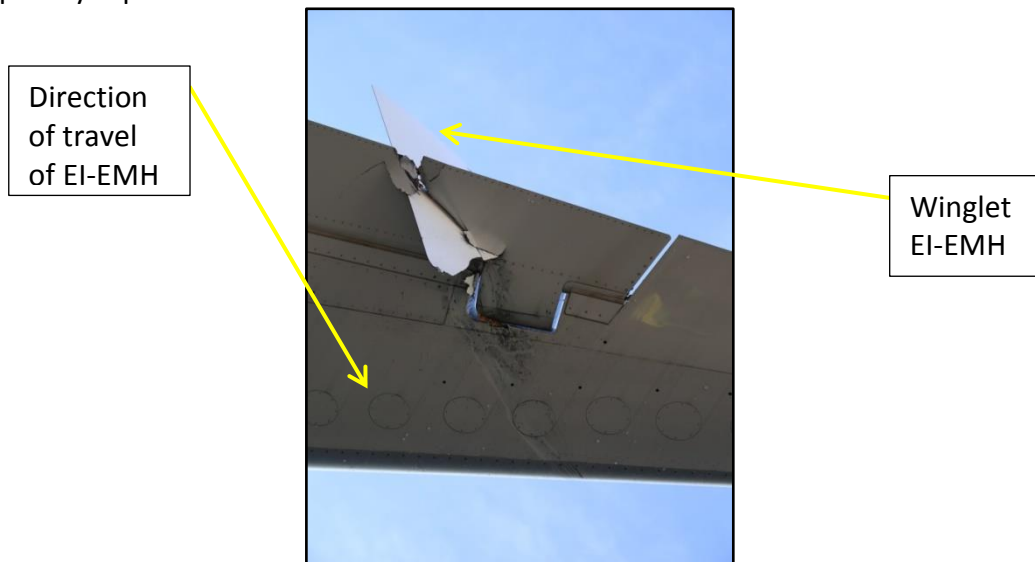
Photo No. 2: Tip of winglet embedded in elevator of EI-EKK and associated scuff marks

The tip section of the port side winglet of EI-EMH struck the outer portion of the starboard elevator of EI-EKK and then sheared from the main part of the winglet as the aircraft continued forward. The underside of the elevator and horizontal stabilizer on EI-EKK suffered scuffing and scrape marks as a result of the stub of the winglet remaining in contact with the aircraft structure as it passed underneath and across the elevator and horizontal stabiliser (**Photo No. 2**). Both the winglet and elevator were extensively damaged and subsequently replaced.

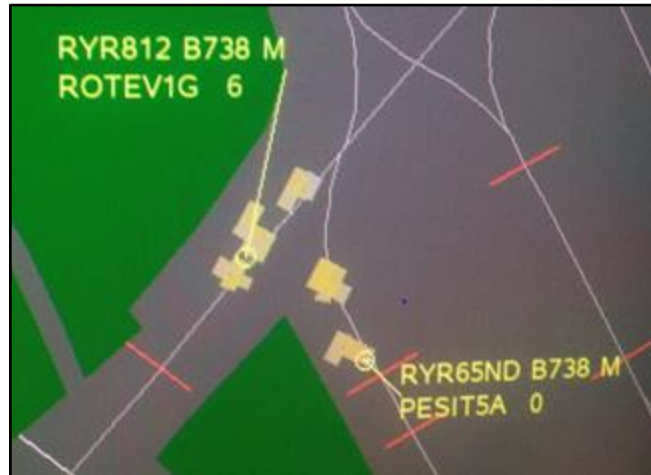
Graphic No. 3: ASMGCS return at point of contact

A review of a series of ASMGCS recordings identified that it was not uncommon for aircraft to stop on the demarcation line LINK 2/F1 when queuing aircraft were ahead on LINK 1/E1.

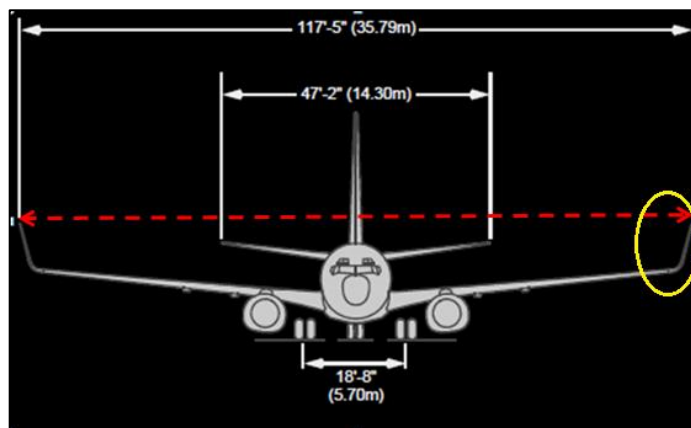
Graphic No. 9: Winglet extending above the height of the aircraft's horizontal stabiliser

The increase in height is significant as it extends above the height of the aircraft's horizontal stabiliser (Graphic No. 9). Prior to the introduction of winglets, wingtips would have had sufficient vertical clearance to pass underneath the horizontal stabilizer of the same aircraft type.

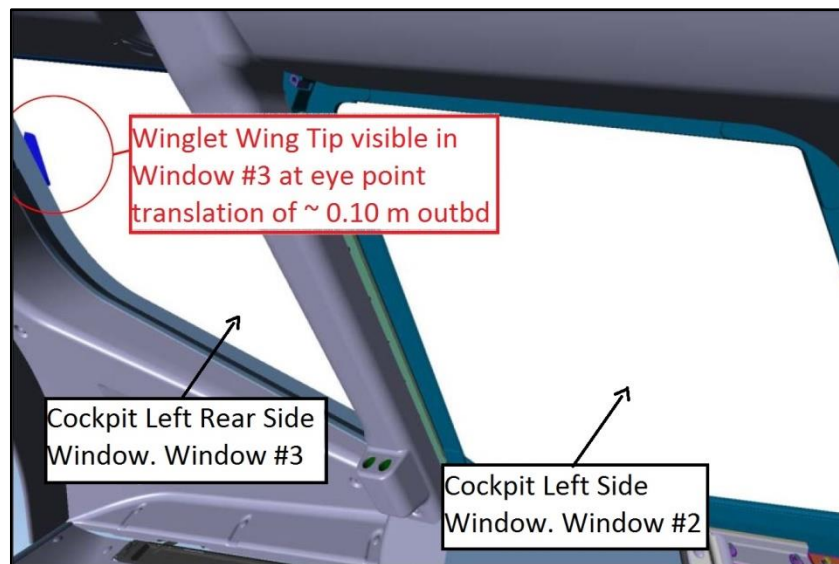
Graphic No. 12: Approximate visibility of winglet wingtip through window No. 3 - 0.10 m outboard of the normal seating position (Boeing Proprietary Copyright © Boeing - Reprinted with permission of The Boeing Company)

This approximation shows that the left winglet of the B737-800 is just visible from the seated position in the pilot's seat, when the viewer's head is turned and moved 0.10 m outboard to the left.

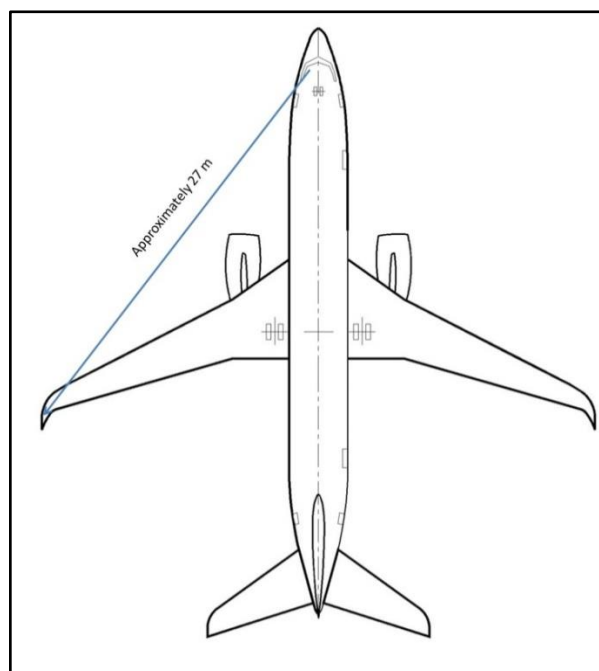
Graphic No. 13: Line of sight distance between cockpit and winglet

The Investigation also carried out its own examination of the view of the wingtip from the Commander's seat. The direct line of sight distance from the Commanders normal seating position to the winglet was approximately 27 m (**Graphic No. 13**).

It was noted that in order to obtain a view of the complete winglet, a pilot would need to move their head closer to the No. 2 window, and then look back through the No. 3 window. This is not a natural seating position, and takes the pilot's visual attention away from the straight ahead view. The Investigation further noted that the thickness and depth of the pillar dividing the No. 2 and No. 3 window interfered with the view.
