## Final report on aircraft accident

Case number: **2015-089-F-026**

Description: **Aircraft collided with the ground during a training flight**

| Factual information | |
|---|---|
| <b>Aircraft type:</b> | Tecnam P2002JF |

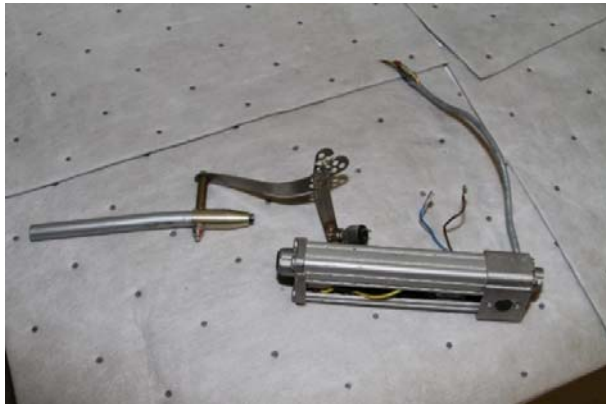
The trim actuator was found in mid position and the flap actuator indicated that the flap position was 0 (clean configuration).

Figure 6: The flap actuator

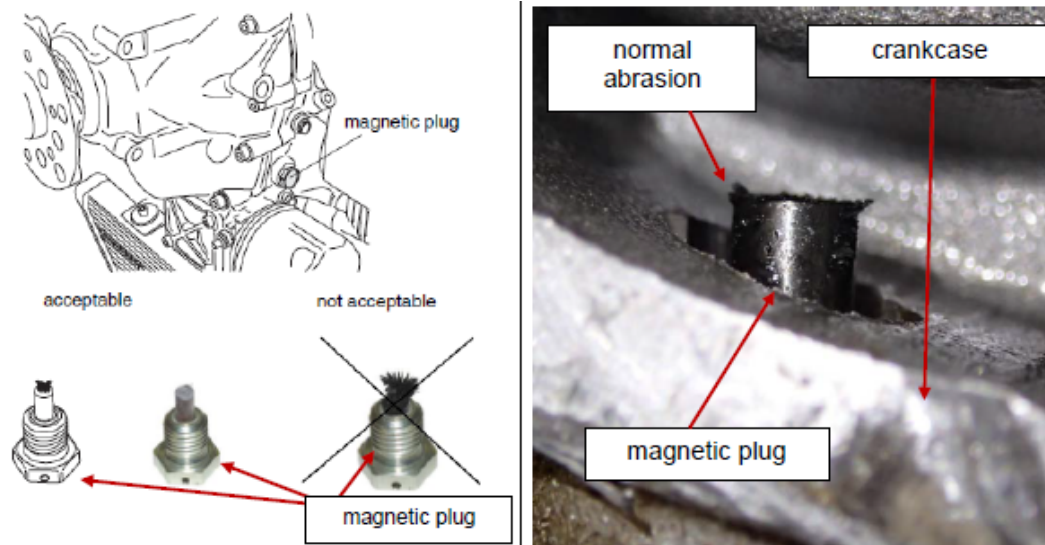
A visual inspection was made of the magnetic plug. There was no abnormal accumulation of chips on the magnetic plug.

Figure 7: Magnetic plug inspection

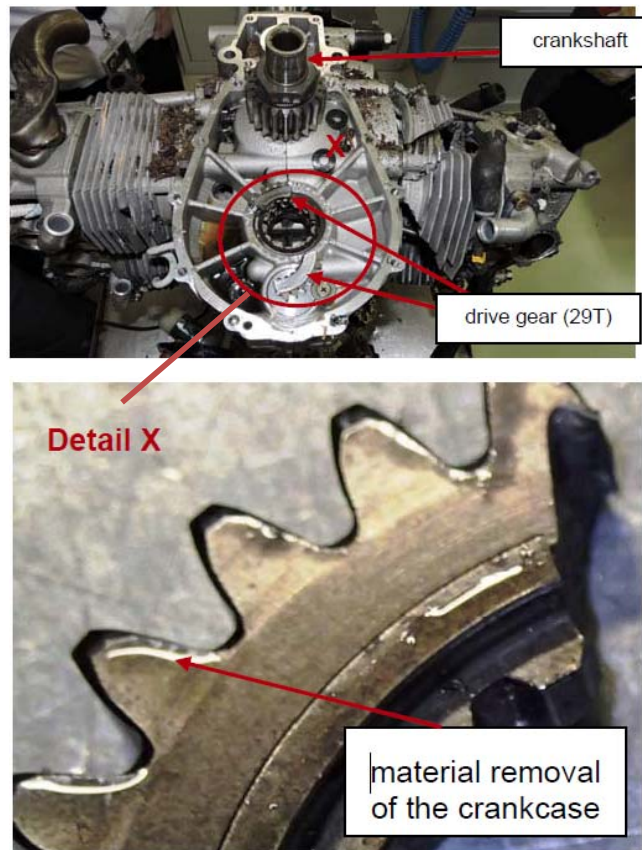
A high level of damage was visible on the crankcase as a result of the crash.

These marks indicate that the crankshaft was slowly turning at the time of the impact.

The investigation of the engine revealed that free movement existed in all connecting rods of the crankshaft before impact. There were no indications or damage visible on the connecting rods that would indicate a seizure. In addition, the main bearings and the support bearings of the crankshaft and crankcase were free of defects and there was no indication of malfunction.

Figure 8: Crankcase inspection

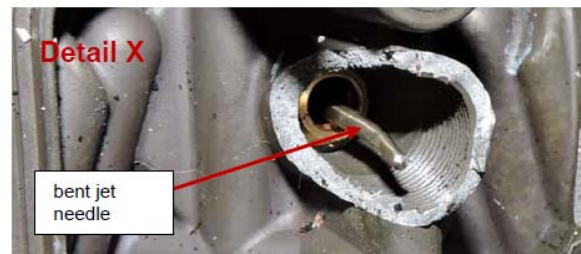
The carburettor (S/N 15.1619) was found severely damaged, as a result of the crash. The jet needle position was found bent and indicated that the power was at idle power at impact (idle position).

Figure 9: Carburettor inspection

No technical abnormalities were found on the carburettor.

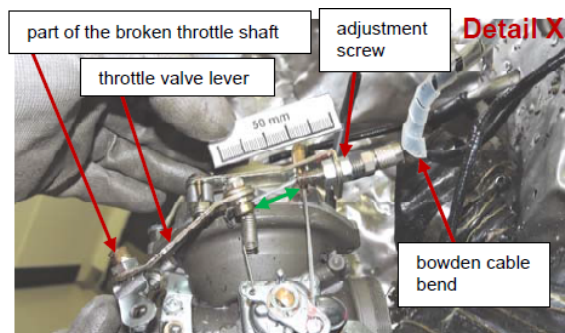
The Bowden throttle control cable was bent approximately 90° in the area of the adjustment screw as a result of the crash (see Figure 9). This was also an indication that the engine power was at idle at the time of impact, regardless of the throttle lever position found at the accident site.

Figure 10: Throttle control cable

Based on the detected carburettor - Bowden cable bent the throttle position and also the jet needle position, it can be assumed that the engine was operating at idle at the time of the impact.

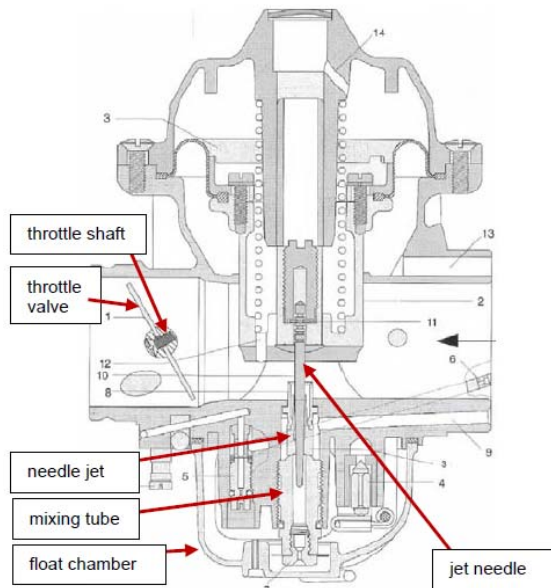
Figure 11: Carburettor

The investigation revealed no evidence of any malfunction of the engine. Furthermore, the teardown inspection of the relevant mechanical engine parts showed no damages or unusual wear, which could explain an engine failure or a loss of power.

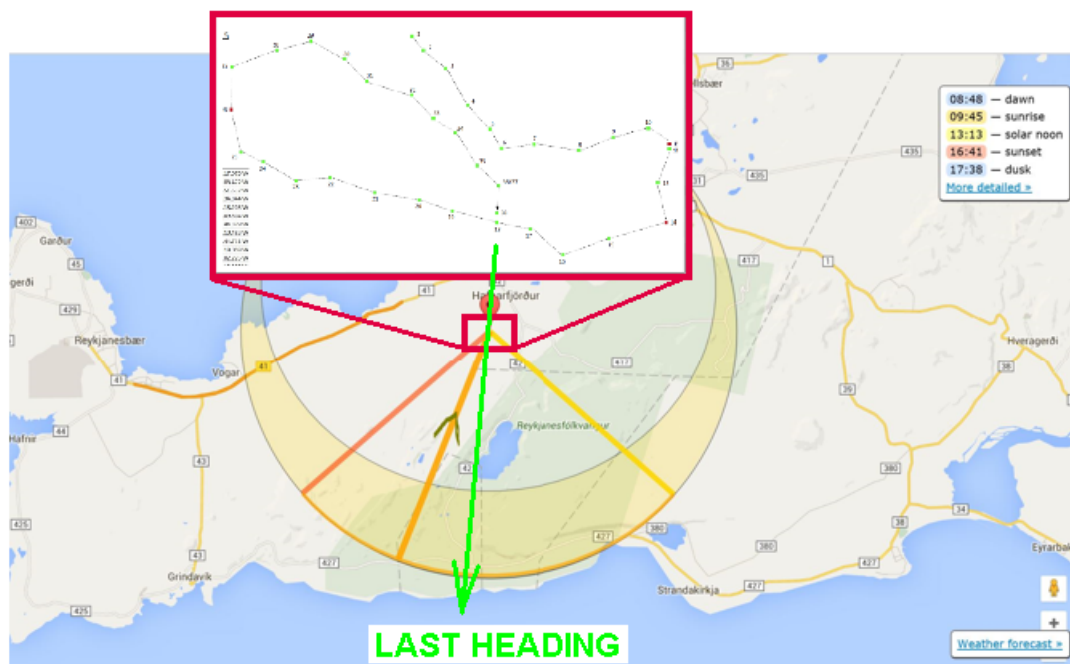
As can be seen in Figure 15, the sun was shining and low in the sky around the time of the accident. The last plotted heading of the aircraft was towards the sun (see Figure 15 and Figure 16), possibly interfering with the pilots' instrument reading.

Figure 16: Last known heading towards the sun

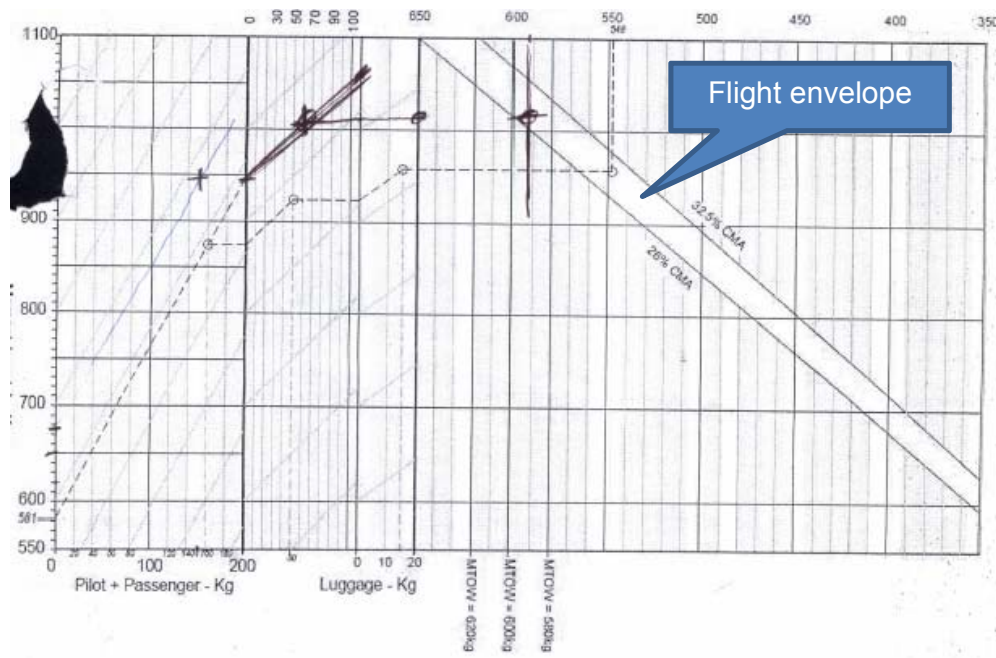
By looking at the Weight and Balance sheet that the pilot filled out, the 676.4 kgm of empty Weight moment is used. Total of 400 kg empty Weight, 150 kg of pilot and passenger Weight, and 60 liters of fuel (which equals to 43 kg of fuel). The Weight and Balance sheet was made manually before the flight and indicated that the aircraft loading was within limits. By filling out the Weight and Balance sheet with a computer, it may be seen that the center of gravity is at the forward limit of the flight envelope (see Figure 23 and Figure 24).

Figure 23: The Weight and Balance sheet – Hand drawn

Due to how narrowly the manufacturer's W&B envelope is presented on the W&B sheet, it is easy to make errors while preparing the sheet. This makes locating accurately the center of gravity difficult and allows cumulative errors to occur.

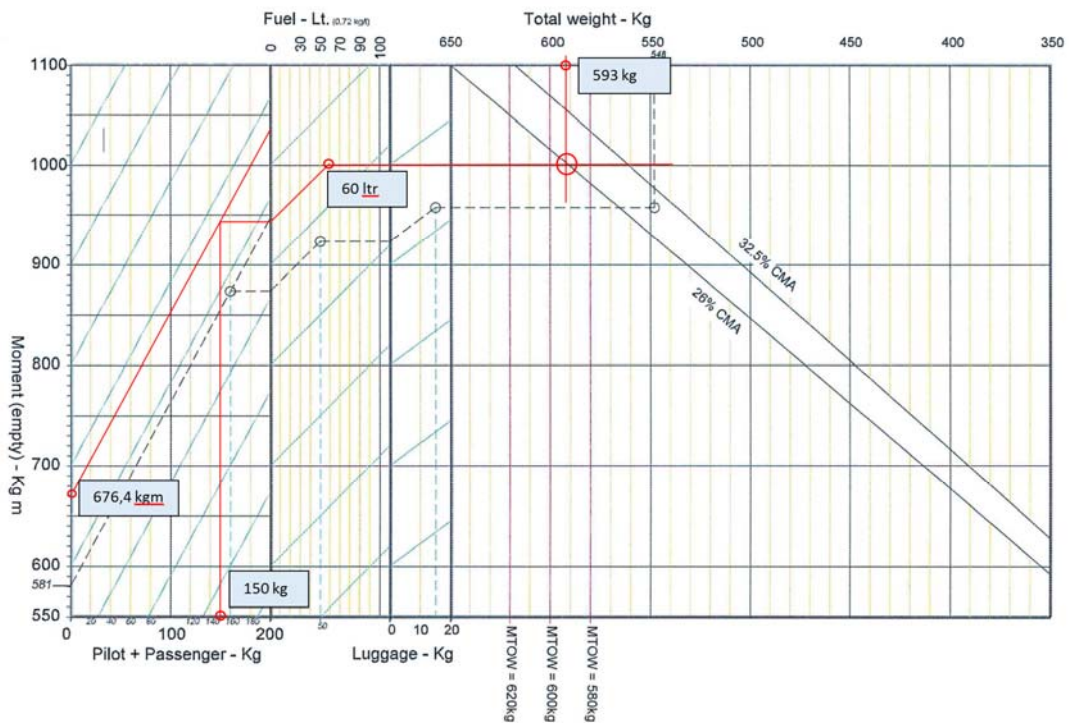
Figure 24: The Weight and Balance sheet – Computer drawn

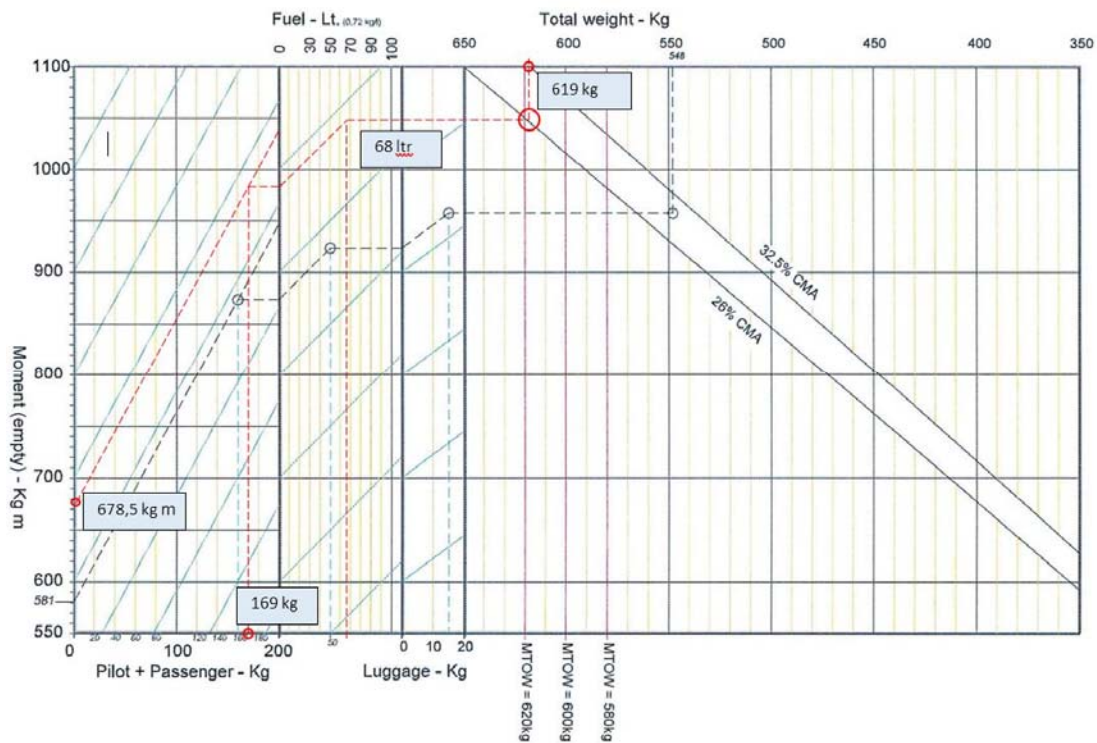
Figure 28: Corrected Weight and Balance sheet

From the calculations above, it is apparent that the aircraft was within the Weight and Balance boundaries but slightly closer to the limits than depicted on the Weight and Balance sheet prepared by the Instructor/student.

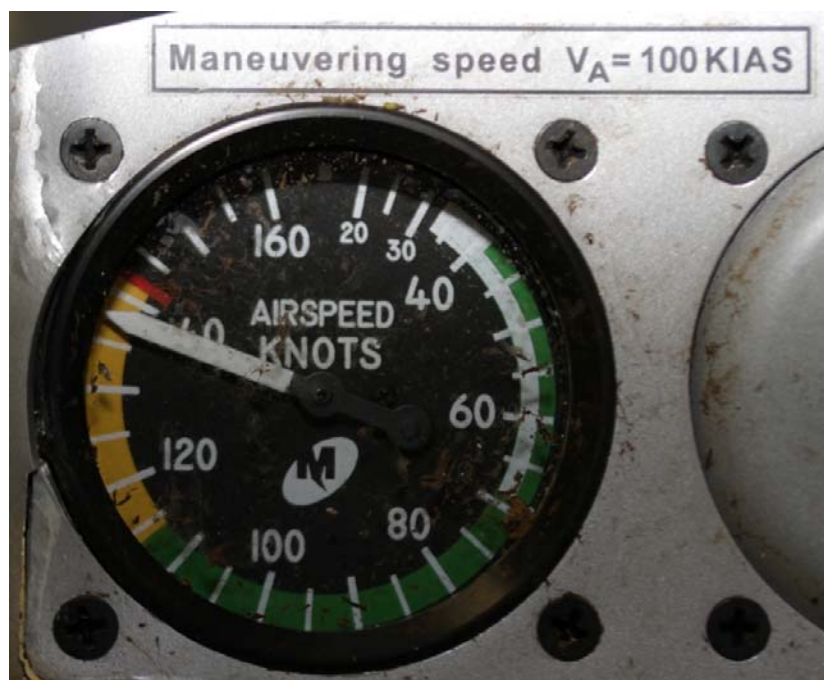
Numerous inconsistencies were found between the airspeed limitation given in the aircraft's handbook and those marked on the airspeed indicator of the accident aircraft.

Figure 33: Airspeed indicator markings on instrument

The reason for this difference is that the table in the AFM is given for the Tecnam P2002JF variant with a MTOW of 580 kg.

The table of Airspeed Indication Markings for MTOW of 620 was missing in the AFM supplement valid at the time of the accident. This has been corrected in the 3<sup>rd</sup> edition – Rev. 14, dated November 11<sup>th</sup> 2019.
