# Misaligned take-off from Runway 24, Amsterdam Airport Schiphol

*The Hague, November 2018*

# GENERAL OVERVIEW

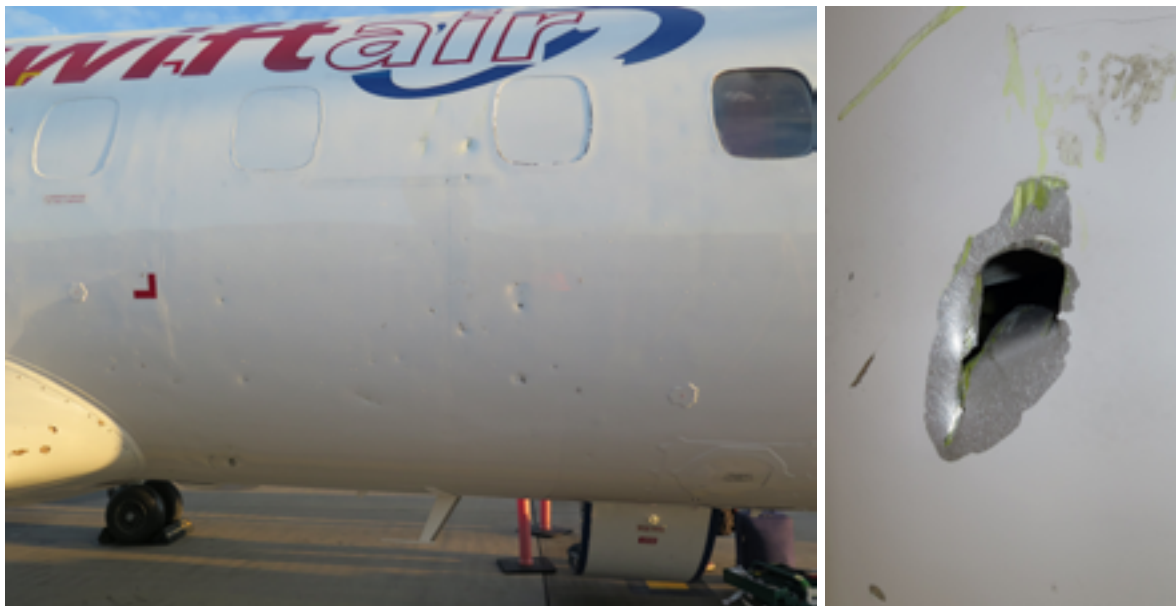
In contrast to the left-hand side, puncture marks were found at several locations on the right-hand side of the fuselage (see Figure 2 left). Around these locations, yellow paint deposits were visible on the white coloured fuselage skin. On one location, near the right-hand wing and body fairing, the fuselage skin was punctured (see Figure 2 right). This punctured hole also exhibited yellow paint marks around it.

*Figure 2: Fuselage on the right-hand side of the aeroplane with the hole pattern (left) and a detailed view of the punctured fuselage with visible yellow paint deposits (right). (Photo: AAIB)*

In order to explain the damage of the propeller and fuselage the following scenario was considered. After the lights were run over by the nose wheel of the aeroplane, parts of the runway edge lights were ejected to the right-hand side. Subsequently, some parts of the disintegrated lights hit the right-hand propeller. The latter is indicated by the yellow paint deposits that were found on the propeller blades. While being hit by the propeller blades, some parts of the edge lights were catapulted towards the fuselage due to the propeller's rotational velocity, leading to penetration of the fuselage skin. This explains the impact marks and punctured holes as found on the right-hand side of the fuselage skin. The yellow residue around the puncture marks on the fuselage matches the colour of the runway edge lights.

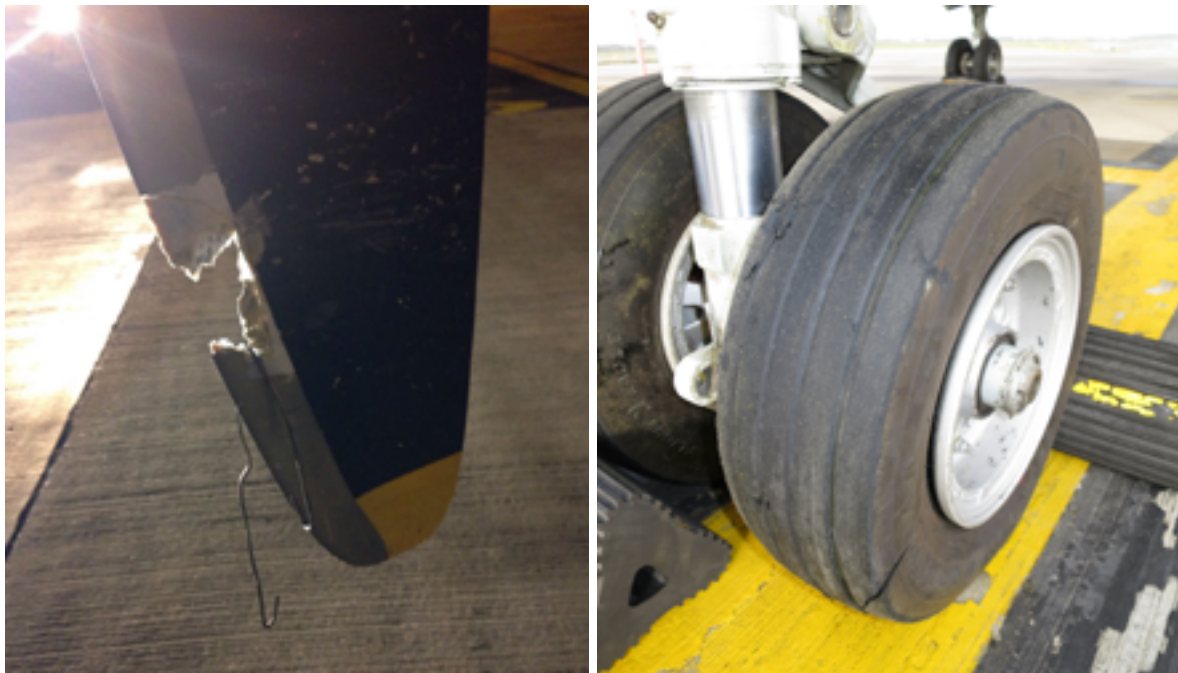
In addition to the damage on the aeroplane's fuselage, damage was found on the right-hand side propeller. This damage varied; one blade had a dent and a second blade was damaged on the leading edge with yellow paint scuff marks and a cut in the trailing edge. A third propeller blade was damaged more severely with a large cut in the leading edge with a piece of wire embedded in it (see Figure 3 left).

Figure 3: Right-hand engine propeller with wire embedded on arrival at Stansted airport (left image). Aeroplane nose wheel, as seen from the front side of the aeroplane, with port wheel damaged (right image). (Photo: AAIB)

The left-hand nose wheel (as seen from the front side of the aeroplane in Figure 3 right) exhibited yellow scuff marks and the tyre was cut just on the outside of the wheel extending to approximately halfway of the tyre's circumference. The tyre was found partially deflated and decoupled from its rim. The starboard nose wheel showed damage to the sidewall. In addition, yellow paint deposits were found on the rim and the outside of the tyre.

The port nose wheel sustained damage and yellow paint residue was found during visual inspection of the damage caused to the aeroplane. Again, this confirms that the runway edge lights were hit by the aeroplane; more specifically, the edge lights were hit by the nose gear.

In addition to the statements presented above, the hypothesis can be supported by the fact that a metal wire, originating from one of the runway edge lights, was found embedded in the leading edge of one of the propeller blades. Despite the embedded wire and other damage to the propeller blades, the propeller imbalance parameter extracted from the FDR, did not show any deviation from its nominal value.

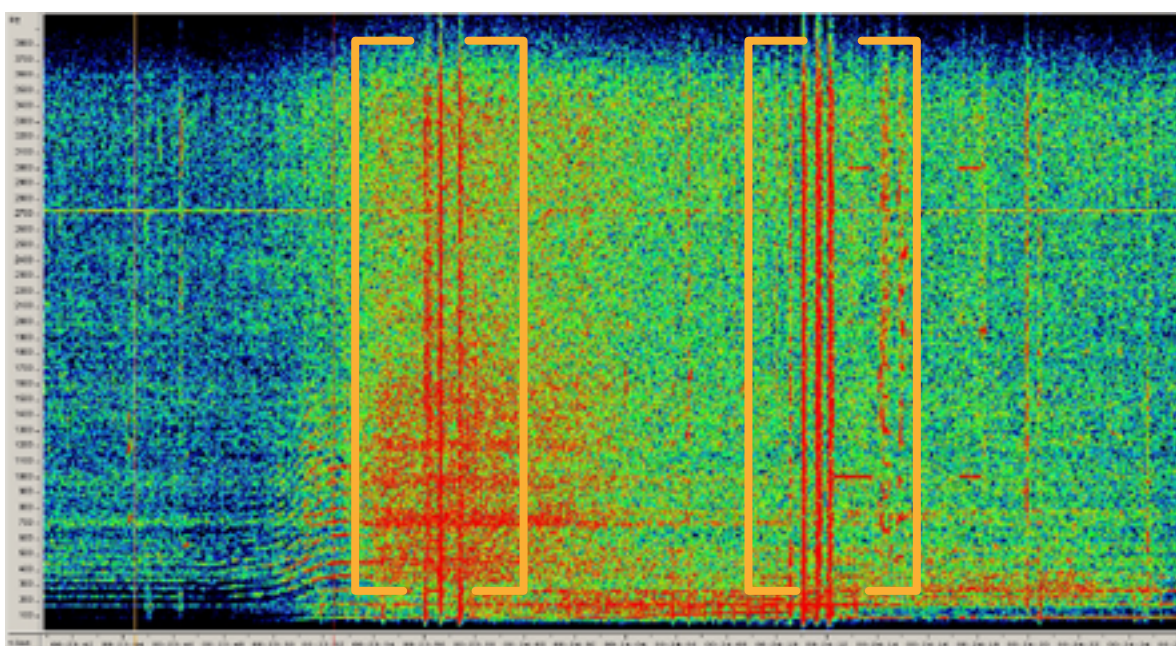
Figure 9: Spectral analysis of the audio track extracted from the CVR for the duration of the take-off. The impact sounds are emphasized by the yellow brackets.

CVR analysis revealed that several impact sounds were recorded by the cockpit area microphone during the take-off run. Following the first impact, it can be heard that the flight crew did discuss hearing a sound but attributed this to a falling pilot briefcase. During the interviews the flight crew acknowledged that some bumps were felt during the take-off run. At the time, the crew was not sure if this was coming from either the nose wheel or the main wheels. However, experiencing such sounds was not unusual for the flight crew because of its resemblance with the sound caused by the front gear running over the runway centre line lights. Hence, the flight crew did not have any indication for the severity of the incident.

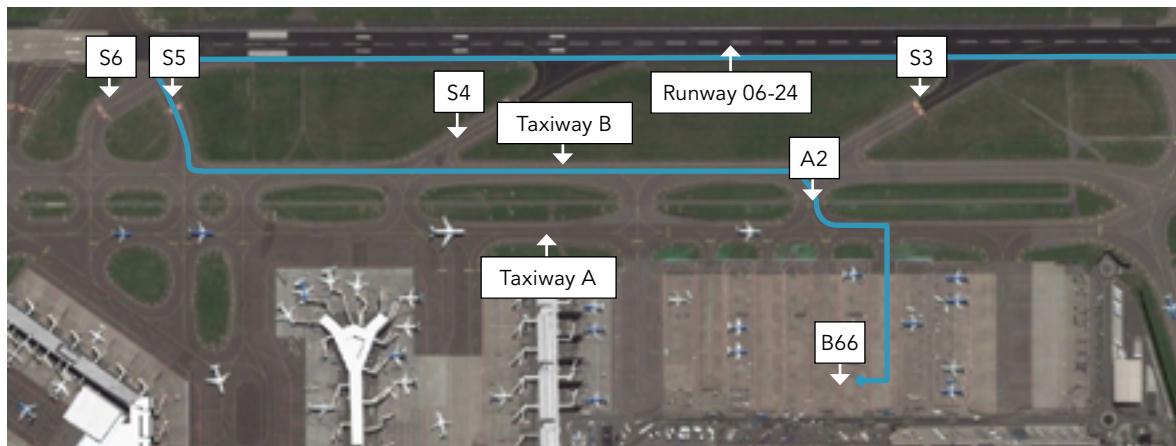
For the investigation, the ground radar data was requested in order to establish the ground track of the aeroplane. Analysis of the radar data confirms earlier findings; the aeroplane left its parking stand B66 and, after taxiing via taxiway A2 and B, a right-hand turn was made onto taxiway S5 (see Figure 10). Subsequently, the aircraft turned towards Runway 06/24. From the ground track it also becomes evident that the aeroplane, upon entering Runway 24, lined up on the right-hand side edge line. The aeroplane took off following the right-hand edge line. Comparison with radar data has confirmed that other aeroplanes, using intersections S5 and S7E, departing between 17.00 and 18.00 hours were correctly aligned with the runway centre line during take-off.

Figure 10: Aeroplane ground track derived from ground radar data. (Photo: Google earth)

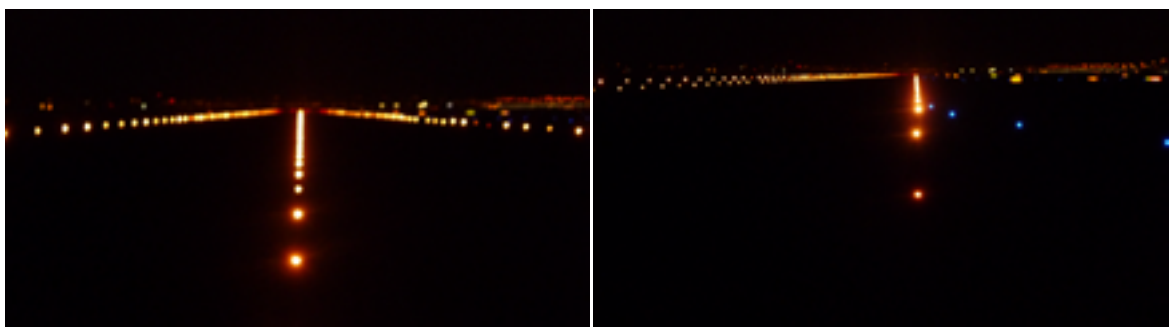
Although visual cues might be available, due to workload and/or other flight crew attention the determination if the aeroplane is lined up correctly might be difficult to make. A runway heading check is not sufficient to establish if the aeroplane is also laterally lined up correctly on the runway. It takes some time to observe and distinguish between the lights and (colour) patterns to establish the lateral position of the aeroplane.

Figure 12: View of Runway 24 from a position aligned with the centre line lights (left) and the runway edge lights (right).

As noted in the Biggin Hill report of the AAIB (AAIB, 2015), the dominant common factor between misaligned take-offs is that a visually compelling line of edge lights was visible to the crew. This edge line with lights was assumed to be the centre line by the crew. There is nothing inherent in an individual edge light that distinguishes it from a centre line light when viewed along the axis, as both have a white colour. It is the pattern of edge lights, and the relationship of this pattern with other lights and visual cues, which identifies them as edge lights. If this complex relationship becomes disrupted or misinterpreted, pilots can lose situational awareness.

It is recommended to initiate the process to develop, within Annex 14 Volume 1 'Aerodrome Design and Operations', a standard for runway edge lights that would allow pilots to identify them, specifically, without reference to other lights or other airfield features.
