# Air Accident Investigation Unit Ireland

## FORMAL REPORT

**ACCIDENT**  
**Fairchild Aircraft Corporation**  
**SA 227-BC Metro III, EC-ITP**  
**Cork Airport, Ireland**  
**10 February 2011**

**AAIU Report No: 2014-001**  
**State File No: IRL00911013**  
**Report Format: Formal Report**  
**Published: 28 January 2014**

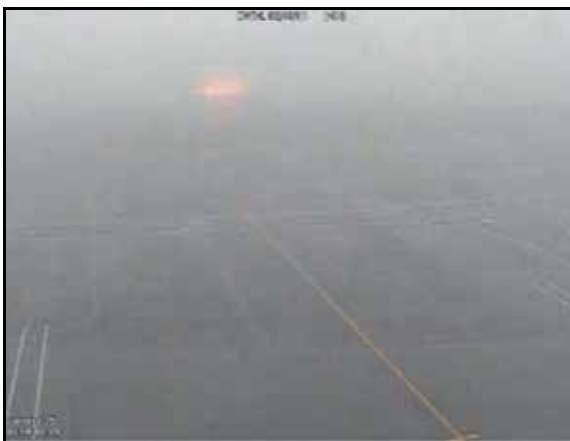
**Photo No. 2:** Initial flash fire

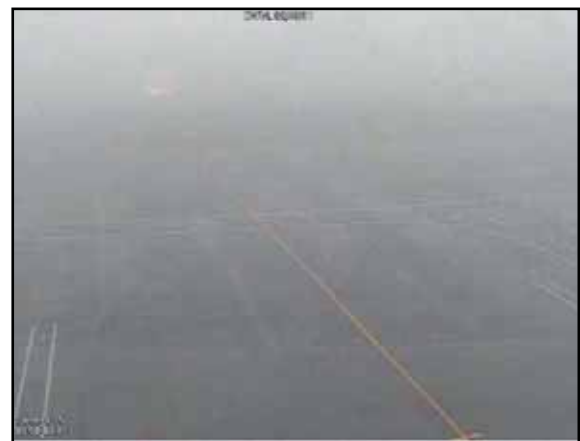
**Photo No. 3:** Second flash fire

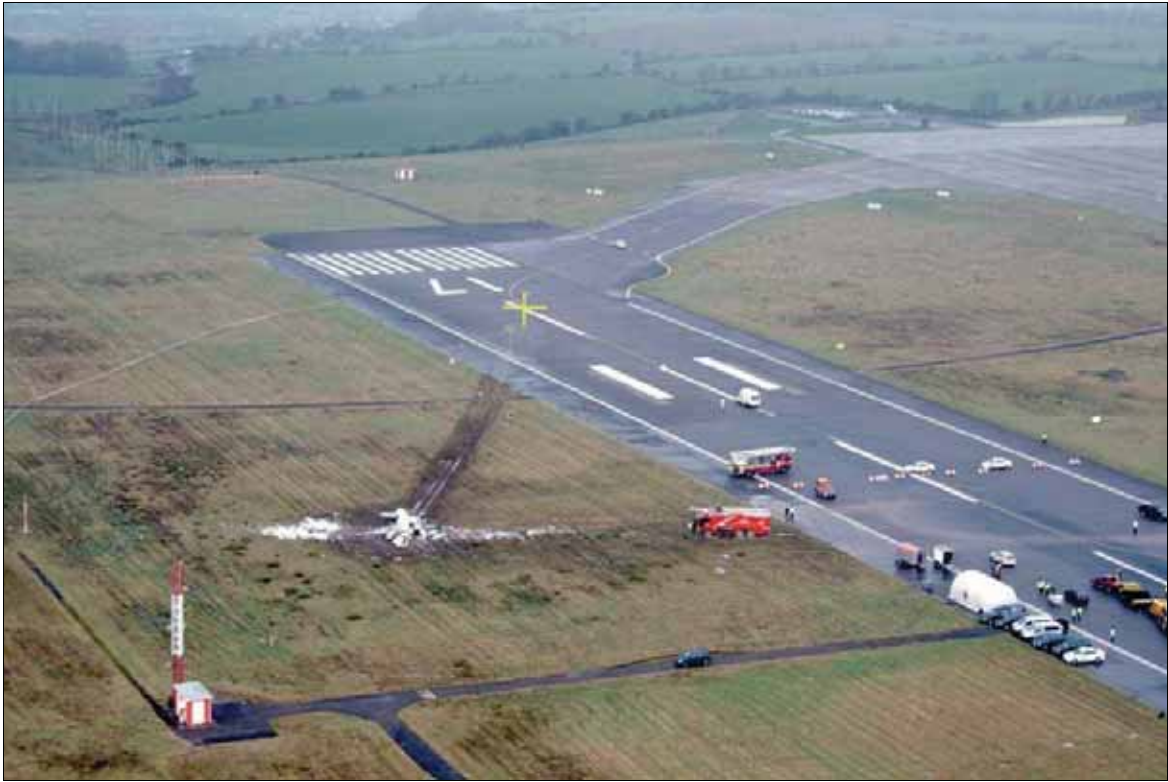
**Photo No. 5:** Point of initial wingtip contact (identified by the yellow reference mark), debris trail and final position of wreckage

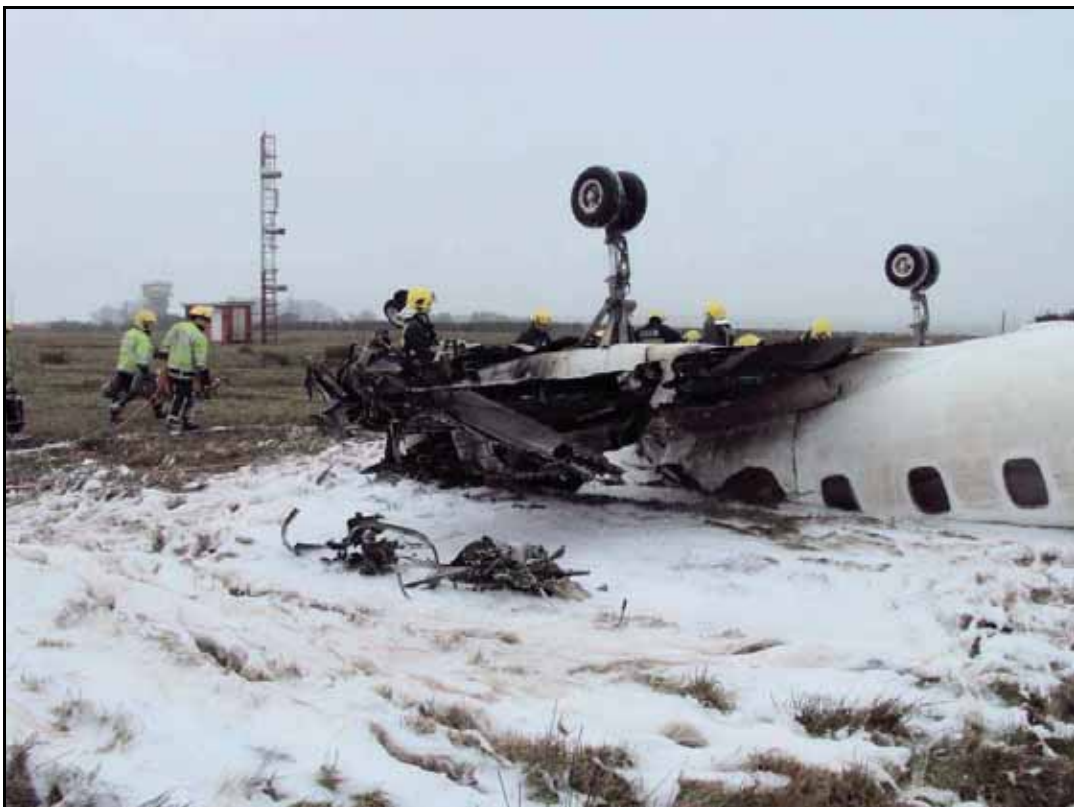
The portion of right wing and flap that remained attached to the fuselage ended several feet outboard of the right engine nacelle. Damage to the right wing had three distinct visible areas; the outboard section, the mid-section and the leading edge. The remnants of the wing attached to the nacelle had extensive fire damage (**Photo No. 6**). The structure had broken downwards at the outer end of the fractured wing.

**Photo No. 6:** Damage to right wing

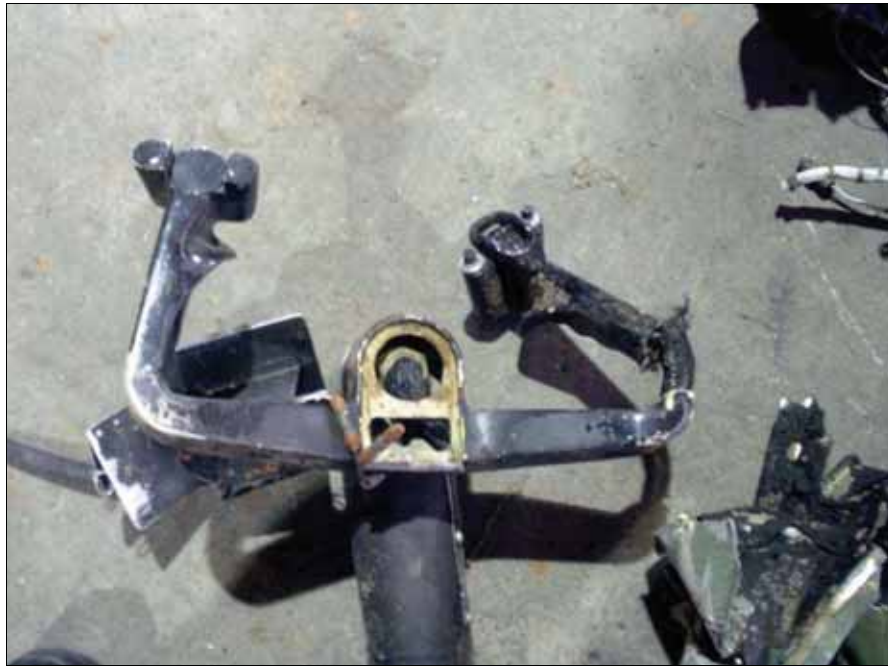
**Photo No. 7:** Co-pilot control wheel showing fracture of right-hand control grip

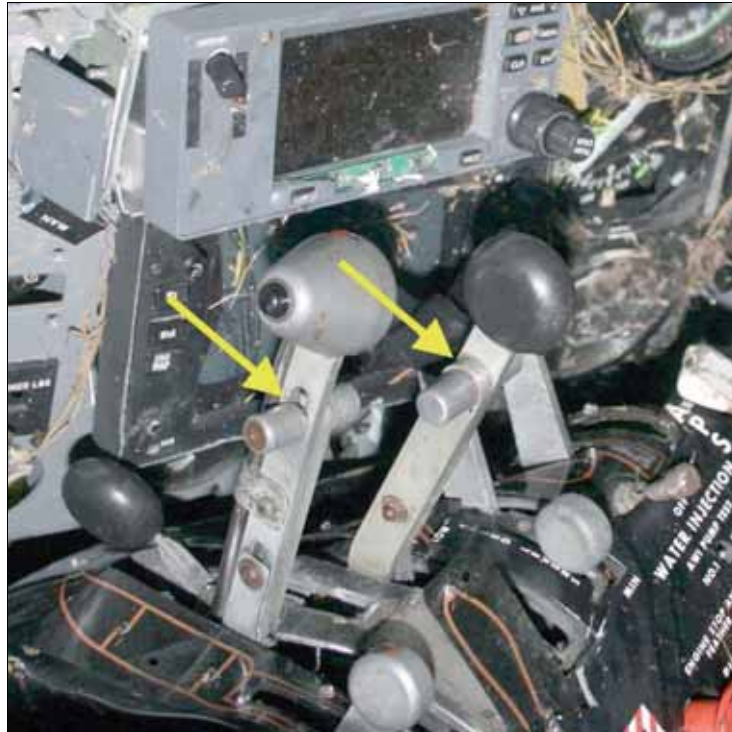
The engine control quadrant and control linkages were damaged by impact. As a result of this damage, the power levers and speed (RPM) levers were restricted in movement. The left Beta latch lever was found in the normal (down) position. The right Beta latch lever was found in the raised position (**Photo No. 8**). Both power levers were bent to the right. When the levers were straightened with minimal pressure, both mechanisms functioned correctly.

**Photo No. 8:** Left and Right Beta Latch lever positions

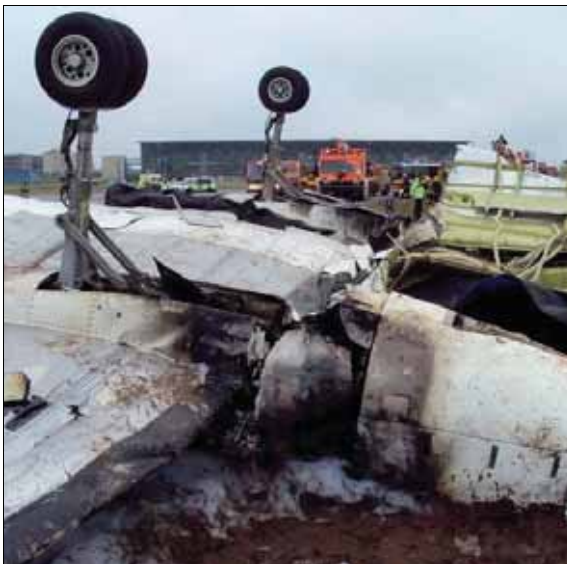
**Photo No. 9:** Left Engine Fire damage

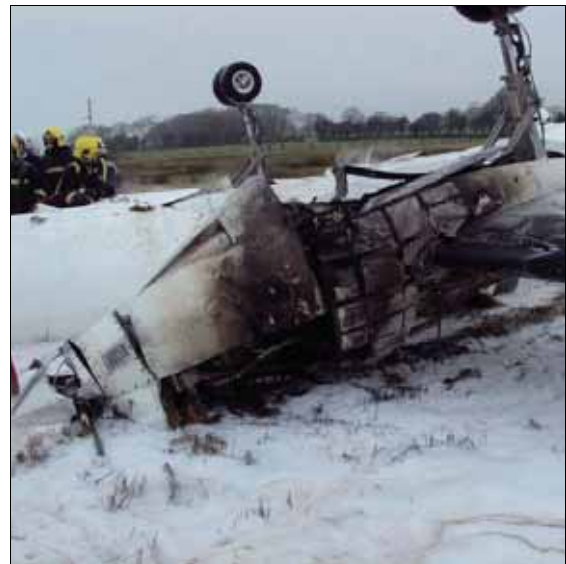
**Photo No. 10:** Right Engine Fire damage

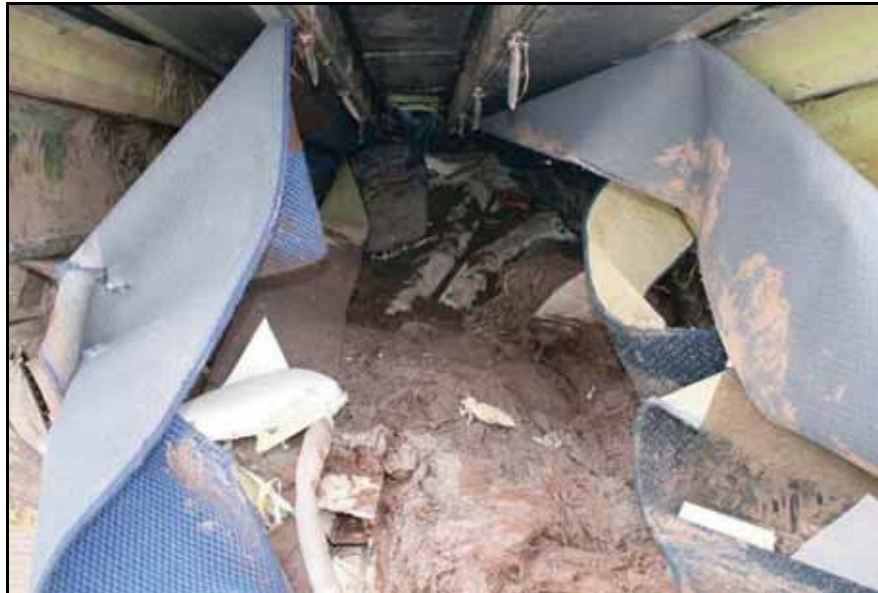
The cockpit and forward cabin were severely crushed in the impact, thus greatly reducing the volume of survival space. Furthermore, the opening in the upper fuselage allowed large amounts of soil to enter the forward cabin as the aircraft transited the grass area (**Photo No. 11**).

**Photo No. 11:** Forward view of inverted passenger cabin following rescue operation

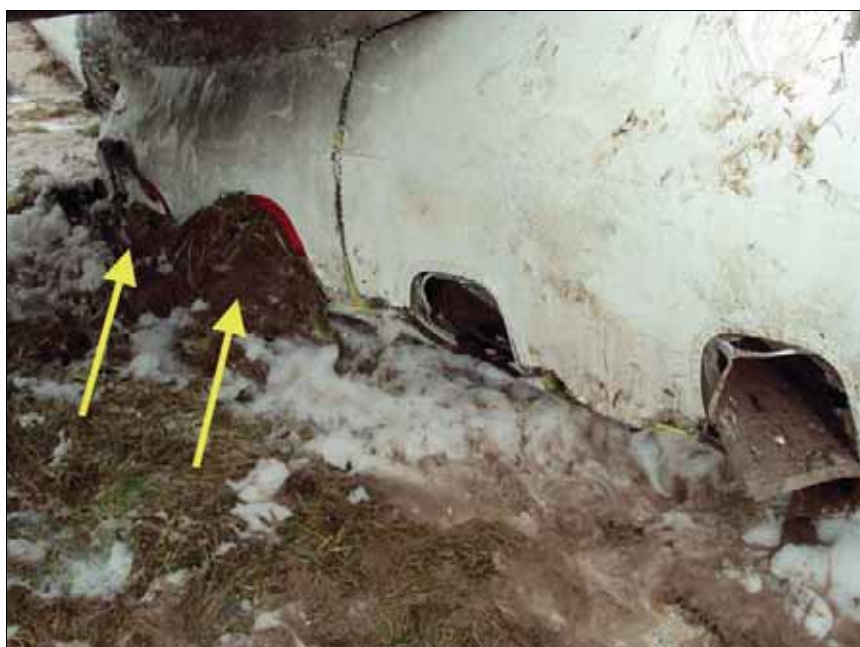
The AFS could not gain entry into the aircraft by normal means as the passenger door at the front left of the fuselage was severely crushed and could not be opened. The three emergency exits in the cabin were unusable due to crushing and were also blocked with soil from inside the cabin (**Photo No. 12**).

**Photo No. 12:** Starboard Emergency Exits

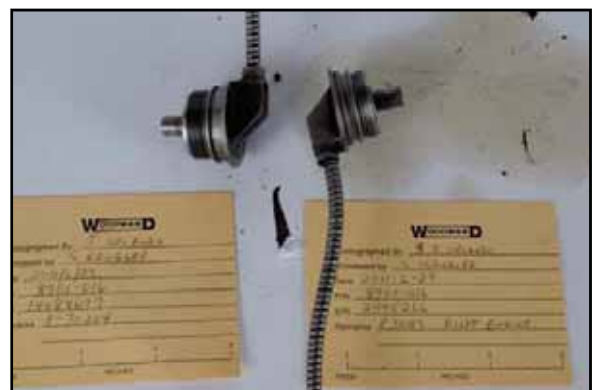
**Photo No. 2:**

According to the component manufacturer, the  $P_{T2}/T_{T2}$  Sensor was produced in August 1999 and was not returned to the manufacturer for any subsequent maintenance. The  $P_{T2}/T_{T2}$  sensor bellows displacement was measured using measuring tool WT-51467 # 1 (**Photo No. 1**). The height of the bellows was measured from the inside of the outer flange to the center of the bellows stem measured was 0.947 inches at a room temperature of approximately 75°F (specification is  $1.023 \pm 0.002$  inches at 75°F). This is consistent with the sensor reading a lower temperature value than actual. The height of the bellows being considerably shorter than required would be consistent with a breach within the system (**Photo No. 2**).

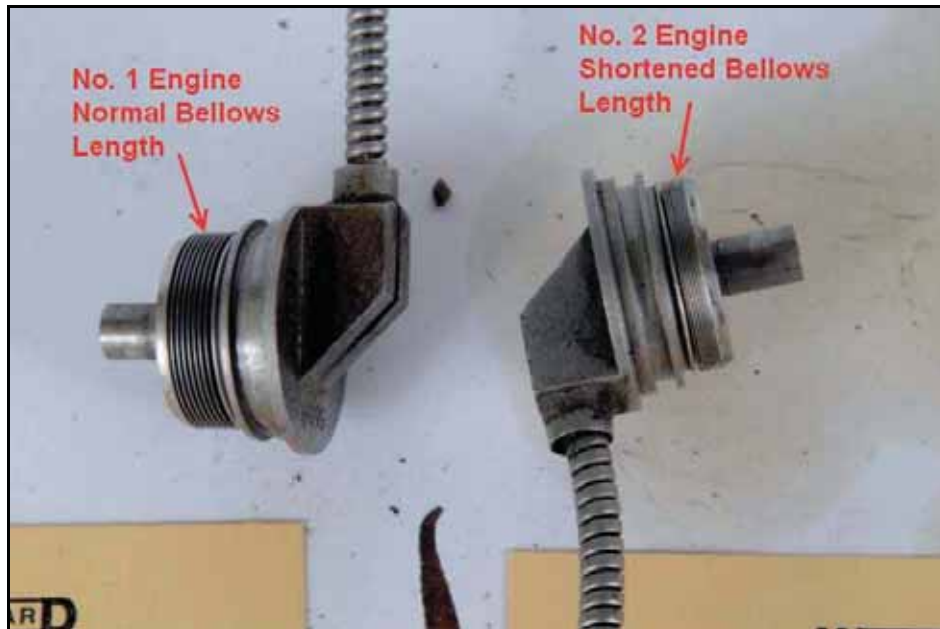
The length of the No. 2 engine bellows being considerably shorter than specified is consistent with a breach or leak within the system.

**Photo No. 1:**  $P_{T2}/T_{T2}$  sensor bellows from No. 1 and No. 2 Engines
