Boeing 747-2B5F, HL-7451: Main document

Aircraft Accident Report No:3/2003 (EW/C99/12/04)

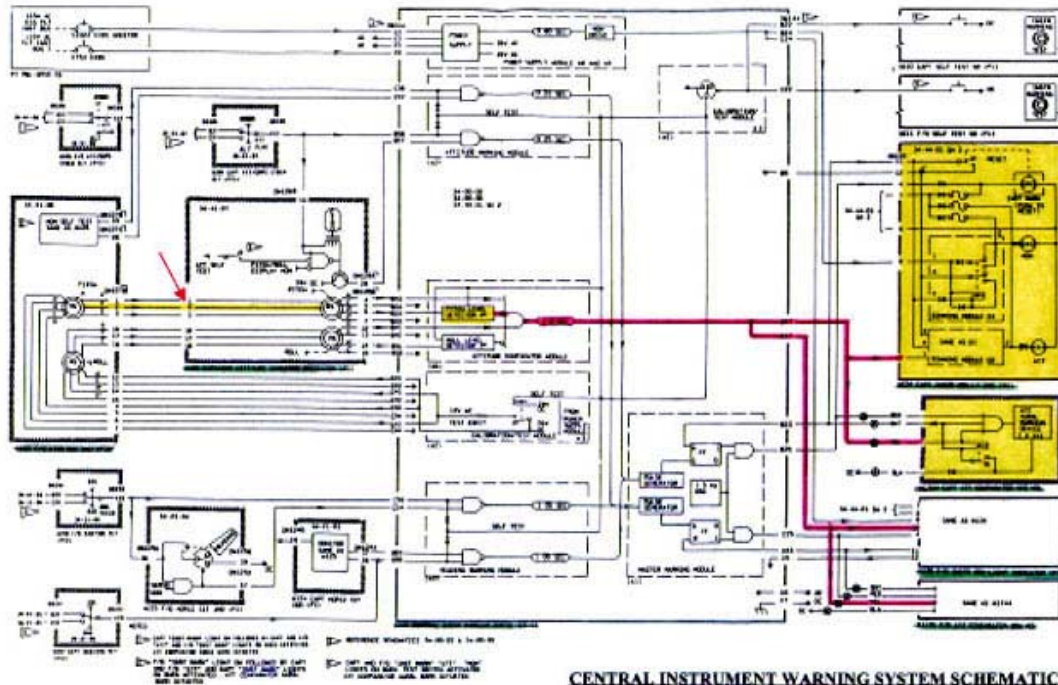
Appendix D - Figure 1 - Central Instrument Warning System Schematic

Location of 'displaced' pin No 2, plug J1, arrowed

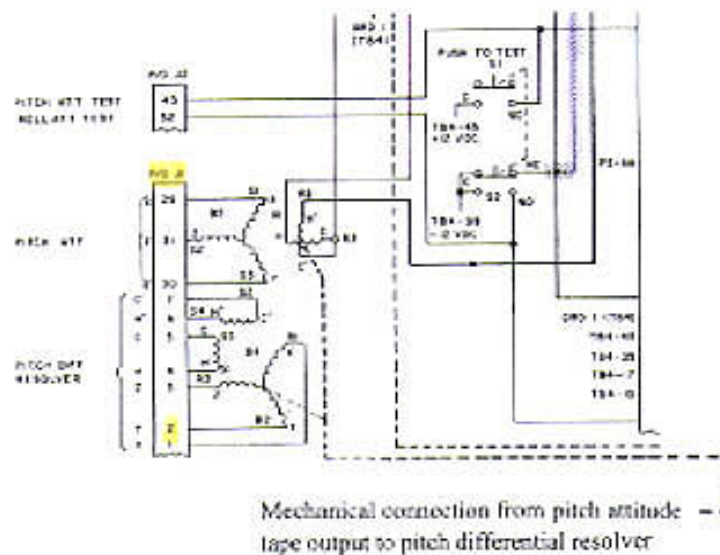
Section of Indicator Circuit Diagram Showing Internal Wiring from Connector J1 pin 2

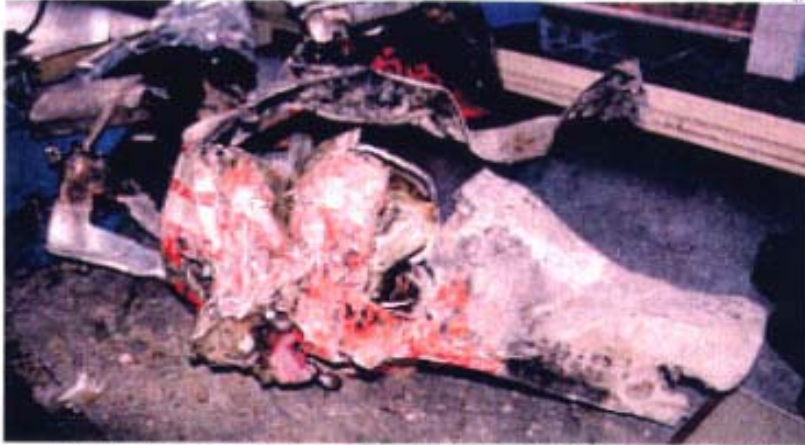
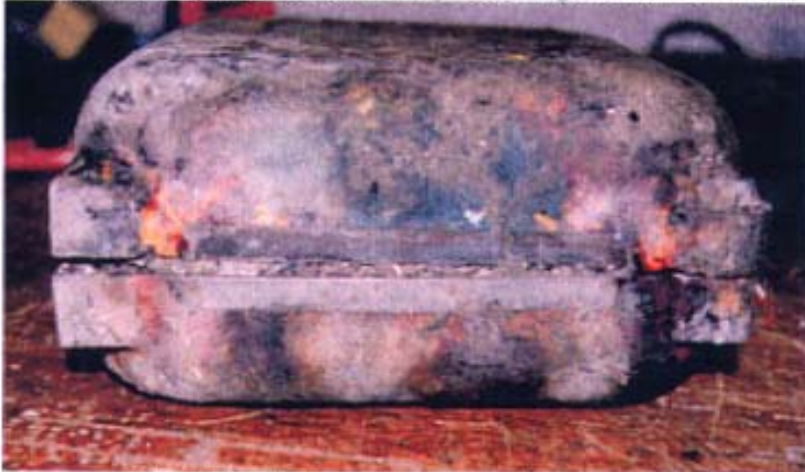
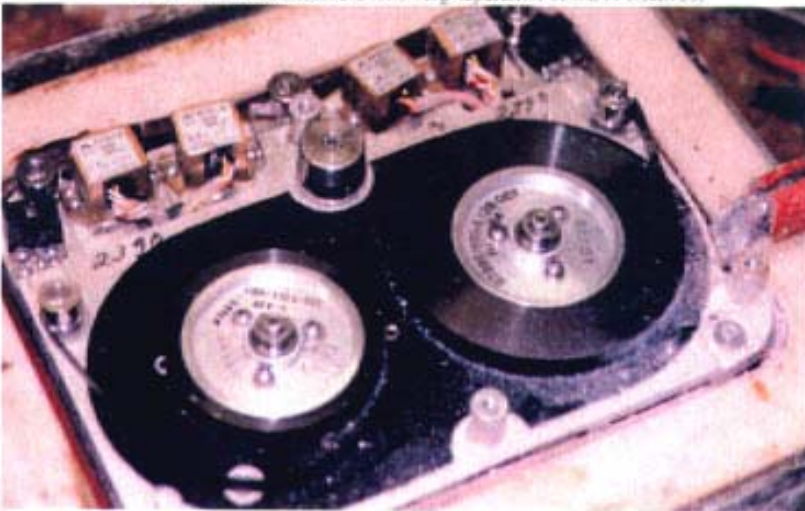
Appendix G
Figures 1, 2, 3

The crash protected thermal enclosure containing the tape was found in the impact crater one week after the accident. It had become separated from the rest of the unit that was also found within the crater. The ULB was found completely detached approximately 10 metres from the edge of the crater. The front panel was never found. Appendix G, Figure 1 shows the damage. The enclosure itself had suffered an impact severe enough to break two of the bolts that secure the two halves of the enclosure together, allowing partial separation (see Appendix G, Figure 2). This could have allowed heat to penetrate the enclosure, but on examination the tape itself was essentially undamaged (Appendix G, Figure 3).

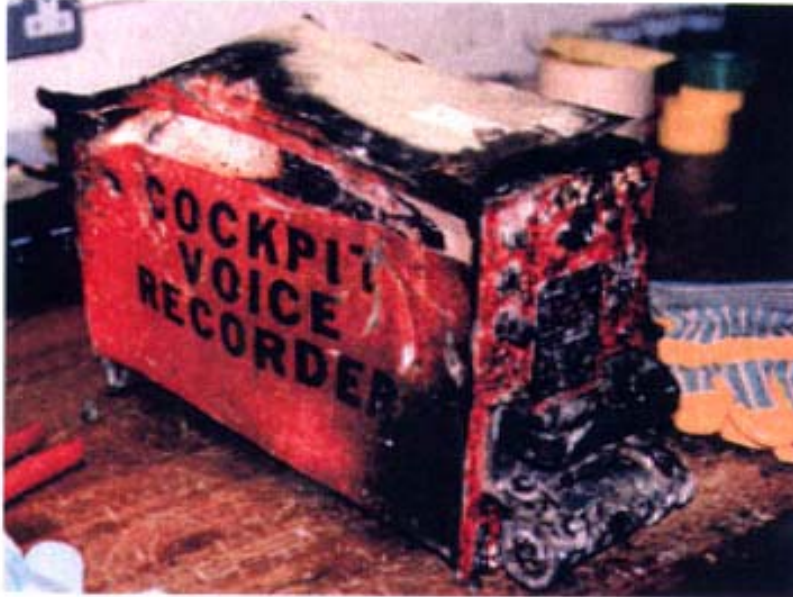
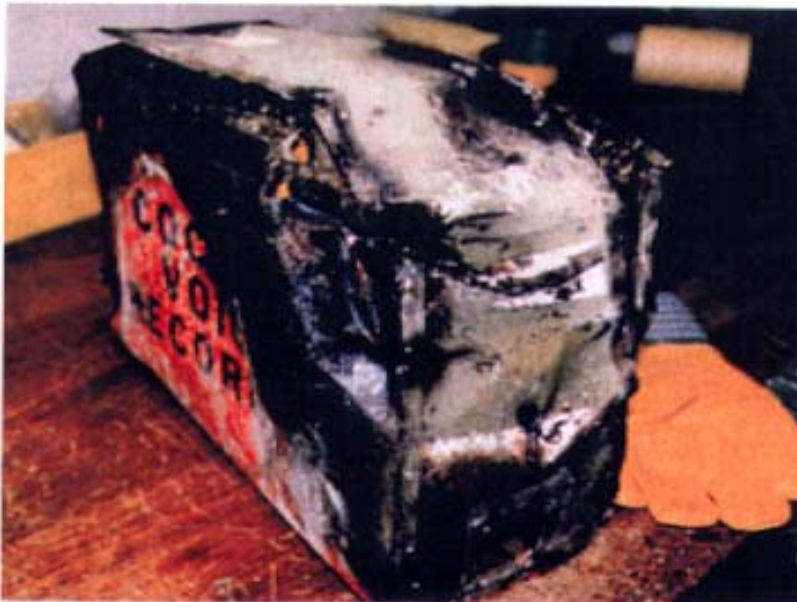
Appendix G
Figure 4

The aircraft was equipped with a Fairchild model A100 re-cycling CVR that records the latest 30 minutes of audio information on four tracks. The CVR, which had suffered much less damage than the FDR, was recovered from beside the impact crater on the night of the accident. Appendix G, Figure 4 shows the CVR unit as found.

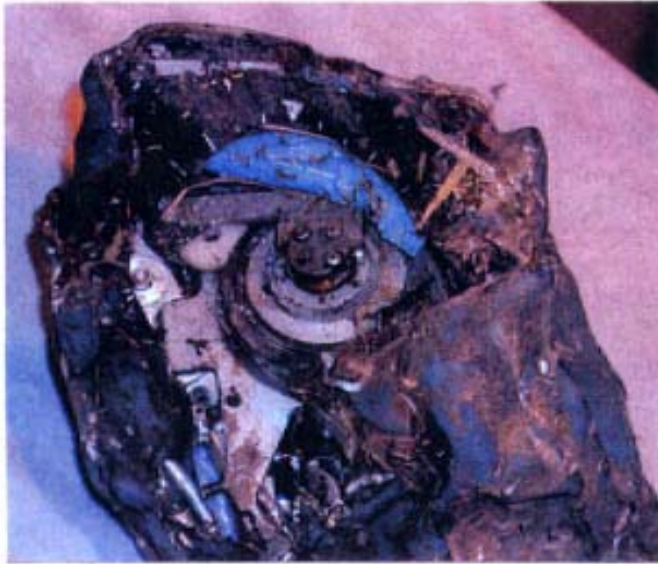
Figure 1

Despite an exhaustive search of the accident site only one relatively complete, but severely damaged, ADI was recovered and a view of its front face is shown in Appendix M, Figure 1. The backplate of another unit, complete with data plate, was also recovered attached by wires to some internal components. The serial number, 5D2193, identified this backplate as belonging to the spare ADI from the 'fly away kit' carried on board the aircraft, thus indicating the more complete unit recovered as one of the two fitted to the instrument panels in the cockpit.

Initial visual examination of the ADI revealed deformation to the rear of the unit consistent with an aircraft impact attitude of some 40° nose down and a roll angle of some 80° to 90° to the left. Although severely crushed, the body of this unit was largely complete and contained within the casing almost all of the mechanical and electronic components. However, most of the delicate warning flags and indicators, together with the lower section of the attitude tape and its support frame, were missing from the front of the instrument. The backplate, containing both electrical connectors, was also missing. From this initial examination the 'as found' position of the attitude tape frame suggested that this ADI had been displaying a low angle of bank at the time of impact with the ground.

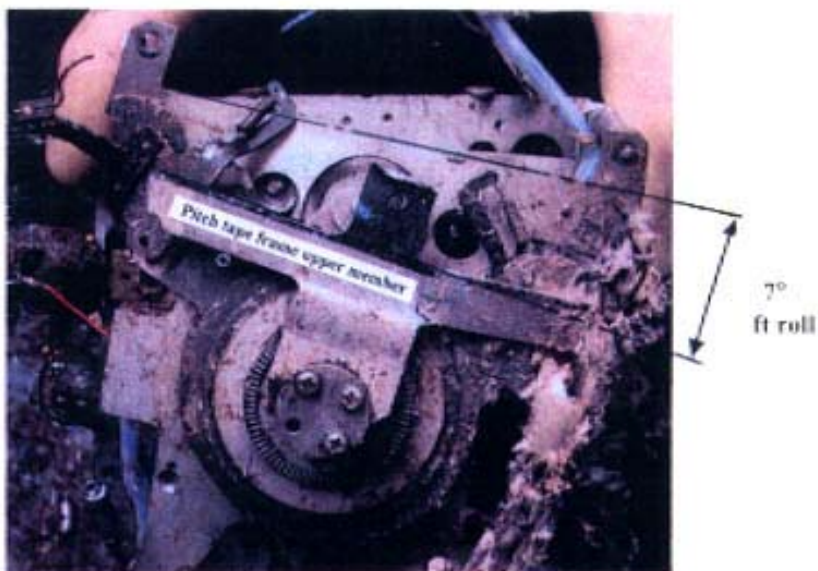
Figure 2

The roll attitude presented at the time of impact was assessed, from the position of the attitude tape casting relative to the internal structure, as being approximately 7° to the left, after making some allowances for impact related distortion of the instrument. As there was no evidence to suggest that the roll attitude mechanism had been forcibly rotated to this 'as found' position, and in consideration that any distortion applied to this unit during the impact would be very likely to cause the mechanisms to jam, this 7° value was considered to be a reasonably good indication of the displayed roll attitude at impact.

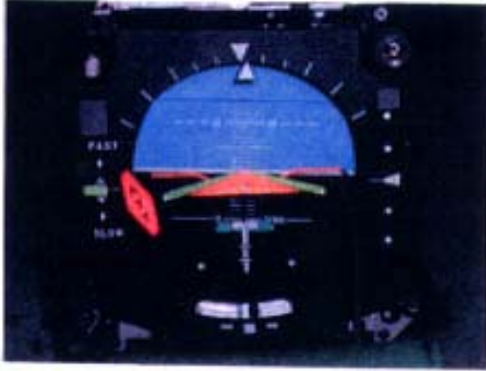
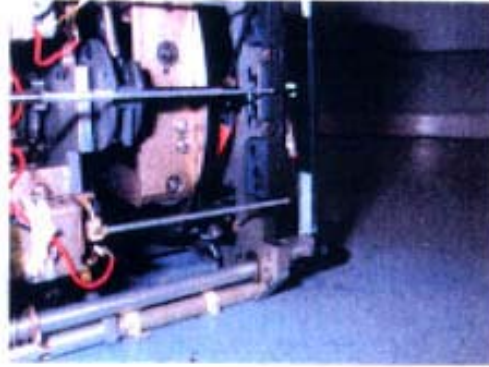
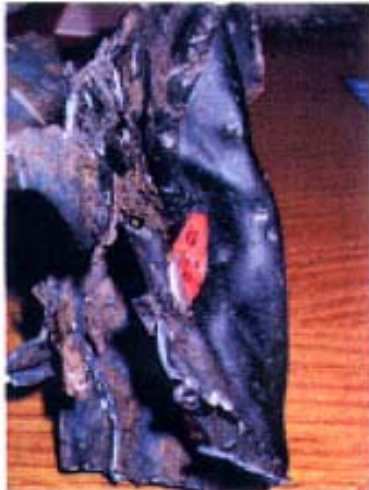
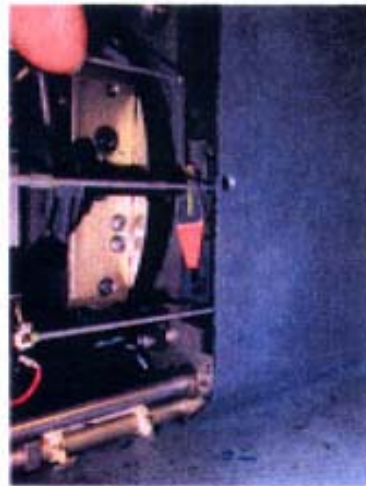
Appendix M
Figures 3 - 6

GYRO flag as-found, seen from the front, crimped between the folds of the FDI case sidewall. Angle of flag, in relation to front and top edge of the casing, is similar to the flag out of view position

ASSESSMENT OF GYRO FLAG POSITION PRIOR TO IMPACT
