## **AVIATION INVESTIGATION REPORT A13H0001**

**CONTROLLED FLIGHT INTO TERRAIN  
7506406 CANADA INC.  
SIKORSKY S-76A (HELICOPTER), C-GIMY  
MOOSONEE, ONTARIO  
31 MAY 2013**

Aviation Investigation Report A13H0001

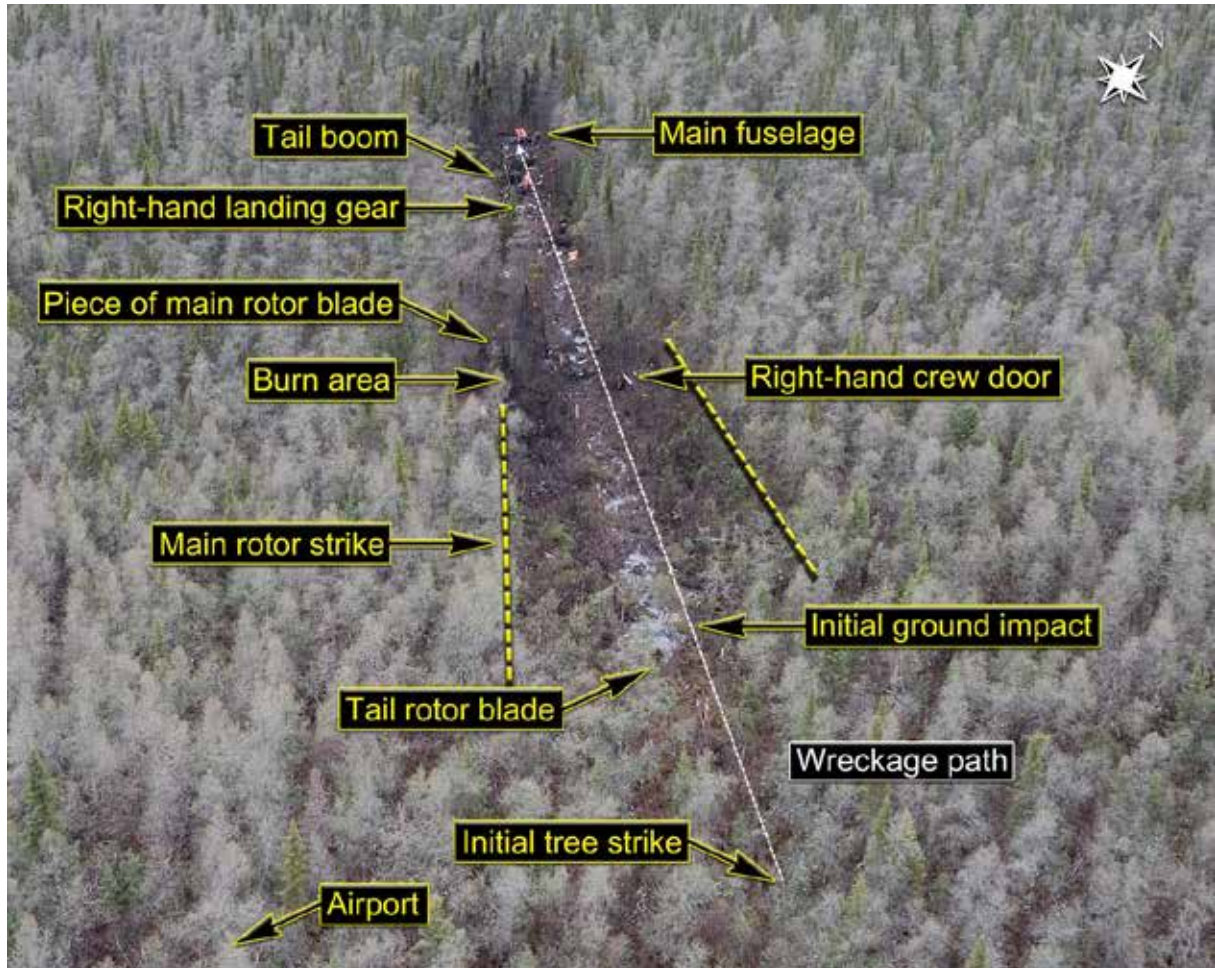
The length of the crash swath path, from the first indication of contact with the trees to the location of the main wreckage, was approximately 405 feet. At the point of ground impact, the swath path was approximately 40 feet wide, gradually narrowing to approximately 20

feet, and then widening out again to form a circular, burned-out area approximately 35 feet in diameter (Figure 4).

Figure 4. Overhead view of the wreckage path: 405 feet, 318°M track
