Air Accident Investigation Sector

- Final Report –

AAIS Case N°. AIFN/0002/2012

Attempted Takeoff from Runway Edge

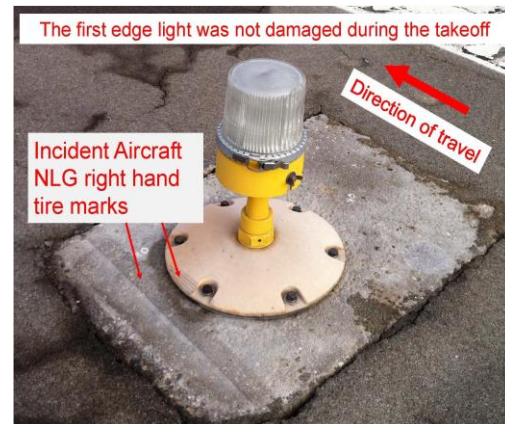
Figure 4. Edge light with tire marks

Figure 4 shows the first left hand edge light with the imprint of the right hand nose landing gear tire marks.

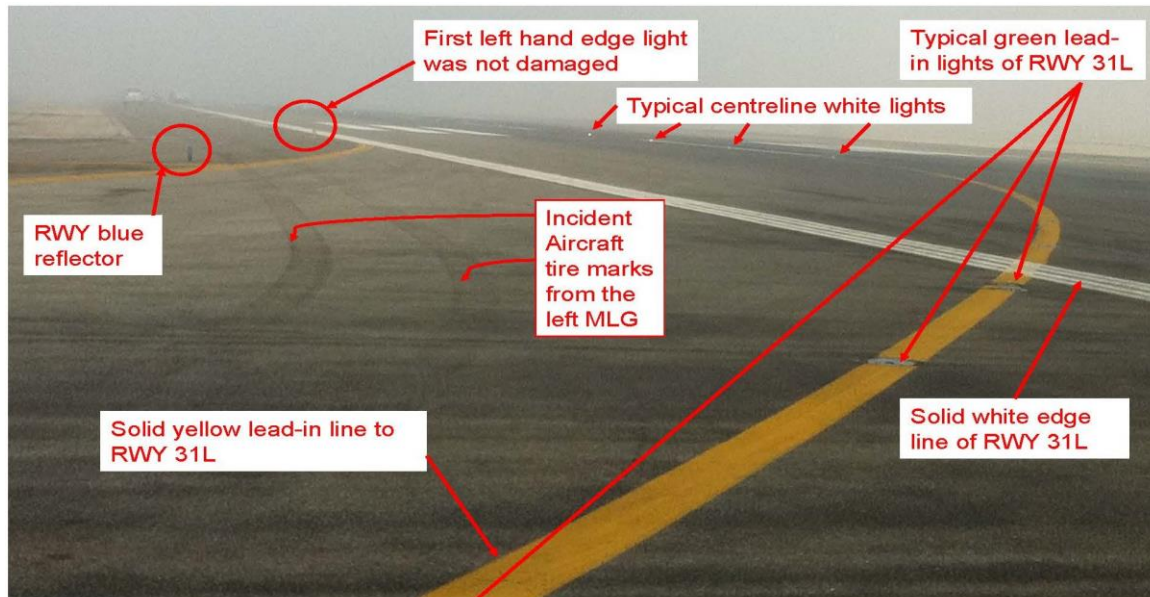
Figure 5. Left hand main landing gear tire marks

Figure 5 shows the imprint of the left hand main landing gear tires on the runway as the Aircraft was turned away from the centerline lead-in yellow line in order to align with the left hand edge light. The first left edge light was not damaged during the attempted takeoff. The figure also shows that the left main gear outer tire passed less than one meter from runway blue reflector.

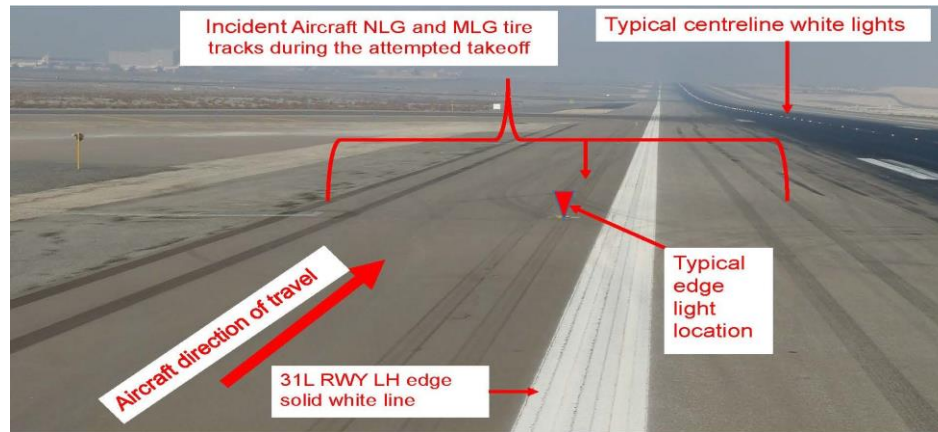
Figure 6. Aircraft NLG and MLG tire tracks

Figure 6 shows the imprint of the Aircraft nose gear tires, and the left and right main landing gear tires during the attempted takeoff.

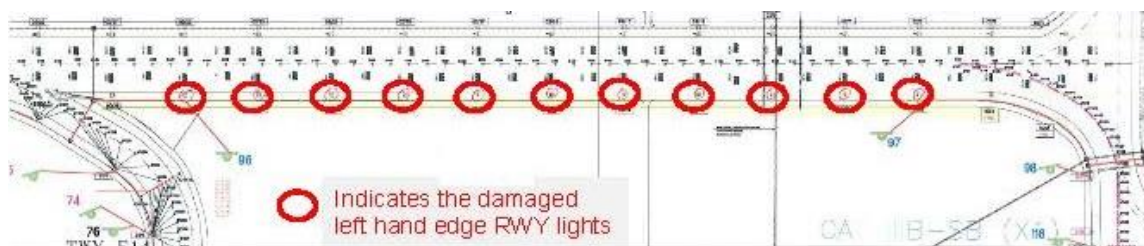
Figure 7. The red circles indicate the damaged edge lights

Figure 7: Starting with the second light, 11 consecutive left hand edge lights on runway 31L were damaged as a result of the Aircraft nose gear tires colliding with the lights as the Aircraft accelerated for the attempted takeoff.

After the Aircraft had impacted nine left hand runway edge lights, the Commander rejected the takeoff. The Aircraft continued to impact two additional lights before becoming to a complete stop on the runway edge. The Commander’s decision to reject the takeoff was based on the unusual sound and thumps coming from the nose landing gear wheels. The Investigation believes that the thumps were a good triggering event that caused the crew to reject the takeoff. Without the thumps, and if the takeoff had continued, it may have resulted in severe consequences.

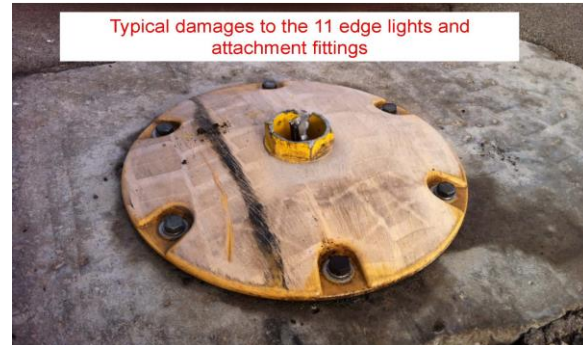
Figure 8. Typical edge light damage

Figure 8: Typical damage found to the 11 edge light base fittings that held the light fixture in position. The glass that surrounded the lights were all broken.
