# Runway excursion involving Boeing 737, VH-VUI

Darwin Airport, Northern Territory | 6 December 2016

**ATSB Transport Safety Report**  
Aviation Occurrence Investigation  
AO-2016-166  
Final – 15 May 2019

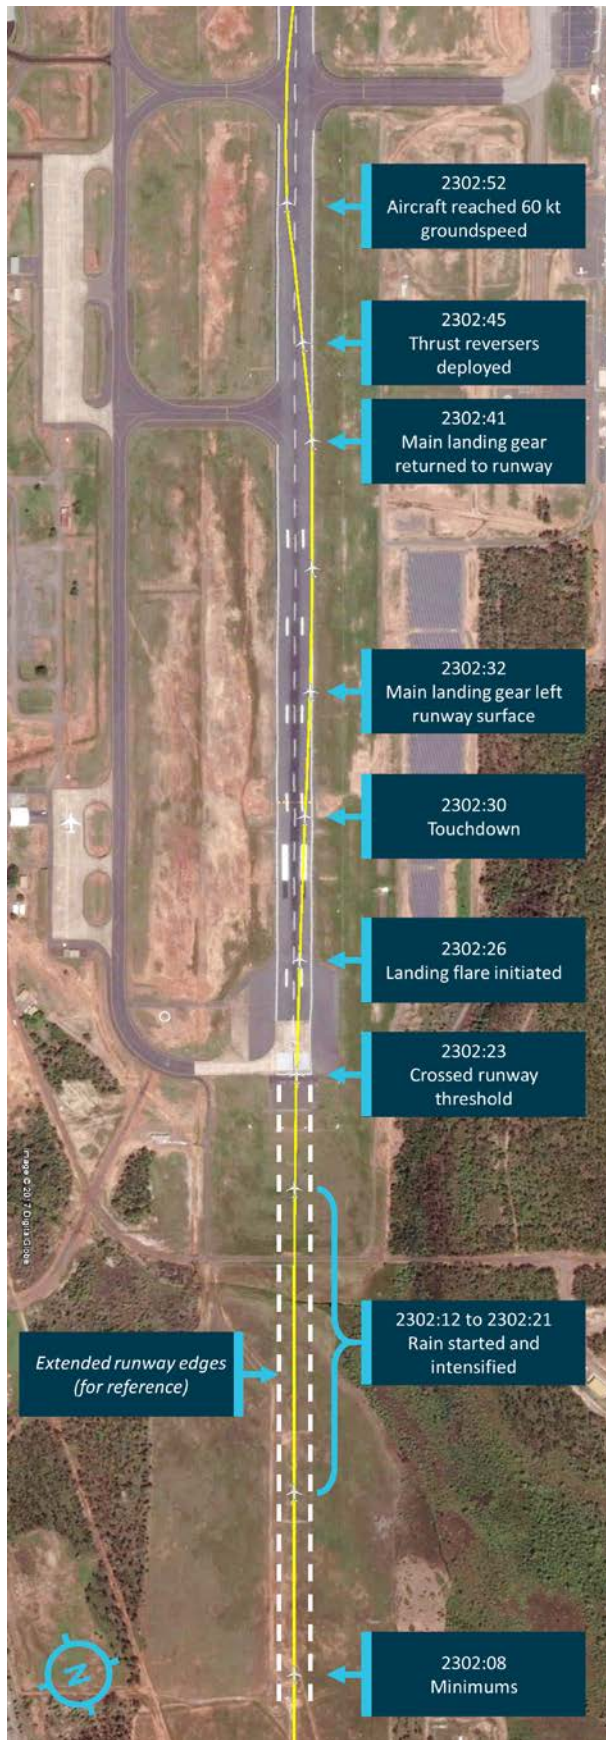
**Figure 1: Final approach and landing roll of VH-VUI**

At 2302:33, 4 seconds after landing, the right main landing gear departed the right side of the runway. The captain recalled hearing a repeated, light thudding noise. He asked the first officer if they had hit the runway lights and the first officer responded that they were just missing the lights. The aircraft's nose was oriented to the left of the direction of travel, placing the flight crew and nose gear over the sealed surface and inside the painted runway edge markings. The first officer later reported feeling a shudder, as though the wheels were skidding. Both flight crew recalled that the physical sensation and noise were not as strong as they would have expected from the wheels departing the runway.

Image shows the aircraft's path crossing the runway threshold near the centreline and deviating to the right edge of the runway before returning. Source: ATSB / Google Earth

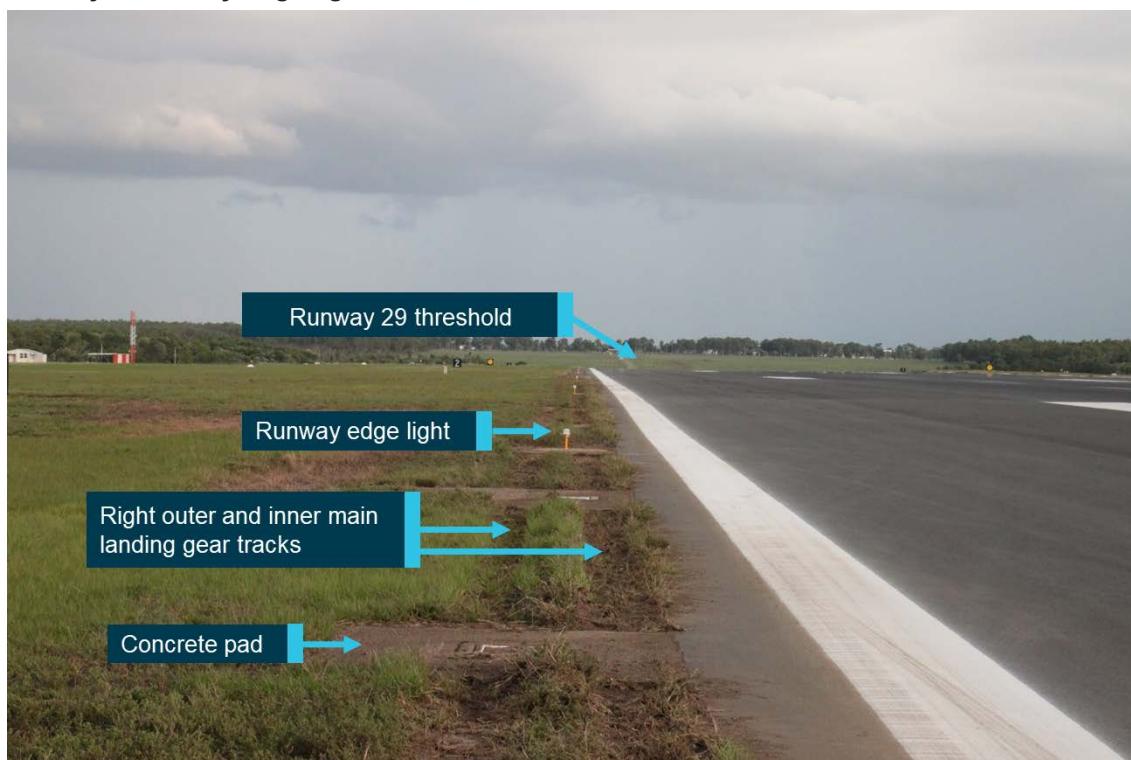
**Figure 2: Wheel tracks where VH-VUI departed the runway 29 sealed surface and destroyed runway edge lights<sup>11</sup>**

The aircraft landed 21 m to the right of the runway centreline and, shortly after touchdown, the right landing gear departed the sealed surface of the runway, destroying six runway lights before the aircraft returned to the runway. The aircraft incurred minor damage from ground debris and there were no injuries.

Image shows the tracks from the right main landing gear through grass and over concrete pads near the runway edge. Photo facing the opposite direction to the landing. Source: ATSB

<sup>11</sup> The photograph was taken after displayed high intensity runway lights that were damaged by impact were replaced.

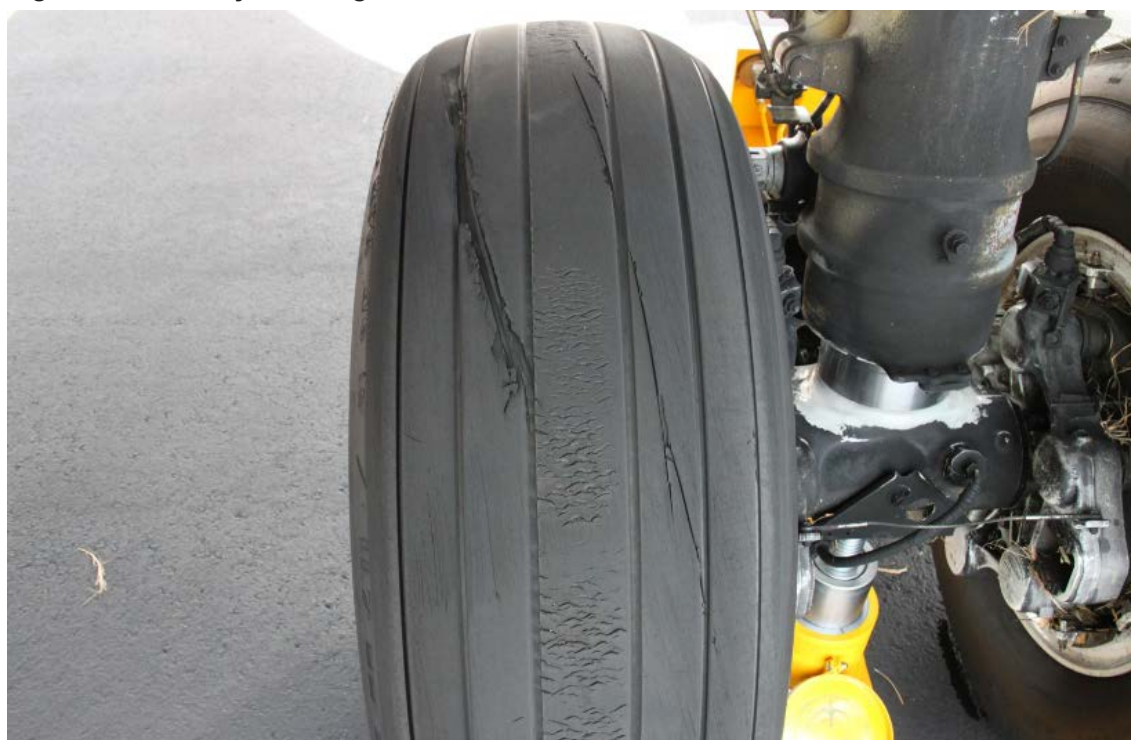
**Figure 3: VH-VUI tyre damage**

Image shows cut damage to the right main landing gear outboard tyre. The chevrons in the centre of the tread are normal. Source: ATSB

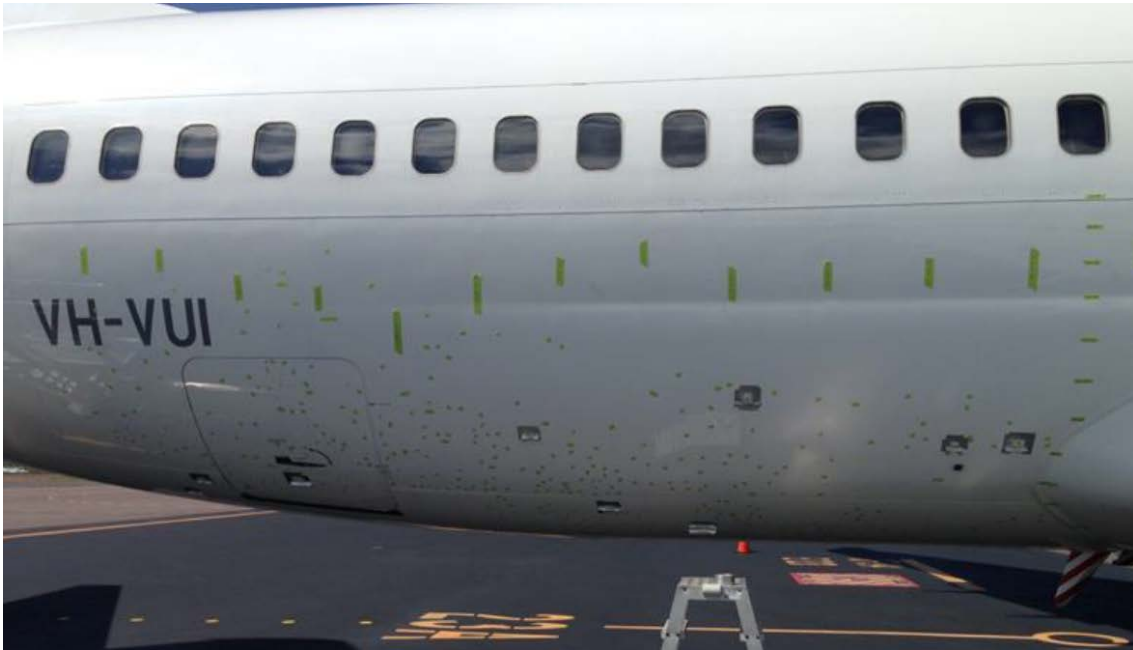
**Figure 4: VH-VUI fuselage damage, marked with green tape**

Debris impacted the aircraft resulting in minor damage to areas of the right aft fuselage and right horizontal stabiliser (Figure 4). A large quantity of grass accumulated in the vicinity of the right wheel well, landing gear and wing flaps.

Image shows the locations of skin damage to the right side of the aircraft fuselage marked with short sections of tape on the underside of the fuselage. Longer sections of tape mark the locations of longitudinal and vertical fuselage reference lines. Source: Virgin Australia

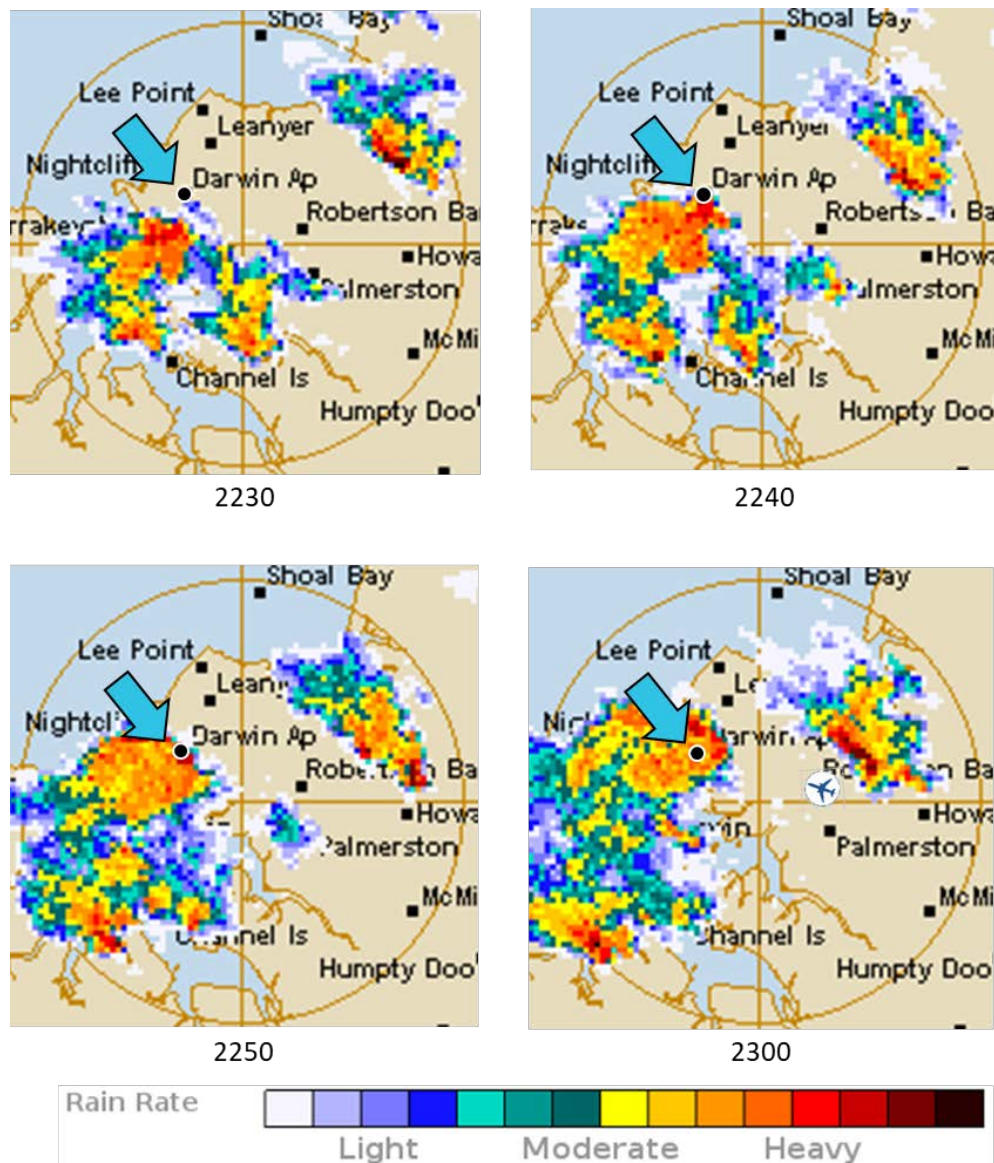
Figure 5: Ground-based radar images showing rainfall near Darwin Airport (blue arrow) during the approach, with the aircraft's position at 2300 indicated by an aircraft symbol

Recorded lightning strike data showed significant activity in the area. In the 5 minutes before VH-VUI landed (at 2302), there were several lightning strikes within 5 NM of the airport and two within 5 NM of the aircraft. Some of these may not have been visible to the flight crew due to them potentially being obscured by cloud.

Image shows heavy rain approaching Darwin Airport from the south-east over a period of 30 minutes, and arriving at the airport while VH-VUI approached. The tan circle has a 20 km (10.8 NM) radius. Note that the picture displayed on the aircraft's weather radar would not be the same. Source: Bureau of Meteorology, modified by ATSB

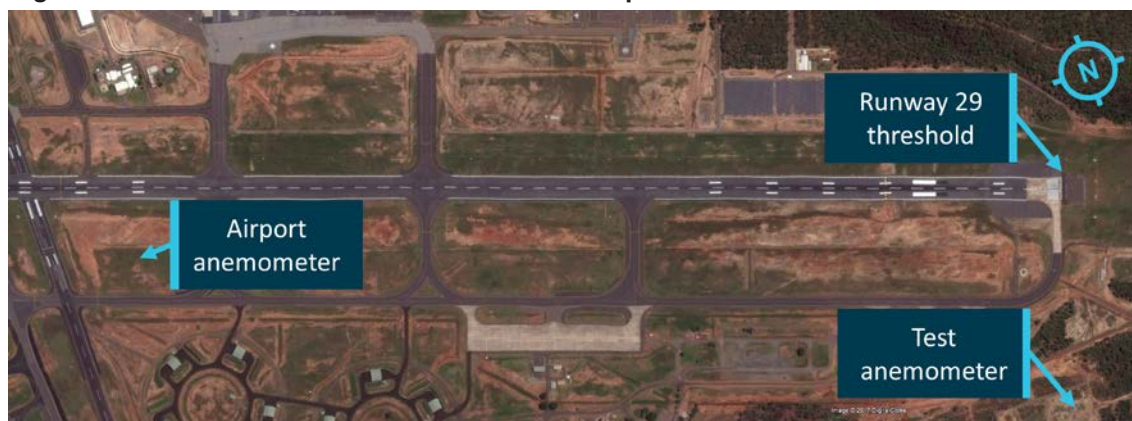
**Figure 6: Location of anemometers at Darwin Airport**

The Darwin control tower was equipped with displays that showed the wind direction and speed sourced from the airport anemometer via the BoM Observations office. This anemometer was located near the centre of the airport, about 2.4 km west of the runway 29 threshold (Figure 6).

Image shows the primary anemometer's location near the centre of the airport and the second (test) anemometer near the runway 29 threshold. Source: ATSB / Google Earth

Due to a failure attributed to a lightning strike,<sup>14</sup> the airport anemometer was unserviceable at the time of the occurrence and no wind information was being displayed in the control tower. Darwin tower controllers obtained wind information from windsocks located at the airport, and through BoM observers via telephone for information from a second, test anemometer about 550 m south of the runway 29 threshold. Wind data from this anemometer was relayed to the tower controllers by a trained BoM observer.

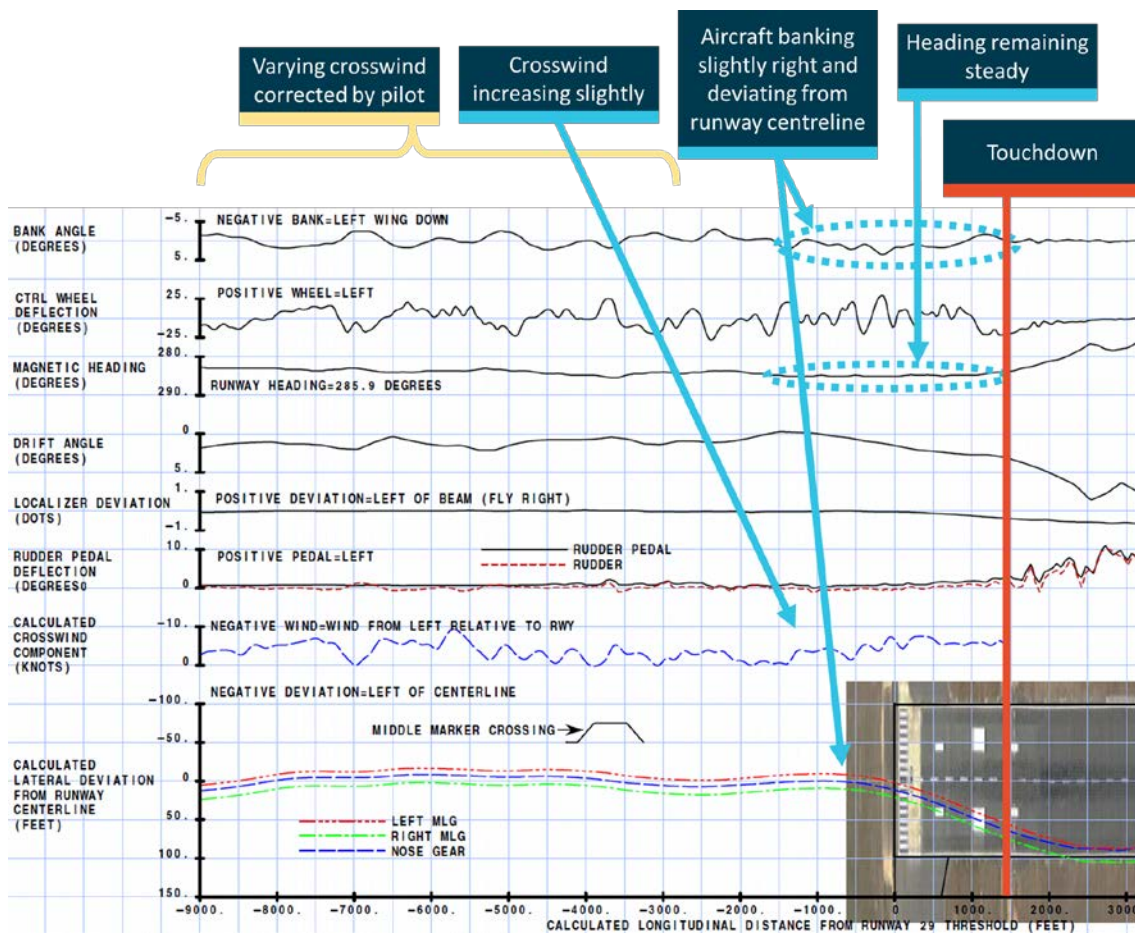
**Figure 7: Recorded data showing the aircraft's drift from centreline. The runway width is exaggerated and the markings are different to those at the time of the occurrence.**

The kinematic analysis indicated that in the few seconds before crossing the threshold (2303:23), the crosswind varied but it was not significantly more than it had been previously (Figure 7). However, in a gradually increasing crosswind from about 140 ft, about 5 seconds before crossing the threshold, the aircraft banked slightly right and began drifting right, without correction. A combination of momentum and continuing crosswind meant that the drift to the right continued until touchdown.

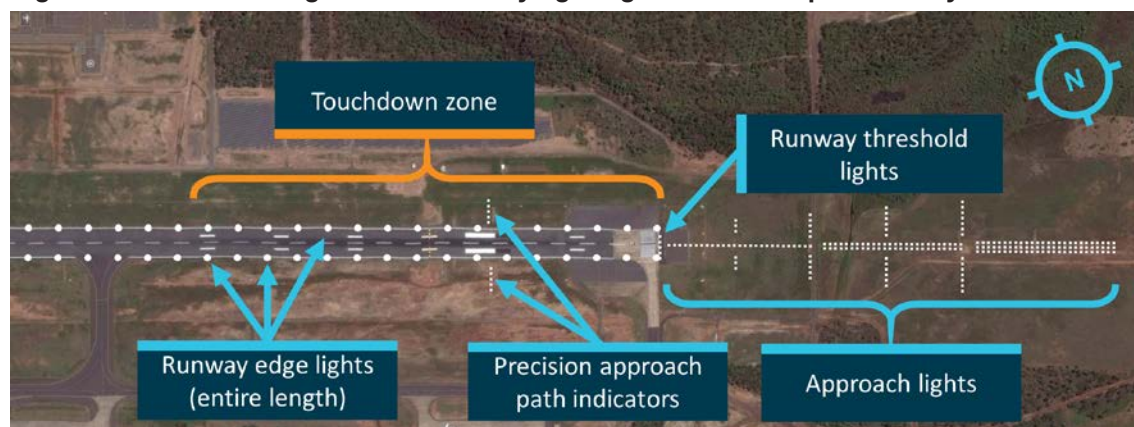
**Figure 8: General arrangement of runway lighting at Darwin Airport runway 29**

The runway had white markings along the centreline, an aim point starting 342 m from the threshold, and five touchdown zone markings from the threshold to 900 m. The runway had high intensity approach lights, runway threshold lights, and runway edge lights spaced at 60 m intervals.<sup>17</sup> There were also precision approach path indicator lights each side of the aim point (Figure 8).

Runway 11/29 at Darwin was significantly wider than most others in Australia (see *Related occurrences in Australia*), resulting in the visual cues and runway perspective being different to those normally available to complete a landing. The runway was not equipped with centreline or touchdown zone<sup>18</sup> lights.
