# **INTERIM STATEMENT**

Accident occurred to AW609 registration marks N609AG, on 30<sup>th</sup> October 2015, in Tronzano Vercellese (VC), Italy.

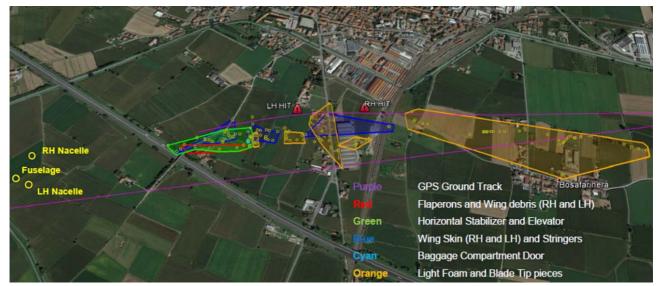
Right after the accident occurred, an investigation team by ANSV was sent to the crash site. The team mapped the debris distribution of the wreckage (picture 1).

Picture 1: debris map.

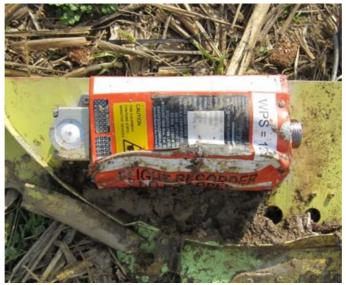
Photo 1: MPFR (combined FDR/CVR) installed on board aircraft AW609 registration marks N609AG.

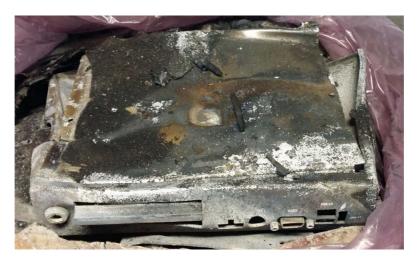
Photo 3: video recorder (DVR) which recorded the data from two cameras.

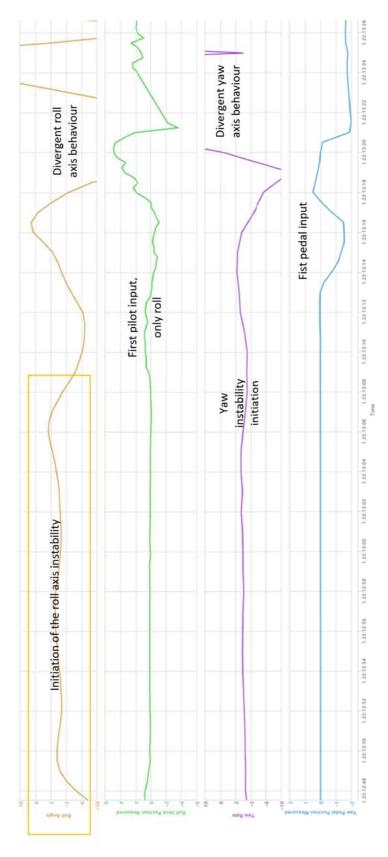
**Motivation:** in the accident flight, during the execution of high speed test maneuvering in symmetric configuration, the aircraft AW609 encountered lateral-directional oscillation (picture 2, attached "A" to this statement, roll depicted in yellow and yaw rate in purple, data from the MPFR). The safety investigation showed that this phenomenon was present to a lesser degree also in previous flights. It was considered to be slight and not dangerous, being assessed as self-damping.

**Motivation:** in the accident flight, during the development of the aerodynamic oscillation, the PIC tried to maintain the aircraft control (picture 2, input on the roll depicted in green and input on the yaw in blue, data from MPFR). The oscillation that started on the roll axis was corrected by the PIC acting on the roll control, as normally expected. The AW609 flight control laws however are designed in such a way that input on roll axis is generating also a coupling on the yaw axis.

Picture 2: FDR data - roll axis (yellow), PIC input on roll axis (green), yaw rate (purple), PIC input on yaw axis (blue).

**Safety Recommendation:** the ANSV recommends, in the framework of the certification process, to verify that the aerodynamic behavior of the aircraft at high-speed conditions will be reviewed, if necessary making use of wind tunnels tests in addition to updated models and simulations that can be representative of the complex flight conditions of this peculiar aircraft.

**Recommendation:** the ANSV recommends, in the framework of the certification process, to verify that the control laws of the aircraft will be reviewed in the management of the extreme flight conditions in which the aircraft could possibly fly. That verification should be addressed to ensure the effectiveness of the flight controls inputs given by the pilot avoiding the possibility of unexpected and un-commanded coupling effects.
