**Accident** to Fokker 27-500  
registered **I-MLVT**  
on 25 October 2013  
during initial climb from Paris-Charles de Gaulle Airport

## Loss of a propeller blade then part of the left engine during initial climb, in-flight turn back, emergency landing

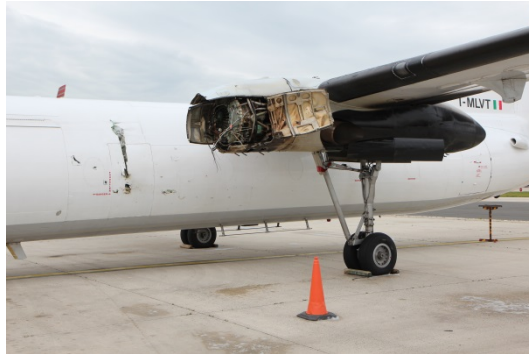
On the left side, the fuselage had a vertical hole that opened from the outside to the inside, and numerous small impacts. On the right side, it was punctured vertically, from the inside to the outside of the fuselage, with a hole of a similar size to the hole on the left fuselage. Inside the fuselage, the postal freight container, between the two puncture holes in the fuselage, was cut from side to side. The electrical cable bundles running along the fuselage side walls had been cut.

View of left side of aircraft

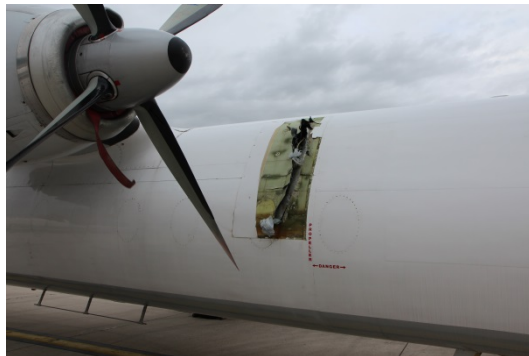
View of right side of aircraft

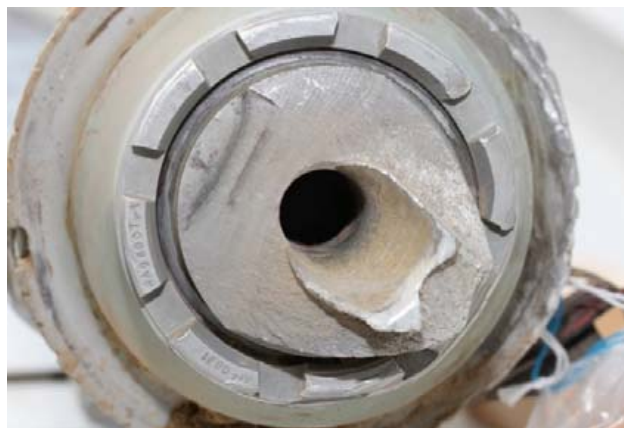
Examinations of the aircraft and blade No. 2 established that the blade separated from the left propeller and struck blade No. 1, causing it to separate from the propeller. Blade No. 2 separated from the propeller as a result of fatigue failure in its pre-load bolt, in the fillet, approximately 8.7 mm below the bolt head.

Detailed examinations with a scanning electron microscope (SEM) showed the presence of fatigue striations, confirming the presence of a crack propagation area under cyclic loading (40% of the total bolt cross-section). The high-relief area (60% of the remaining cross-sectional area) had numerous dimples, which were characteristic of a sudden ductile fracture.

Figure 2: fracture pattern on blade No.2 pre-load bolt

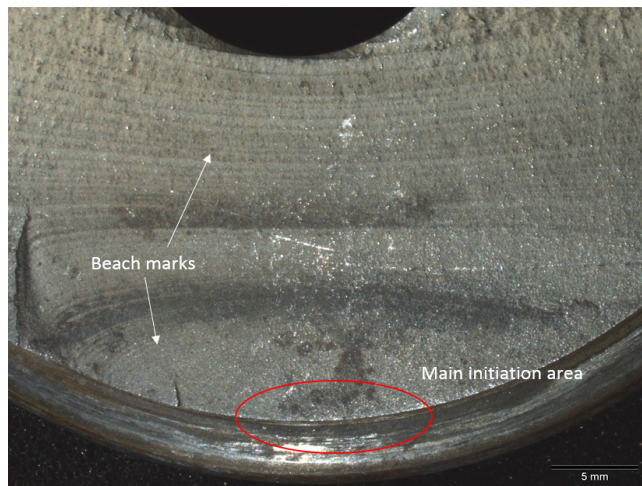
Figure 3: close-up of the fracture pattern, initiation crack area

By observing the beach marks (concentric lines at the start of propagation, visible on Figure 3), the crack initiation area could be determined; it was located on the leading edge side of the blade. The presence of two ratchet lines suggested that two secondary cracks were also initiated and propagated.

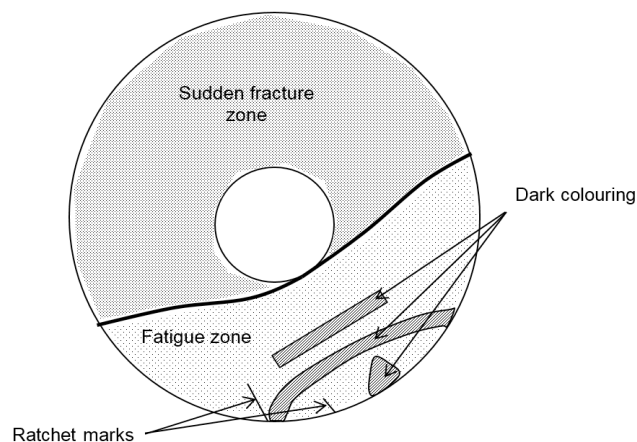
Figure 4: Fractographic description of the fracture surface of blade No. 2 pre-load bolt

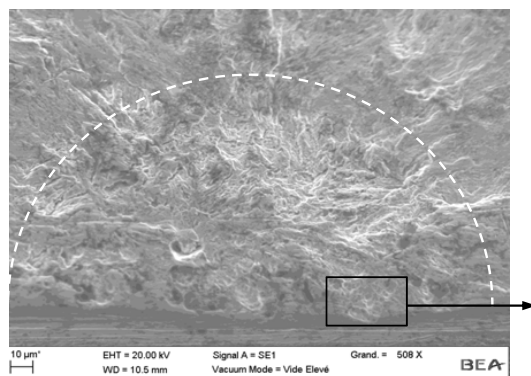
The main crack initiation area locally presented a pattern with porosities (*Figure 6*). An inclusion was also observed, 100 µm from the fracture pattern. Through chemical analysis, it was determined that it was a non-metallic manganese sulphide (MnS) inclusion.

No prior damage (tool impact, machining fault, etc.), no corrosion pitting and no geometric defects were observed at the main crack initiation area.

Figure 5: morphology of the main crack initiation area

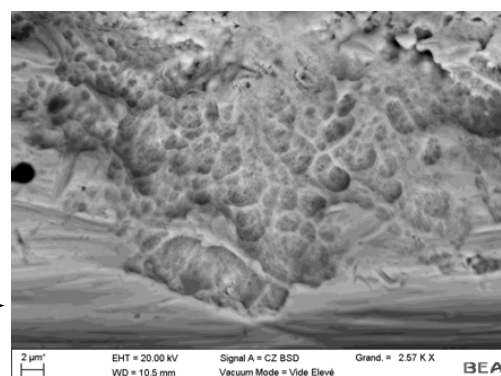
Figure 6: porosities in the main crack initiation area (detail of Figure 5)
