# Report

Serious incident on **22 July 2011**  
**in cruise at FL350, north Atlantic Ocean**  
to the **Airbus A340-313**  
registered **F-GLZU**  
operated by **Air France**

Bureau d'Enquêtes et d'Analyses  
pour la sécurité de l'aviation civile

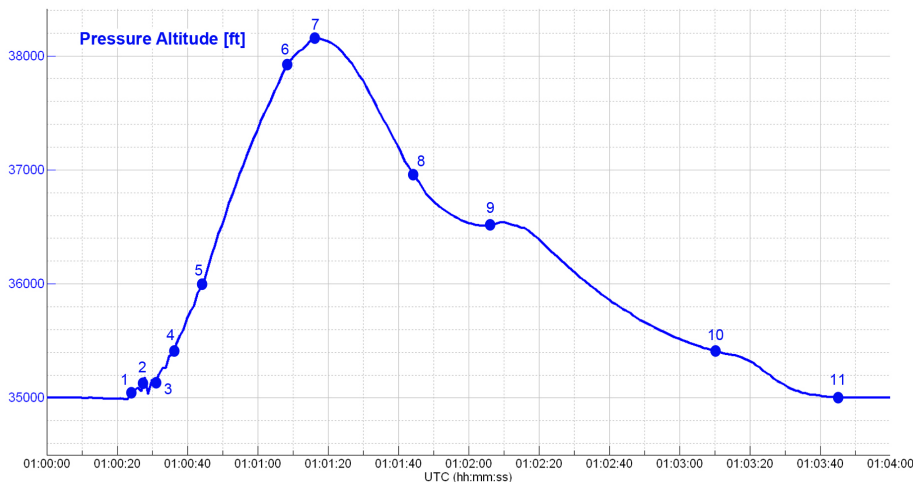
Figure 1 - Vertical flight path

At 1 h 00 min 24 (point n°1 on Figure 1), about 2 NM after passing coordinates 18N 60W, the aeroplane entered a zone of moderate turbulence. The overspeed warning ("OVERSPEED") was triggered<sup>(3)</sup> and the "Master Warning" warning light came on. The crew stated that they were very surprised by this warning. Mach reached 0.87.

At 1 h 00 min 27 (point n°2), the PNF manually disengaged the AP by pressing the takeover pushbutton on the side-stick. A pitch-up input on the PNF's side-stick going as far as  $\frac{3}{4}$  to stop was recorded for 6 seconds. This input was accompanied by an input to bank to the right then left. The PNF stated that he did not remember these inputs.

At 1 h 00 min 31 (point n°3), the PF extended the speedbrakes. Mach was 0.84 and started to decrease 2 seconds later.

At 1 h 00 min 37 (point n°4), the speedbrakes started to retract automatically. Pitch attitude then varied between 8° and 10°.

At 1 h 00 min 44 (point n°5), the aeroplane was at FL360. The speedbrakes were retracted. Pitch attitude increased to about 12° in 2 seconds. The aeroplane continued to climb and Mach decreased.

At 1 h 01 min 08 (point n°6), while the aeroplane was at 37,950 ft in climb, the PF disengaged the A/THR and moved thrust levers forward to the TO/GA detent.

At 1 h 01 min 17 (point n°7), altitude reached maximum: 38,150 ft. Mach was 0.66.

At 1 h 02 min 06 (point n°9), the aeroplane descended past 36,520 ft. The PF then became aware of the disengagement of the AP and made a pitch-down input on his sidestick. Pitch attitude began to decrease 2 seconds later.

From 35,400 ft (point n°10), the PF re-engaged AP1, altitude stabilised at FL350 (point n°11), and A/THR was re-engaged.
