FINAL REPORT

Investigation of a serious incident on 30.06.2015 with FALCON F900 aircraft, registration marks VP-CGD, and EMBRAER 170 aircraft, registration marks SP-LDK, started in the controlled air space of the Republic of Romania and realized in the controlled air space of the Republic of Bulgaria.

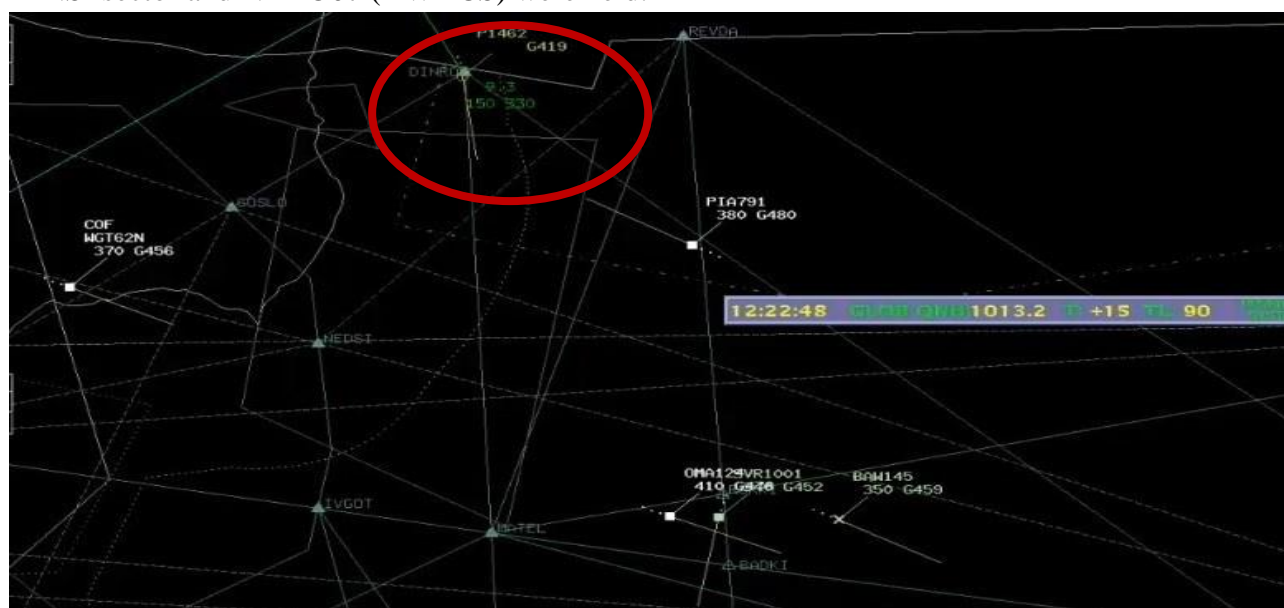
Fig. 1

At 12:22:48 UTC an unidentified primary target entered the controlled air space of ACC Sofia overflying TCP DINRO) (see Fig.1).

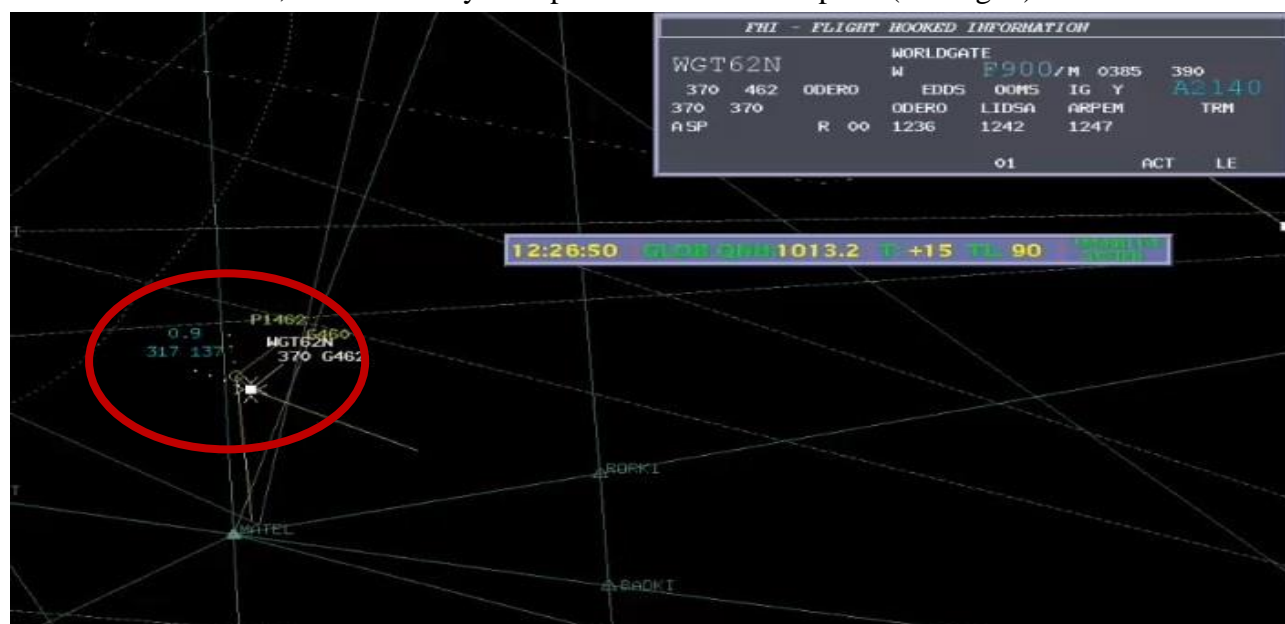
Fig. 2

At 12:26:50 UTC the horizontal distance between WGT62N and LOT7293 is 0,9 nm, at one and the same FL 370, determined by extrapolation of the radar plots (see Fig. 2).

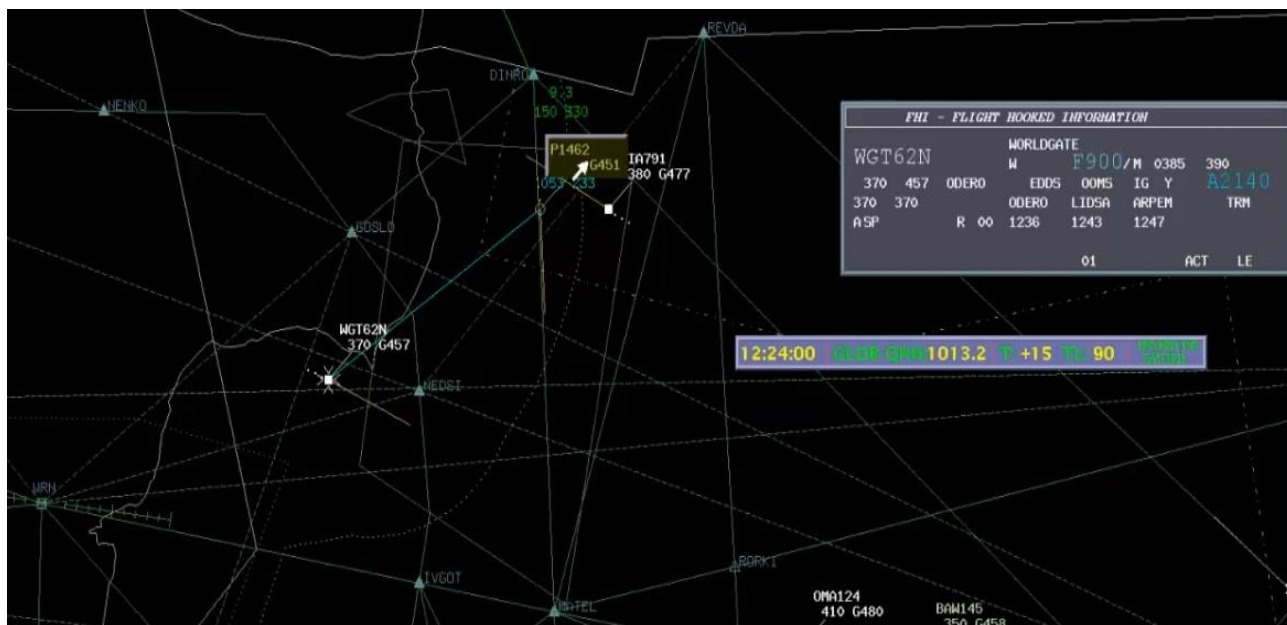
Fig. 3

At 12:24:00 UTC, ACC Bucharest requested confirmation of information about the unknown aircraft: “I want to ask you if you have on the primary radar over DINRO any traffic” (see Fig. 3).

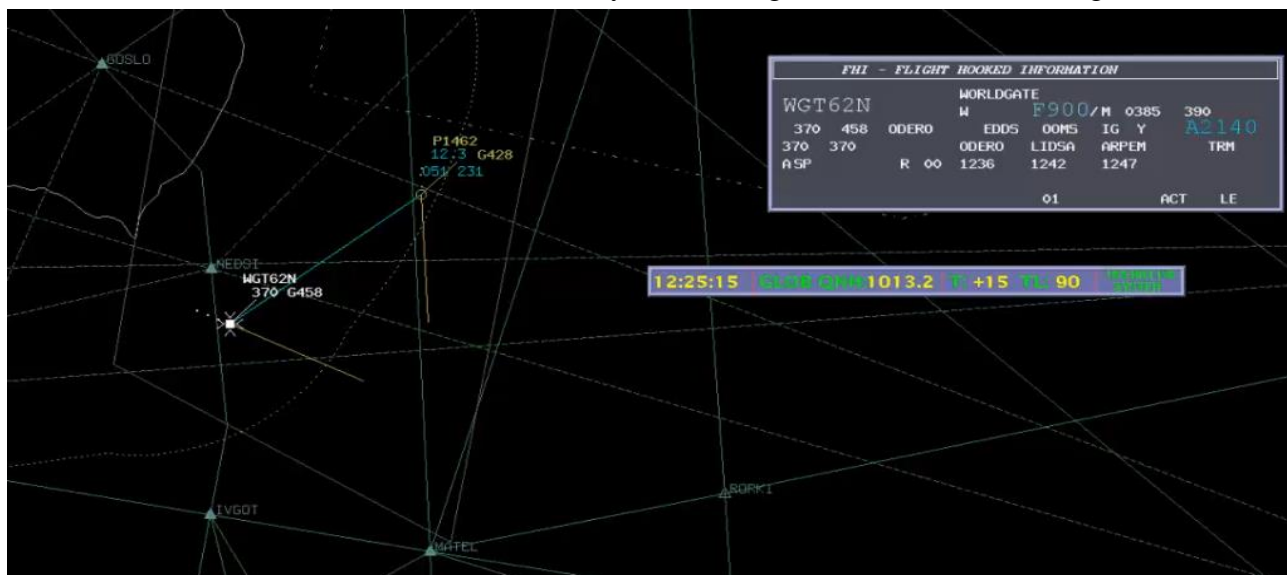
Fig. 4

At 12:25:15 UTC ACC Bucharest: “So you have target over DINRO” (see Fig. 4).

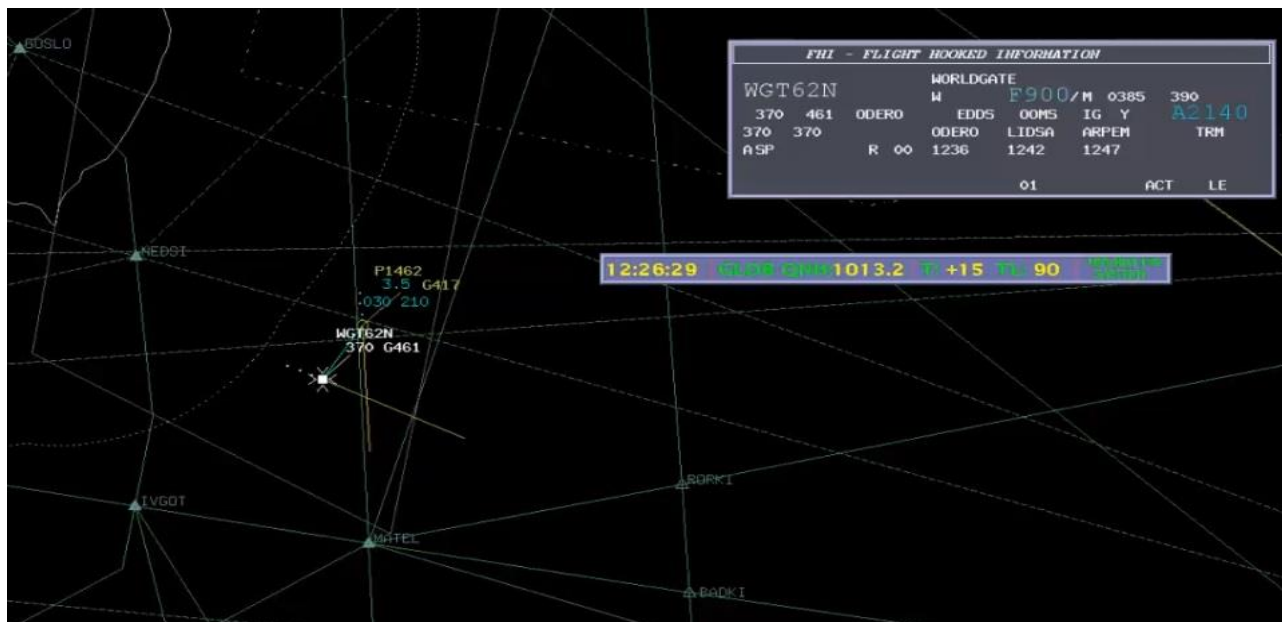
Fig. 5

At 12:26:29 UTC ACC Bucharest: “It might be LOT7293 It might have FL370, Yes, LOT7293 Flight Level 370 ok” (see Fig. 5).

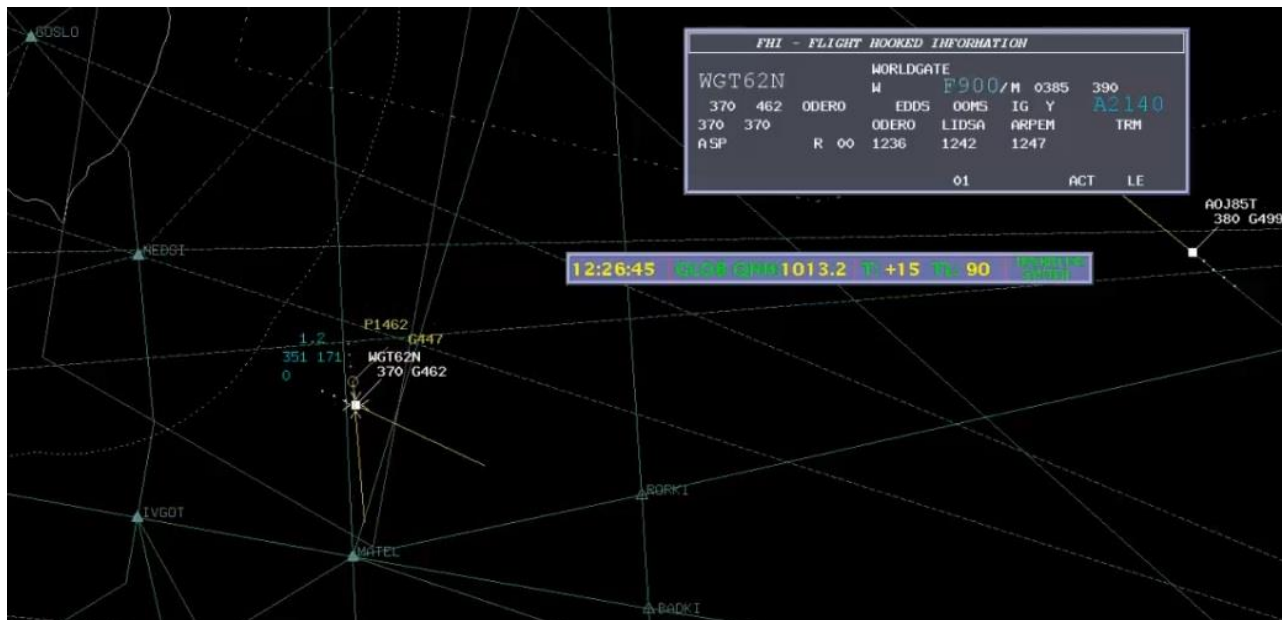
Fig. 6

At 12:26:45 UTC ACC Bucharest: “LOT7293 It might be flight level. Stand by”(see Fig. 6).

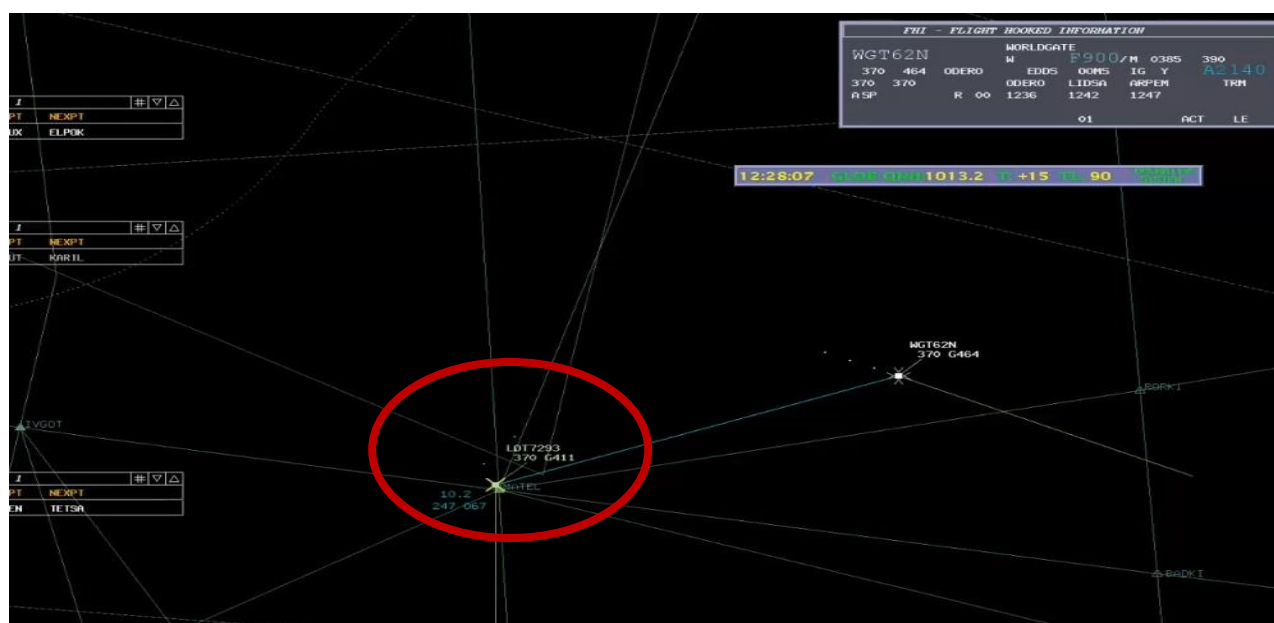
Fig. 7

At 12:28:10 UTC LOT 7293: “Thank you very much sir LOT 7293” (see Fig. 7).

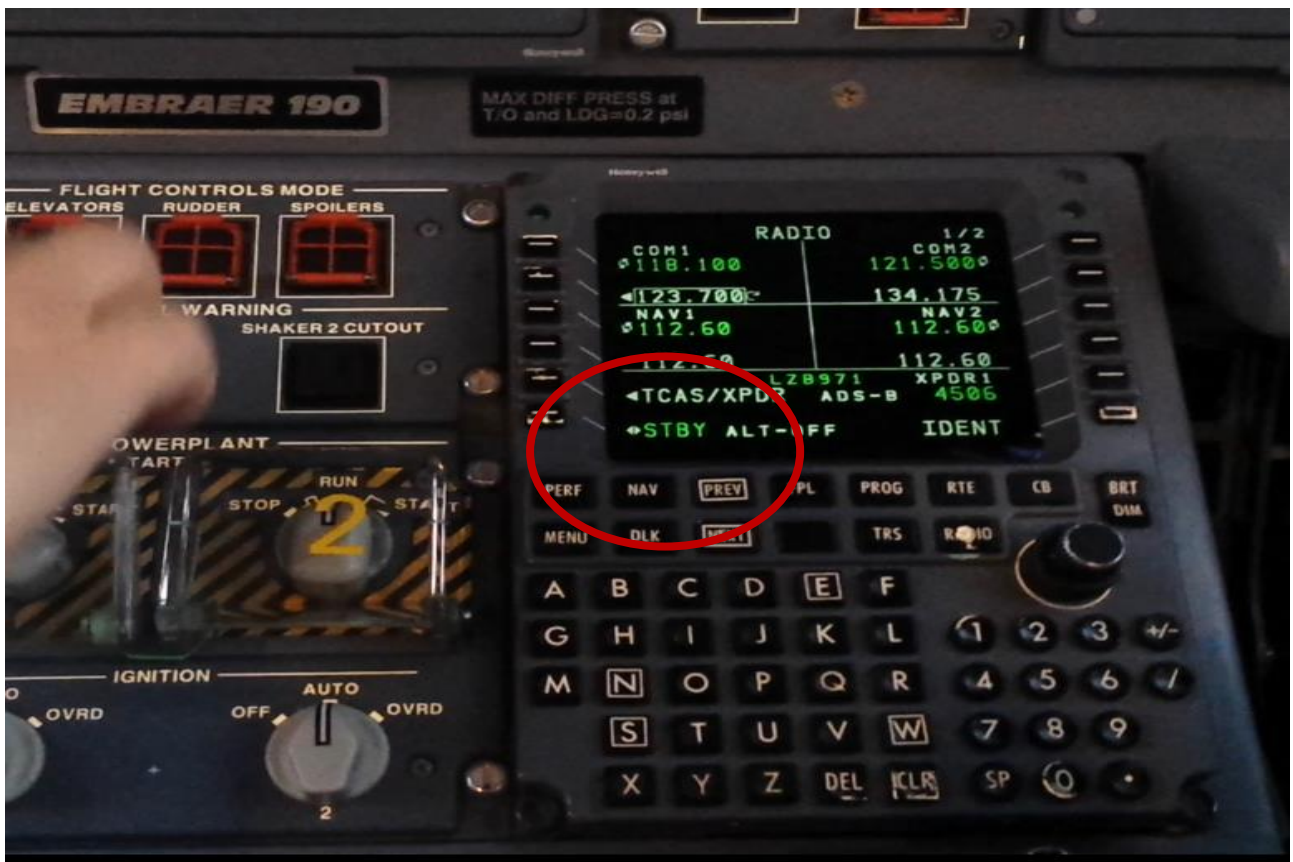
Fig. 10

Where the transponder is in STANDBY Mode, a “STANDBY” inscription is displayed in green on the MCDU (see Fig. 10).

- The flight crew did not notice the current STABDBY mode of the transponder indication, as well as the inscription TCAS OFF on PFD and did not report about the improper operation of the XPDR/Transponder system to the Air Traffic Service authorities till ACC Sofia Control FS Varna West informed them about the non-operating transponder.

BG.SIA-2015/03/06. “LOT” AO shall perform in the shortest time simulator training for actions on detection, reporting and rectification of failure of the XPDR/Transponder system to be performed by the flight crews operating Embraer 170/175/190/195 aircraft.

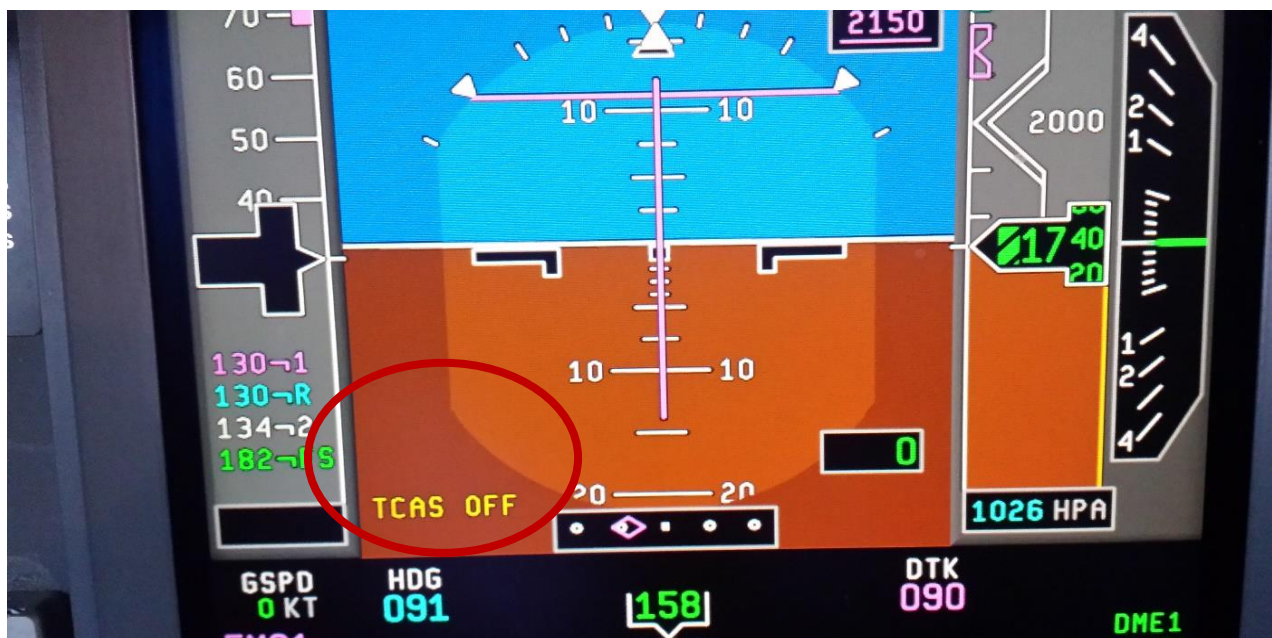
Fig. 11

and a “TCAS OFF” message is displayed on both Primary Flight Displays (see Fig. 11).
