FINAL REPORT

on
investigation of a serious incident, realized on 11.03.2018 with B737-400 aircraft, registration marks TC-TLC, operated by TAILWIND AIRLINES AO, in a flight on route Antalya - Zurich over the territory of Republic of Bulgaria.

BULGARIAN AIRCRAFT ACCIDENT INVESTIGATION UNIT

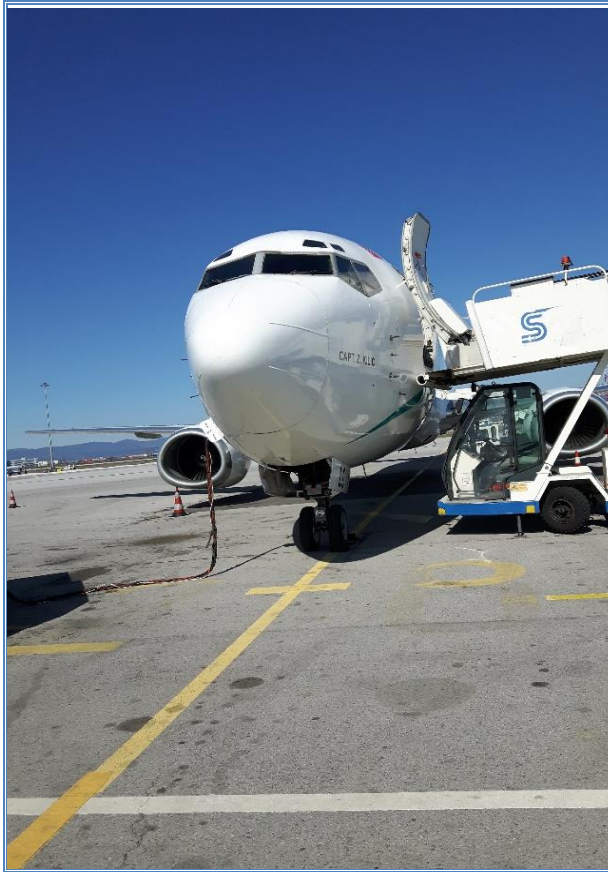
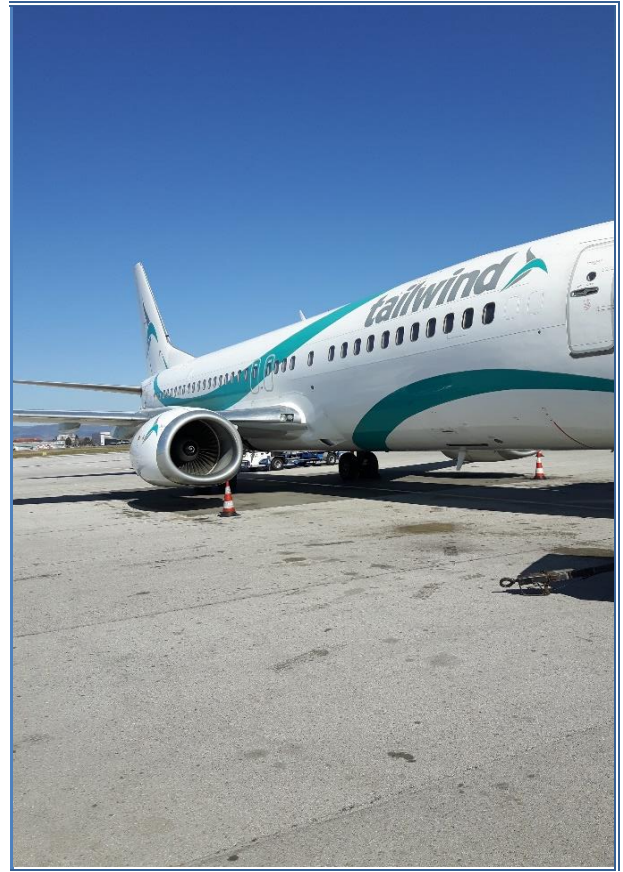
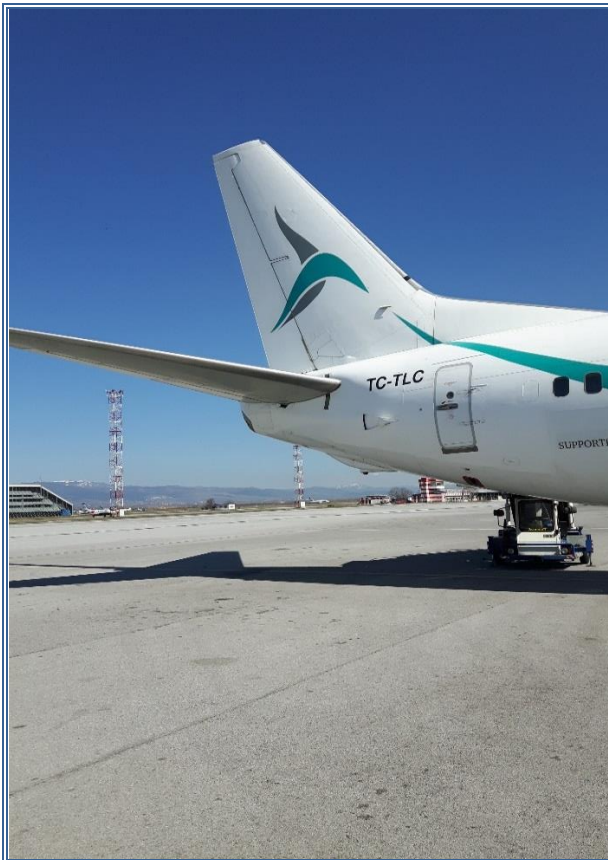
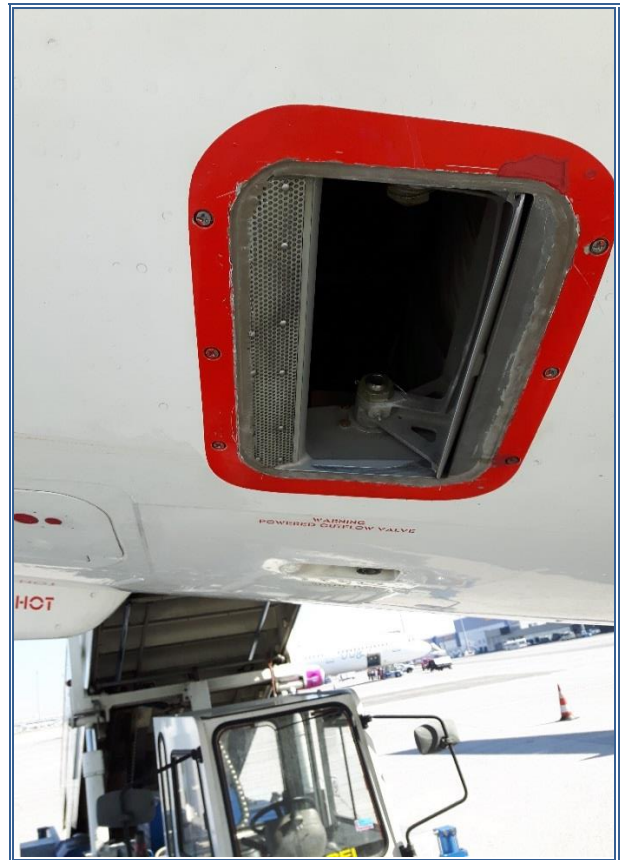
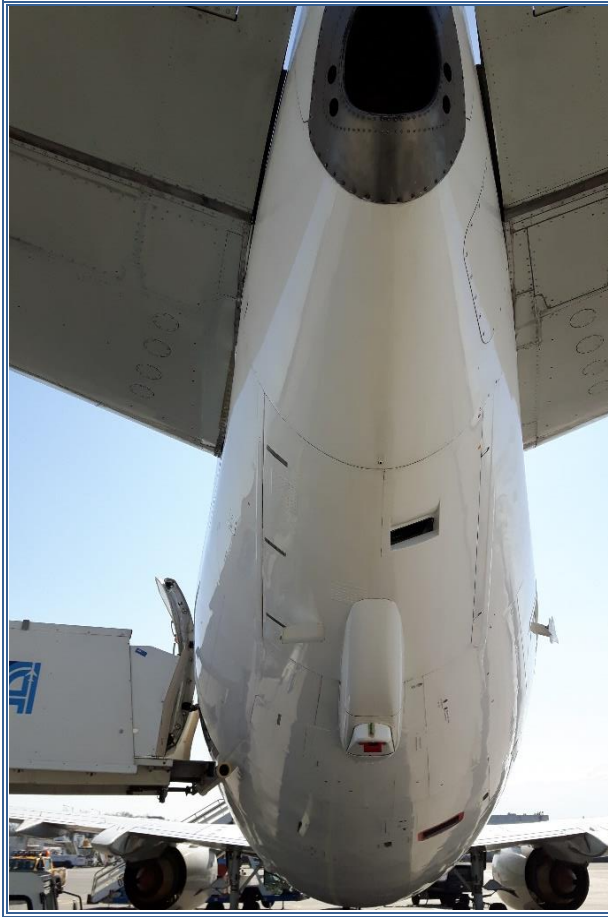
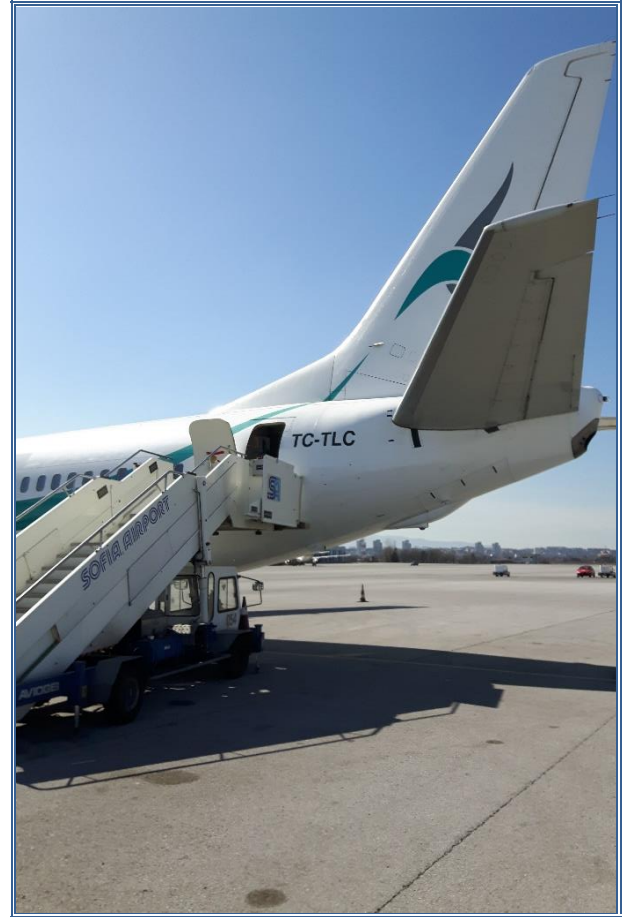
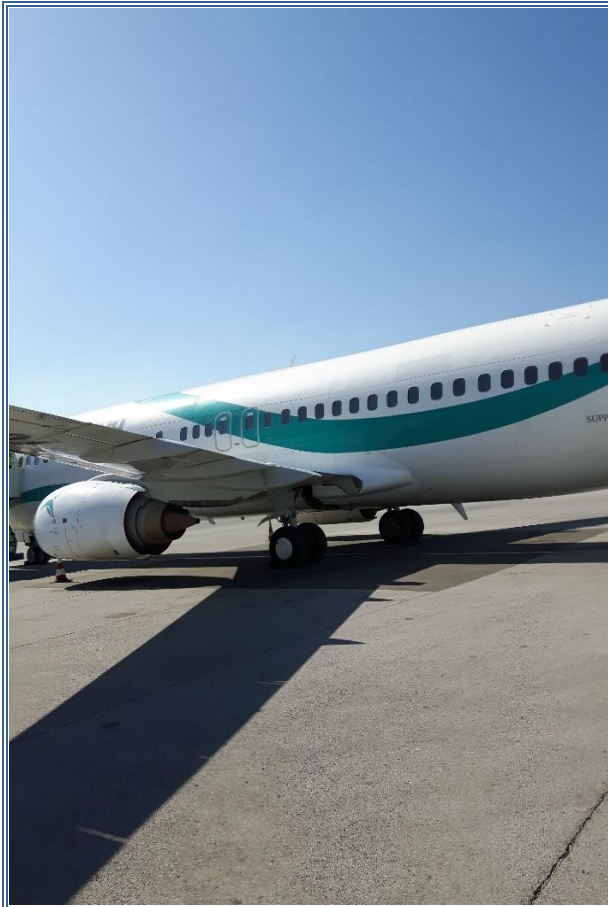
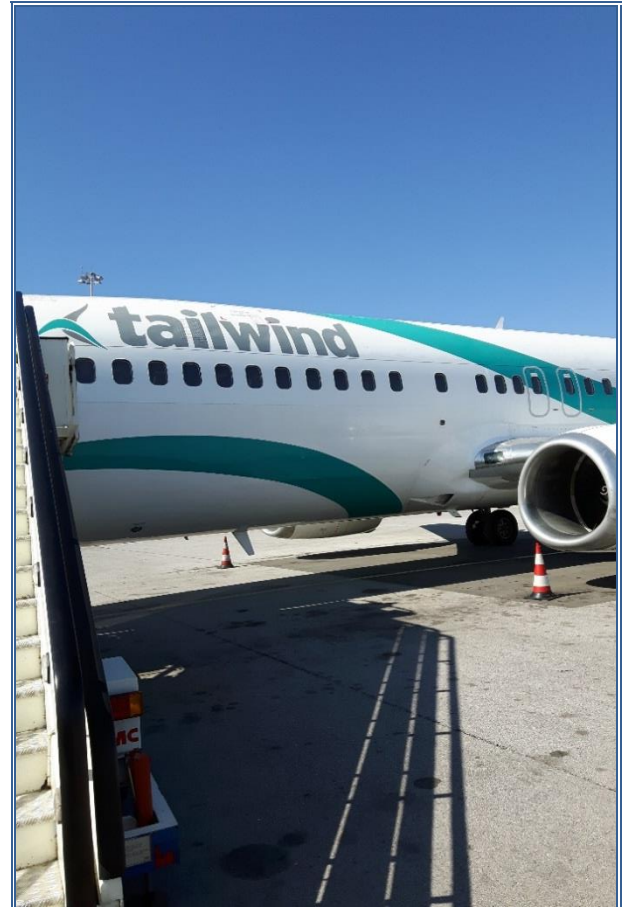
During the inspection of the aircraft after realization of air occurrence no damages on the airframe: The external condition of the airplane is visible from the photos shown in Enclosure 1. All oxygen masks in the passenger cabin were activated, Fig. 9 and 10 of Annex 1. A QAR memory card with flight parameters was downloaded. An inspection of the cabin pressure control system performed by CAMO of AO has revealed a failure of the outflow valve gasket

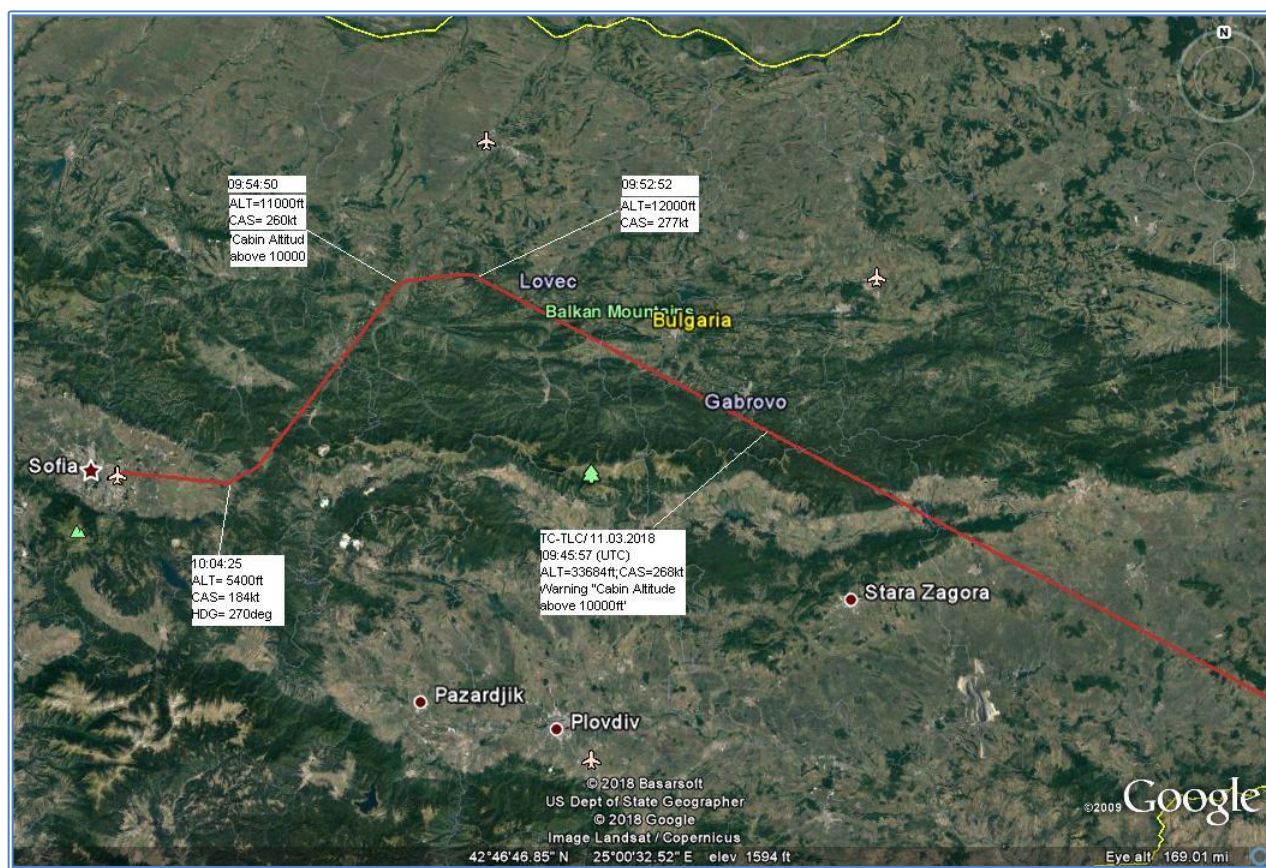
Fig. 12.

towards reporting point UTEKA. At about 80 nm east of Sofia Airport the crew of the aircraft decided to climb to FL 340, starting at a vertical speed of about 1000 ft / min. The flight trajectory of the airplane over the Republic of Bulgaria is shown on Fig. 12 of Enclosure 1.
