**INCIDENT**

| <b>Aircraft Type and Registration:</b> | Douglas DC-8-63F, YA-VIC | |
| <b>Location:</b> | Manston Airport (Kent International) | |

**Synopsis**

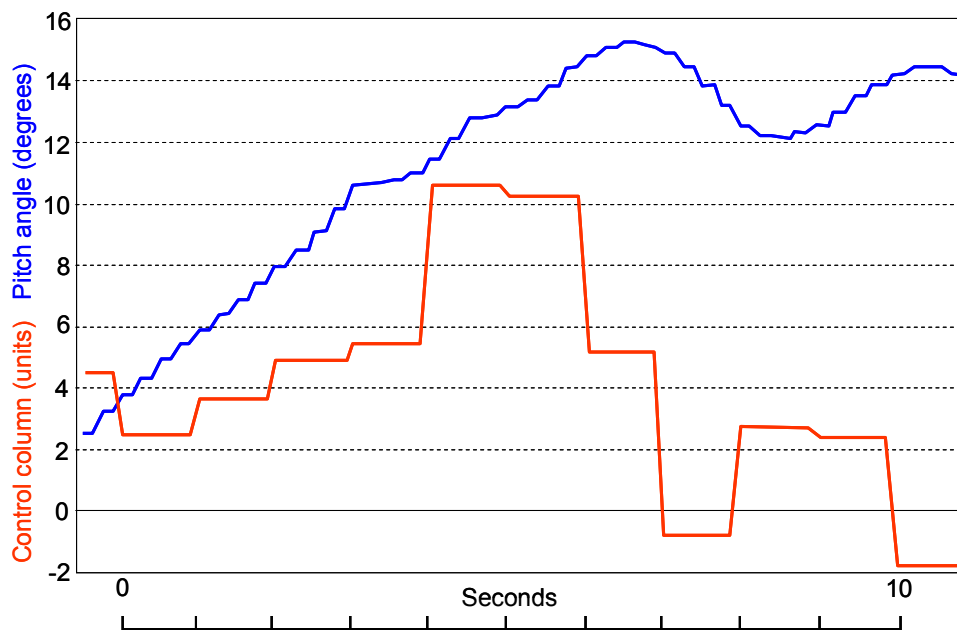
**Figure 1**

Aircraft pitch attitude and control column position during rotation

For the majority of the initial rotation, there was a steady aft movement of the control column (as far as can be determined, given the relatively infrequent update rate of once per second), resulting in a constant pitch rate. The aircraft reached 8° pitch in about five seconds and continued to increase at a constant rate until nearly 11°, at which point there was a marked reduction in pitch rate. A significant aft control column input was made at about this time, after which the pitch attitude continued to increase to a recorded maximum of 15.2°.

The FDR data suggests that the initial tailstrike occurred at about 11° pitch attitude, identified by a marked slowing of the rotation rate. As the AOM warned that tailstrike would occur at 8.95° pitch, the aircraft had probably just become airborne when the tail skid contacted the runway. After the initial tail strike the right main gear struck the raised approach light.

The aircraft then continued to rotate as a result of the increased control input, causing the tail skid to contact the soft ground beyond the runway end. A second, lesser, reduction in pitch rate is evident on the FDR data at about 13° pitch, which probably marks the second tail strike. The time interval between pitch events is about 1.5 seconds, which is equivalent to the time the aircraft would have taken to travel the distance between start and finish of the ground marks at the liftoff speed.
