## Serious incident

to the EMBRAER - ERJ170 registered **F-HBXK**  
and to the AIRBUS - A320 registered **OO-SNE**  
on 21 October 2020  
at Paris-Charles de Gaulle (Val-d'Oise)

## Windshear warning on final approach, flight path deviation during the missed approach, abnormal proximity with an aeroplane taking off from a parallel runway, TCAS resolution advisory

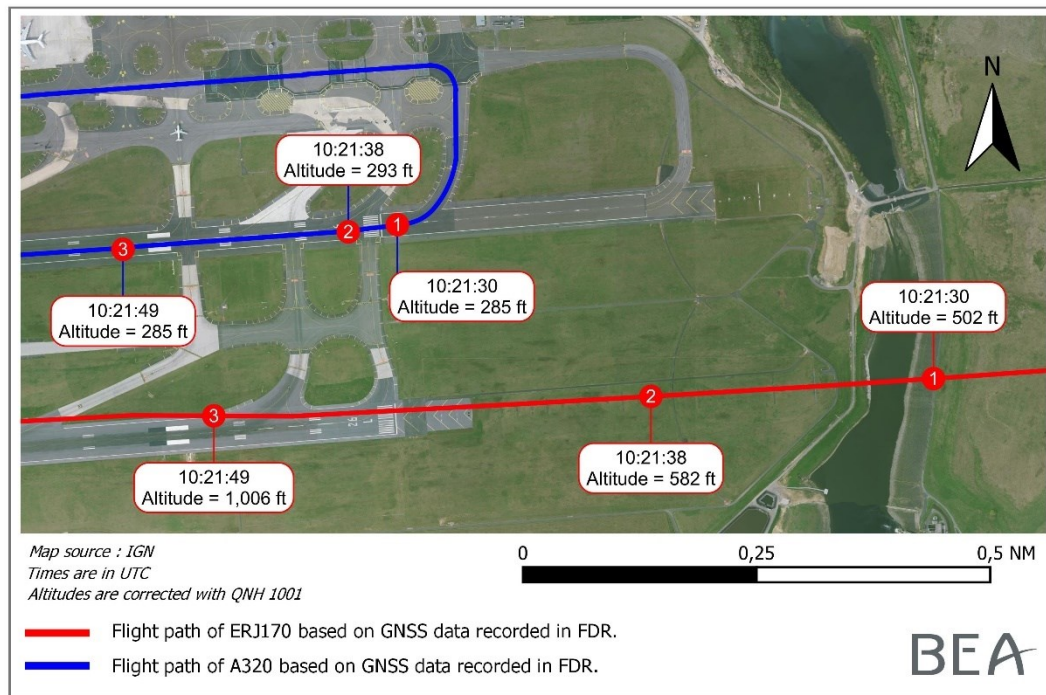
Figure 1: flight paths of the ERJ170 (red) and the A320 (blue)

Under the influence of the wind increasing with the altitude, and the changes in speed of the ERJ170 during the manoeuvre, the flight path deviated to the right and approached runway 26R.

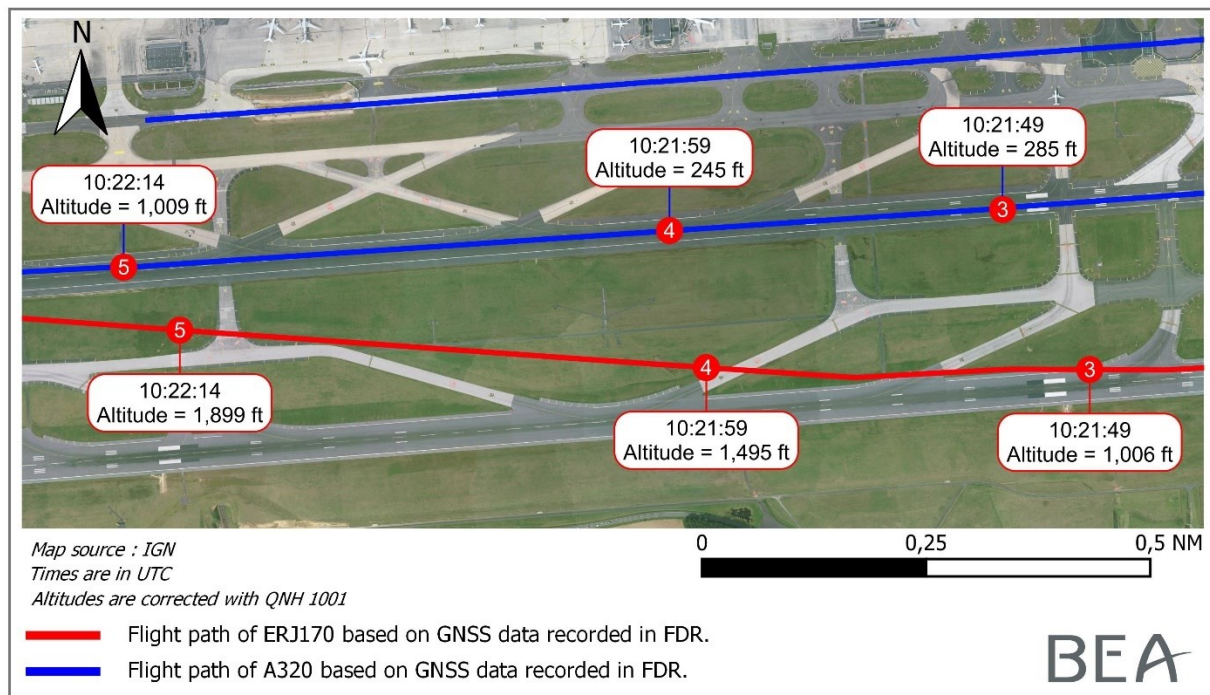
Figure 2: flight paths of the ERJ170 (red) and the A320 (blue)

On the controller's radar display, a Short Term Conflict Alert (STCA) was triggered, warning the controller of the potentially conflicting paths of the ERJ170 and the A320.

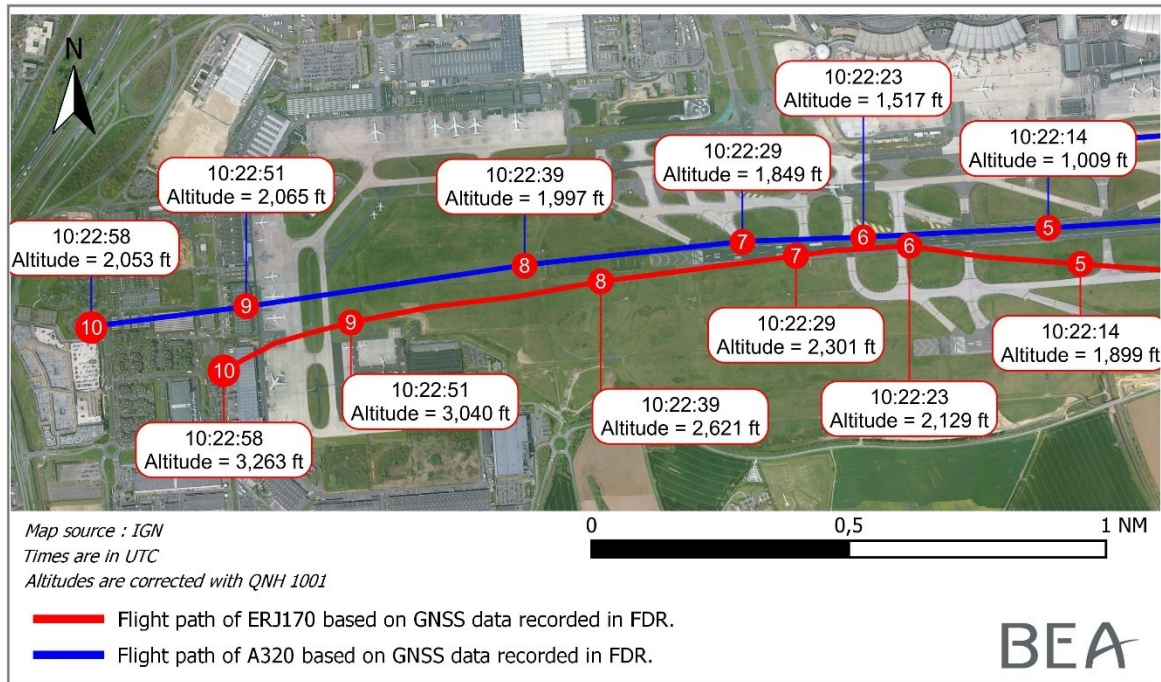
One second later, at 10:22:23, when the ERJ170 flew through 2,150 ft in climb, the TCAS issued a Resolution Advisory (RA) to climb with the voice alert, "Climb Climb" (see Figure 3, point 6). The PF of the ERJ170 executed the associated procedure and adjusted the attitude. In addition, she moved the thrust lever to the TOGA detent. She levelled the wings and held the 250° heading, with an average track of around 263°.

Figure 3: flight paths of the ERJ170 (red) and the A320 (blue)

The minimum separation<sup>3</sup> between the two aeroplanes during the incident was 0.09 NM laterally and 460 ft vertically (point 7).

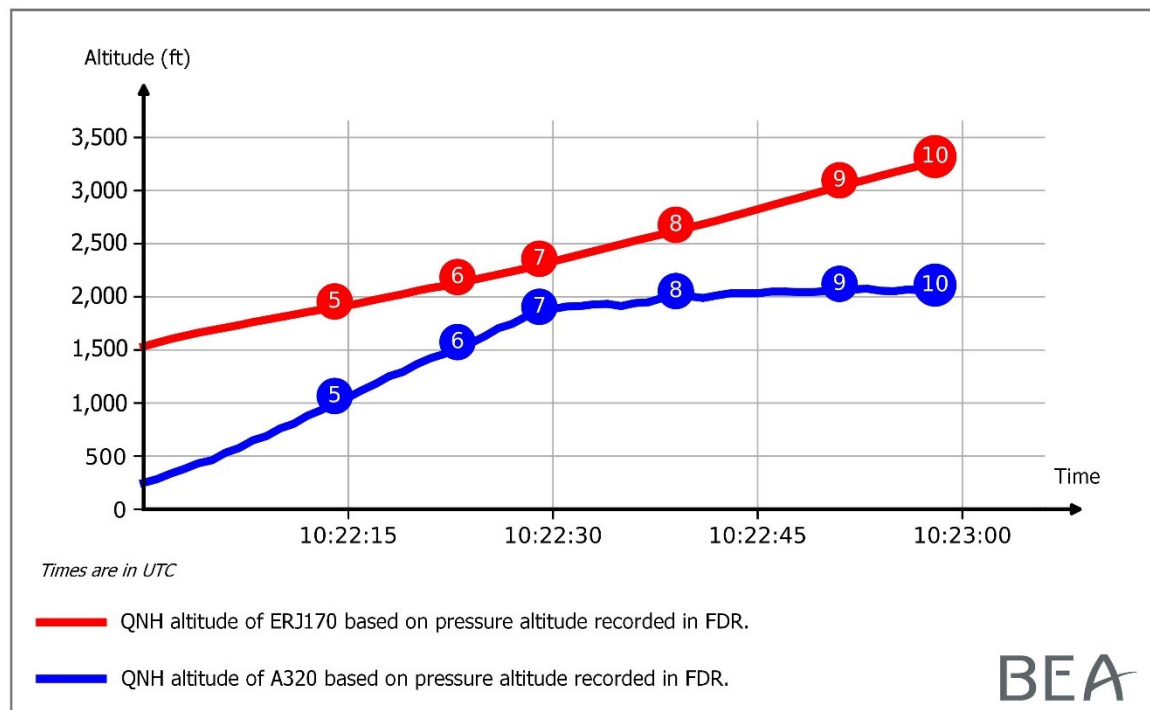
Figure 4: vertical separation between the ERJ170 (red) and the A320 (blue)  
(The graph does not show the horizontal separation of the two aeroplanes)
