Report

IN-009/2016

Incident involving an Airbus A-320-232 aircraft, registration
EC-MGE, at the Bilbao Airport on 28 March 2016

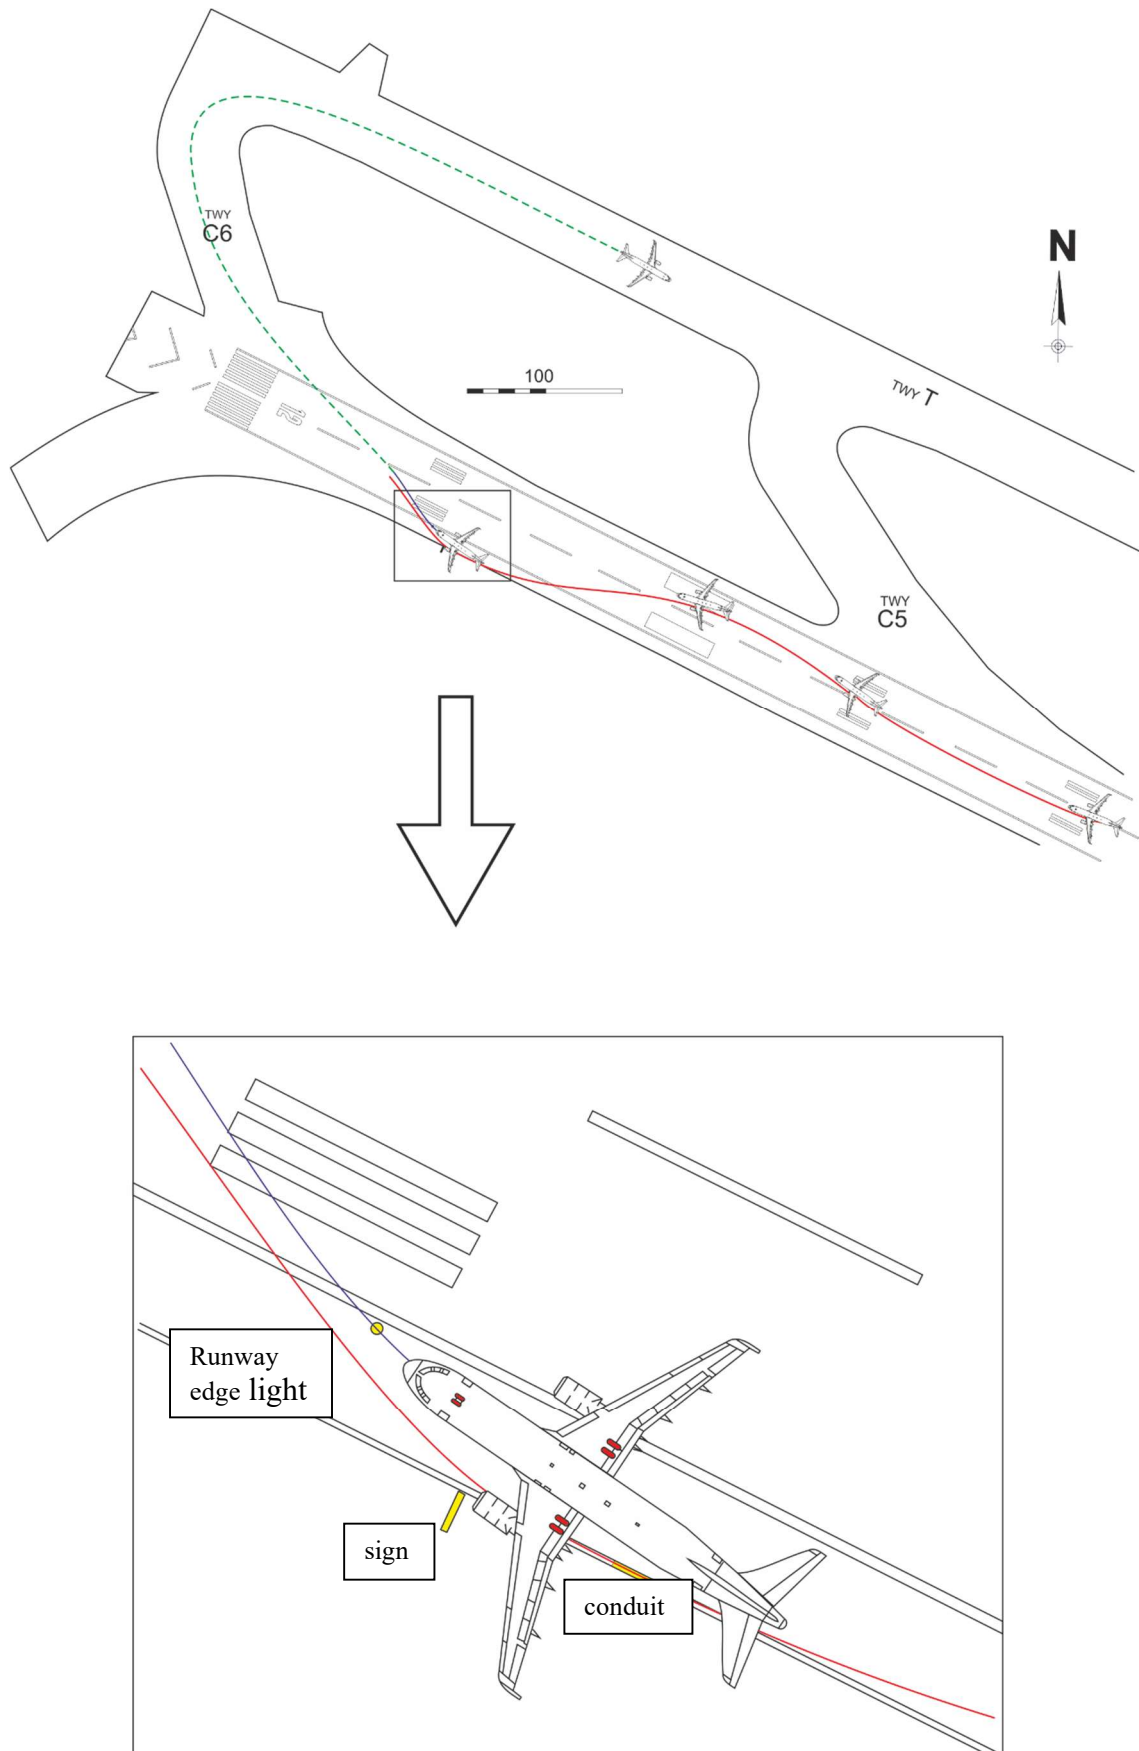
Fig.1.- Diagram of the aircraft's path and location

The aircraft then landed on runway 30 at the Bilbao Airport. It was a normal landing until, during the landing run, the crew were unable to maintain the path, with the aircraft veering from side to side on the runway before eventually leaving the runway via the left shoulder between exit taxiways 5 and 6. The aircraft then momentarily taxied over an unpaved area with its left main gear before returning to the runway, which it then exited via taxiway C6. The aircraft then came to a stop on taxiway T, just before taxiway C5 (see Fig. 1).

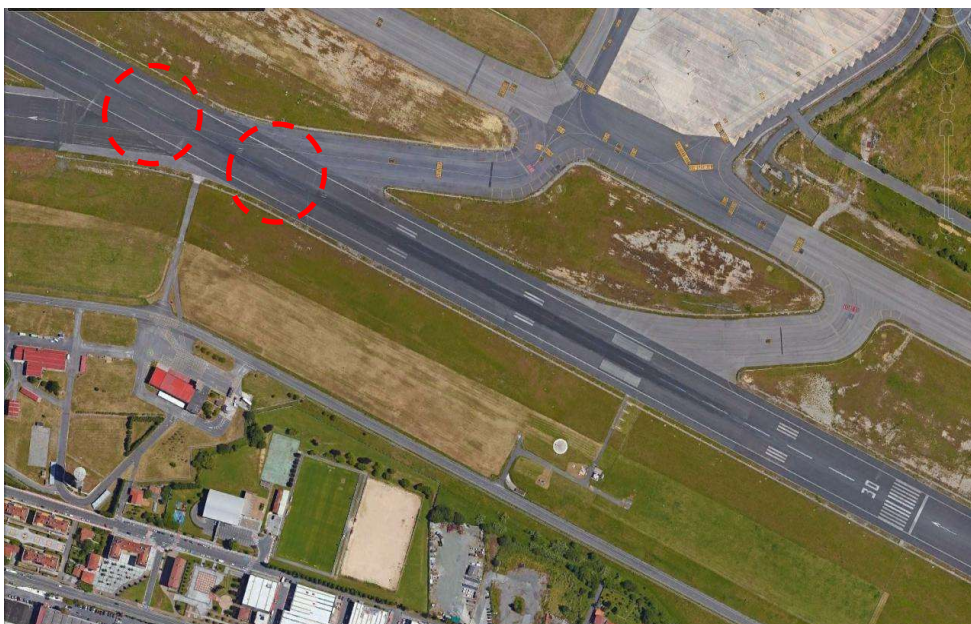
Figure 4. Photograph 1 TDZ marking, runway 30, on date of incident

To help guide the pilot to make contact with the main gear in the touchdown zone, runway 30 at the Bilbao Airport has touchdown zone markings that consist of four pairs of rectangular markings (two set of three and two sets of two) arranged symmetrically around the runway centerline and extending 600 m away from the threshold. Since the second pair of three bars coincide with the aiming point marking, only the latter is indicated in the PAPI.

Also indicated, though not as prominently, are two pairs of rectangular markings with one bar that extend a further 300 m.

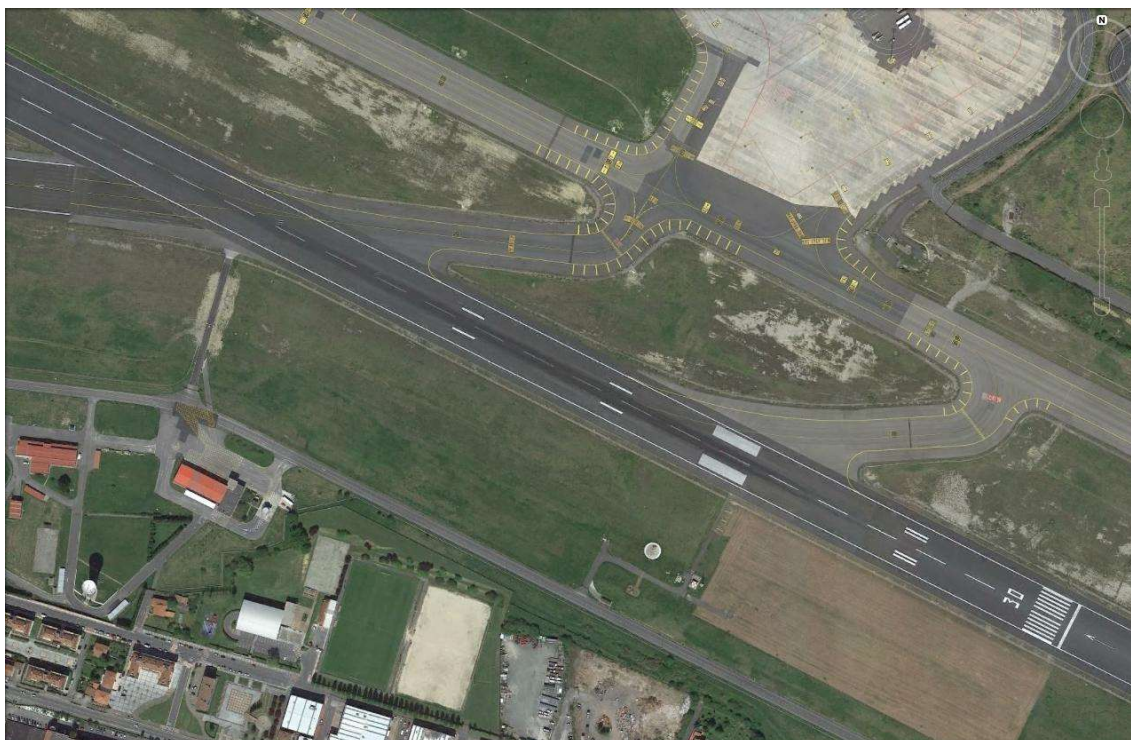
Figure 5. Photograph 2 Current TDZ markings on runway 30.

According to these specifications, on the date of the incident, runway 30 (LDA⁵ of 2140 m) should have had its TDZ indicated with four distance-coded markings consisting of four pairs of markings extending 600 m away from the threshold, separated by 150 m between them (only three are present, since the second coincides with the aiming point marking), concluding with two pairs of markings with a single line each to provide intuitive information on the length of the TDZ, the LDA and the distance between thresholds.

REC 05/19. It is recommended that EASA amend the Certification Specifications and Guidance Material for Aerodromes Design CS-ADR-DSN so as to standardize the distances for the touchdown zone signs, whether they are markings or lights.

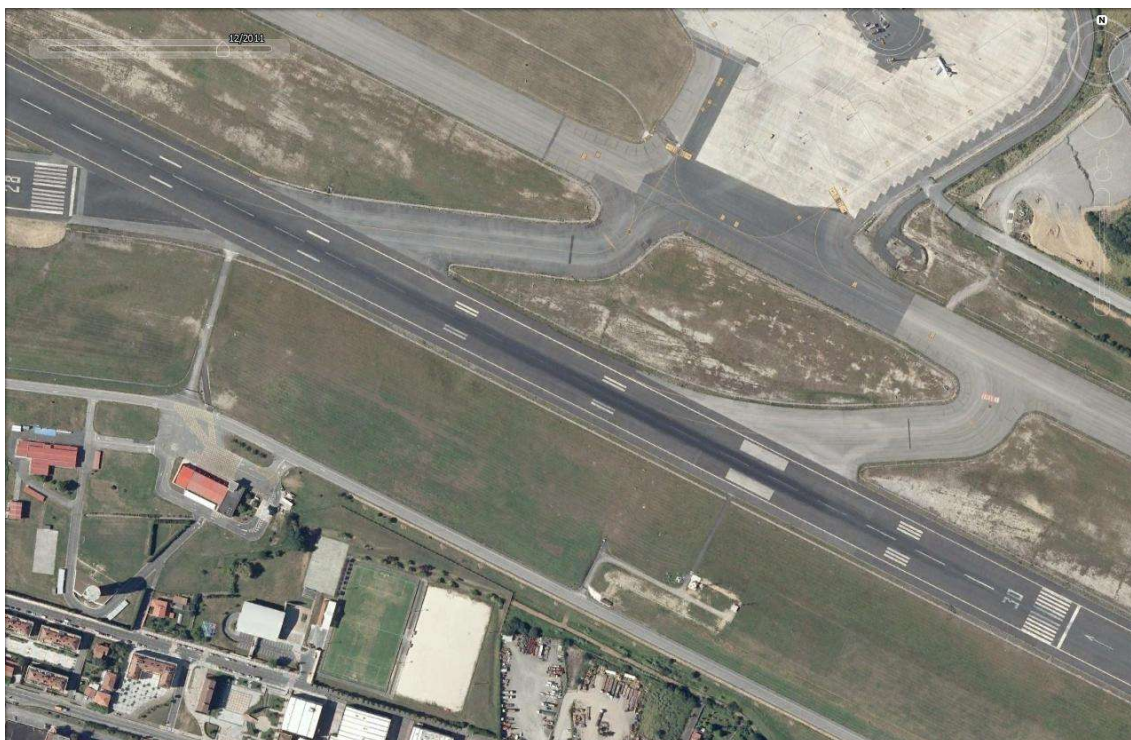
Figure 6. Photograph 3 TDZ markings, runway 30, before the date of the incident

Initially, runway 30 had one indication for the touchdown zone consisting of six pairs of markings separated by 150 m between them and extending along 900 m from the threshold (only five were visible, since the second coincided with the aiming point marking).

According to information provided by AENA, in August 2012, work was done to adapt the horizontal markings by using pressurized water to change from 3-2-2-1-1 to a 3-2-2 configuration. The transition from a 3-2-2 to a 2-2-1 configuration took place in November 2016, and relied on pressurized water to clean the six outside lateral stripes on the first pair and then repainting them, and the four erased in 2012, with a gray patina to remove any doubt with respect to the contrast between the clean aggregate and the asphalt.

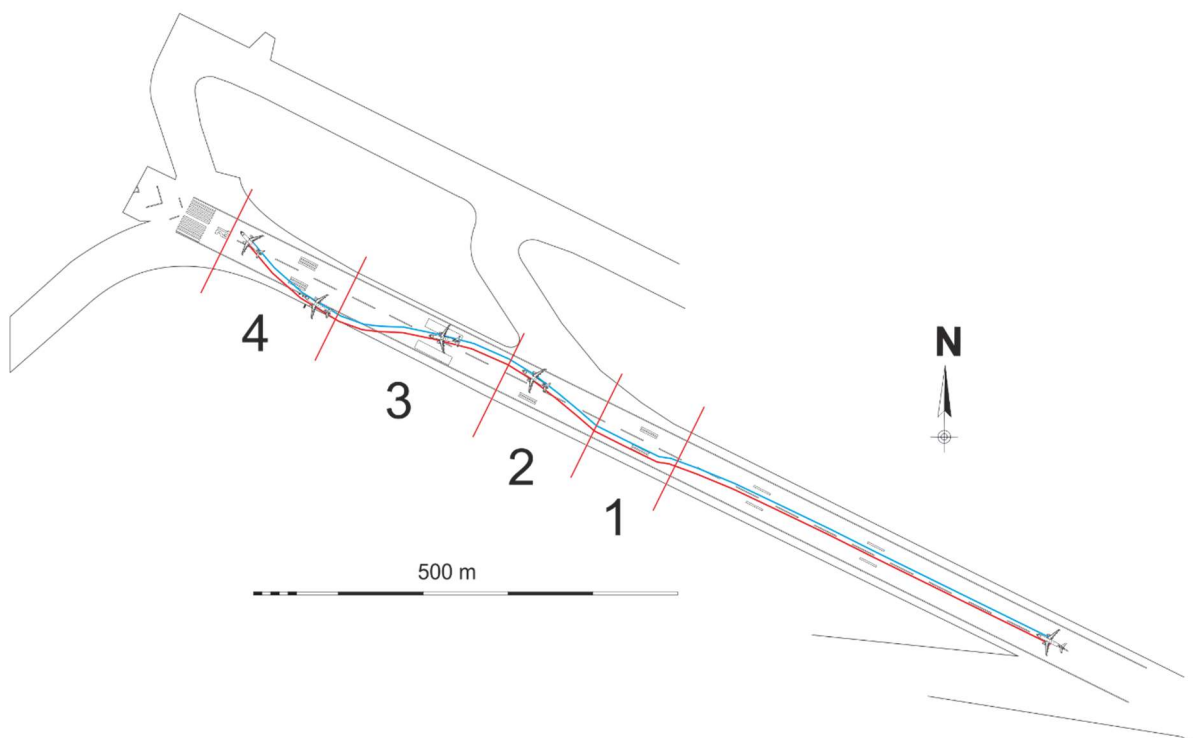
Fig. 9.- Segments of the aircraft's path on the runway

Starting at 06:52:18, the pilot applied symmetric braking to stop the airplane, with a GS of 30 kt on a heading of 322°. At that point, idle reverse thrust was applied. The reversers were stowed with the airplane under control at 8 kt.

After diverting to the left, the crew attempted to return to the runway centerline by making inputs to the rudder and right brake. The fact that they overran the centerline indicates that their inputs were inadequate (either in duration or intensity), made more difficult by the variable wind gust conditions that caused the deviation in the first place.

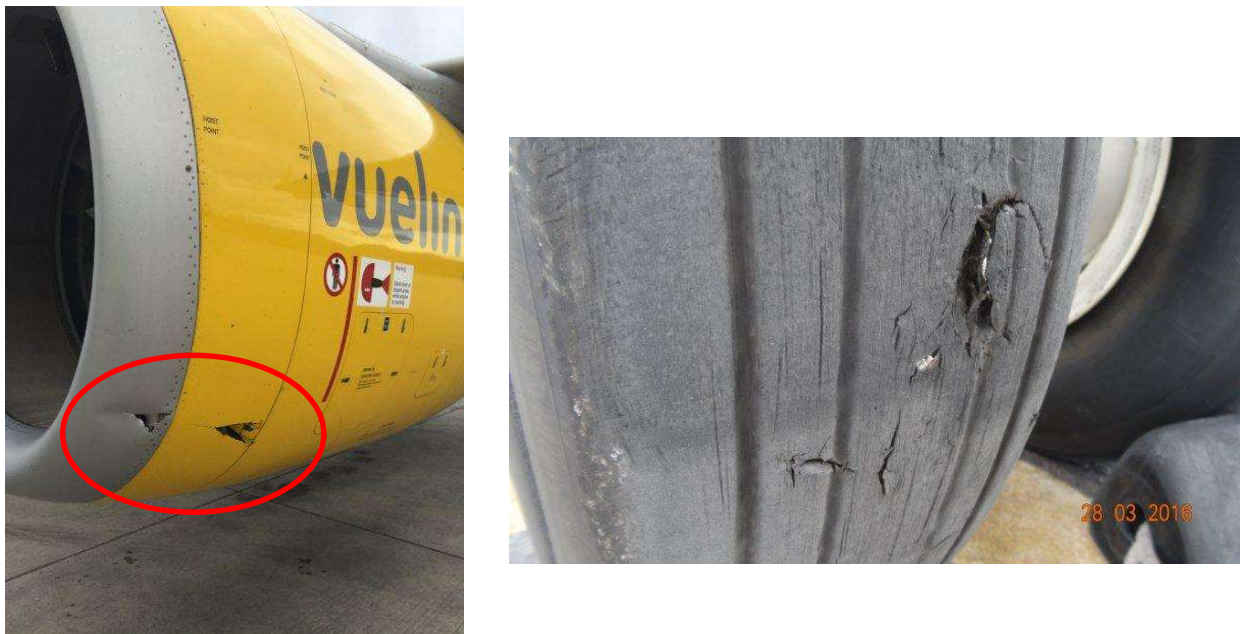
Fig. 10.- Damage to the aircraft

As a result of its runway excursion, the aircraft sustained damage to its left engine cowling, and loss of material from a tire on the nosewheel landing gear.

- According to information provided by ATS, the wind and gust values could have differed by 10 or 15 kt between the two thresholds.
- The aircraft sustained minor damage, consisting of dents in the left engine housing and detached material from one of the nose gear wheels.

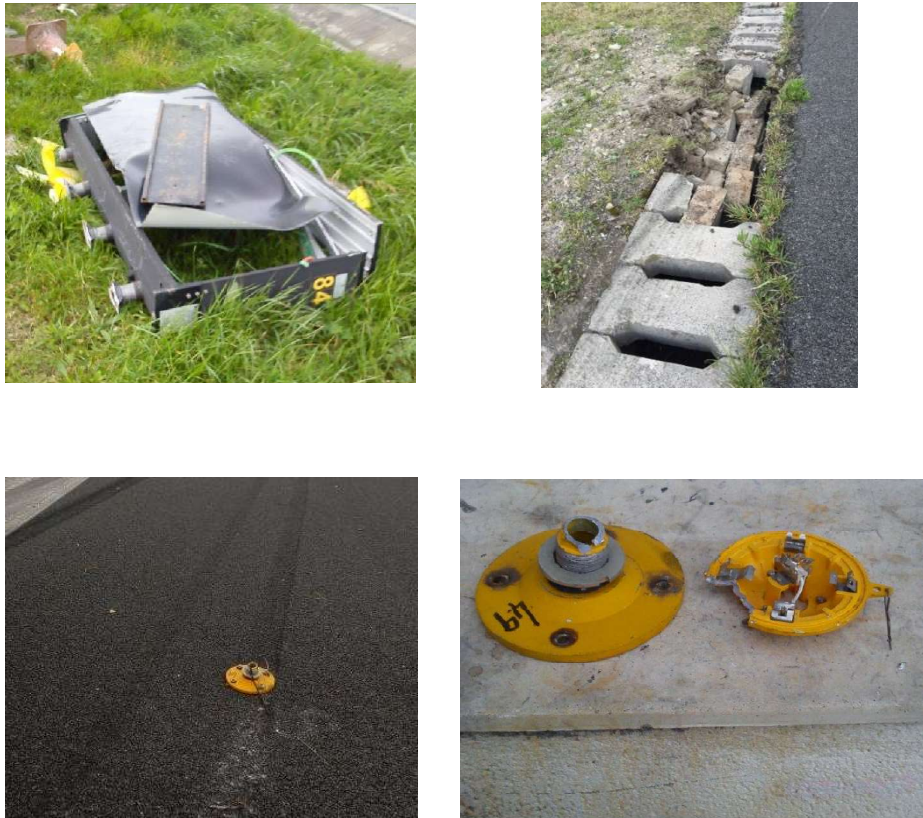
Fig. 11.- Damage to the airport

A runway edge light was broken, a sign indicating the runway exit to a taxiway was pulled out of the ground and broken, and a conduit along the runway edge was broken

In addition, as the aircraft traveled on the runway, it broke a runway edge light, a sign indicating the exit to a taxiway and part of a conduit on the runway strip.

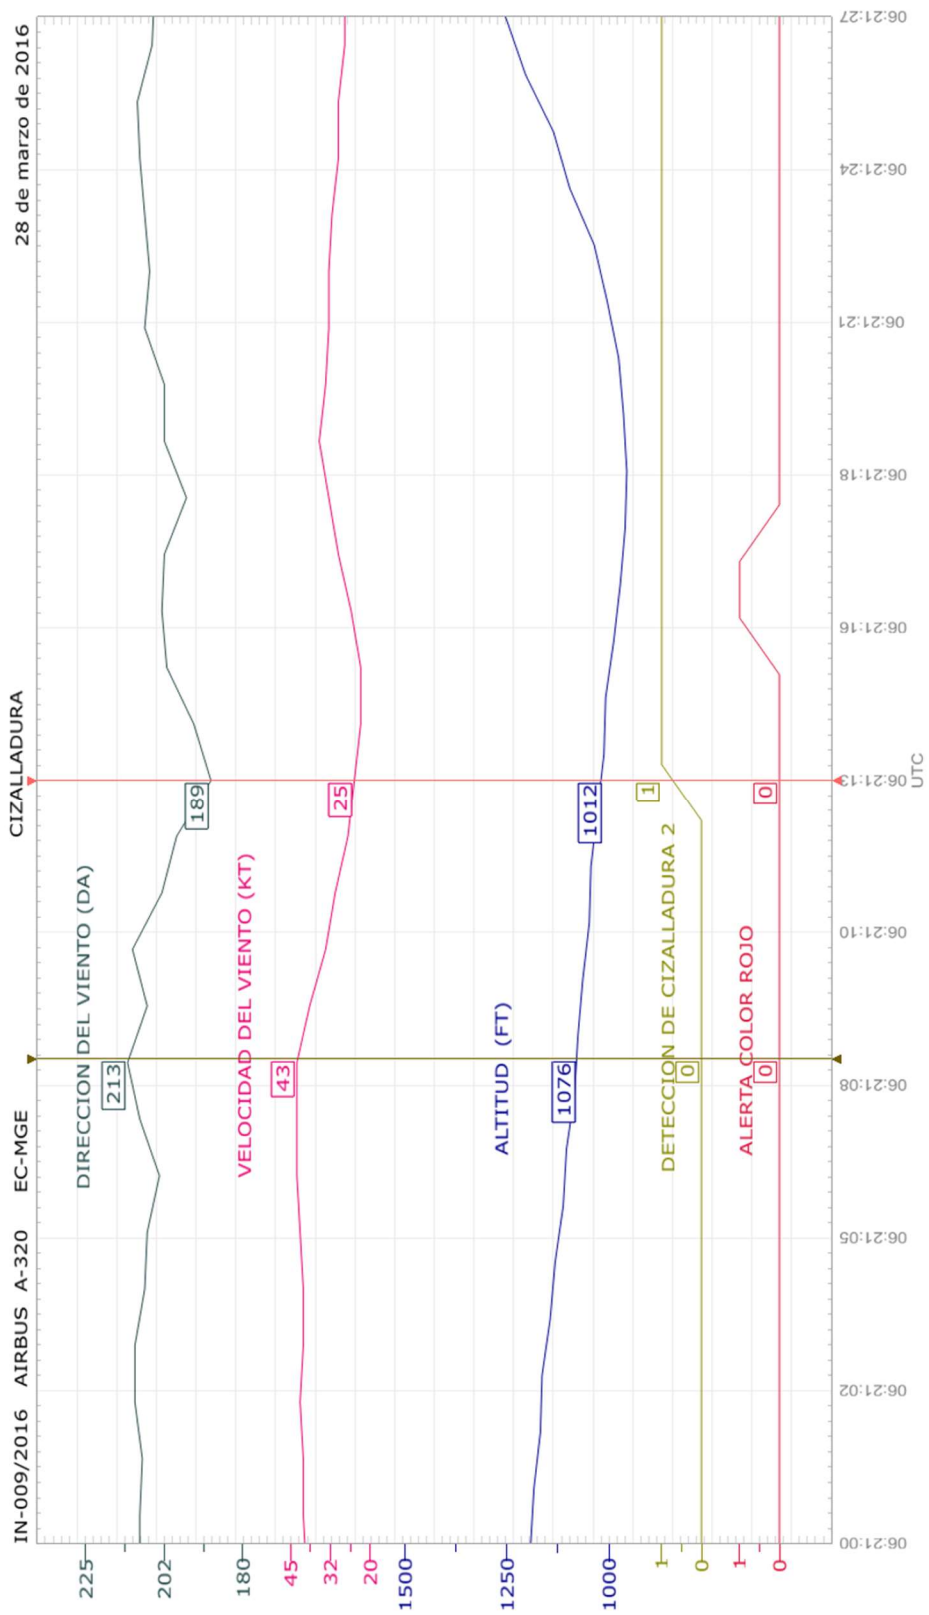
Activation of reactive windshear warning system

The graph in Appendix C shows this change in the wind along with the activation of the windshear reactive warning.

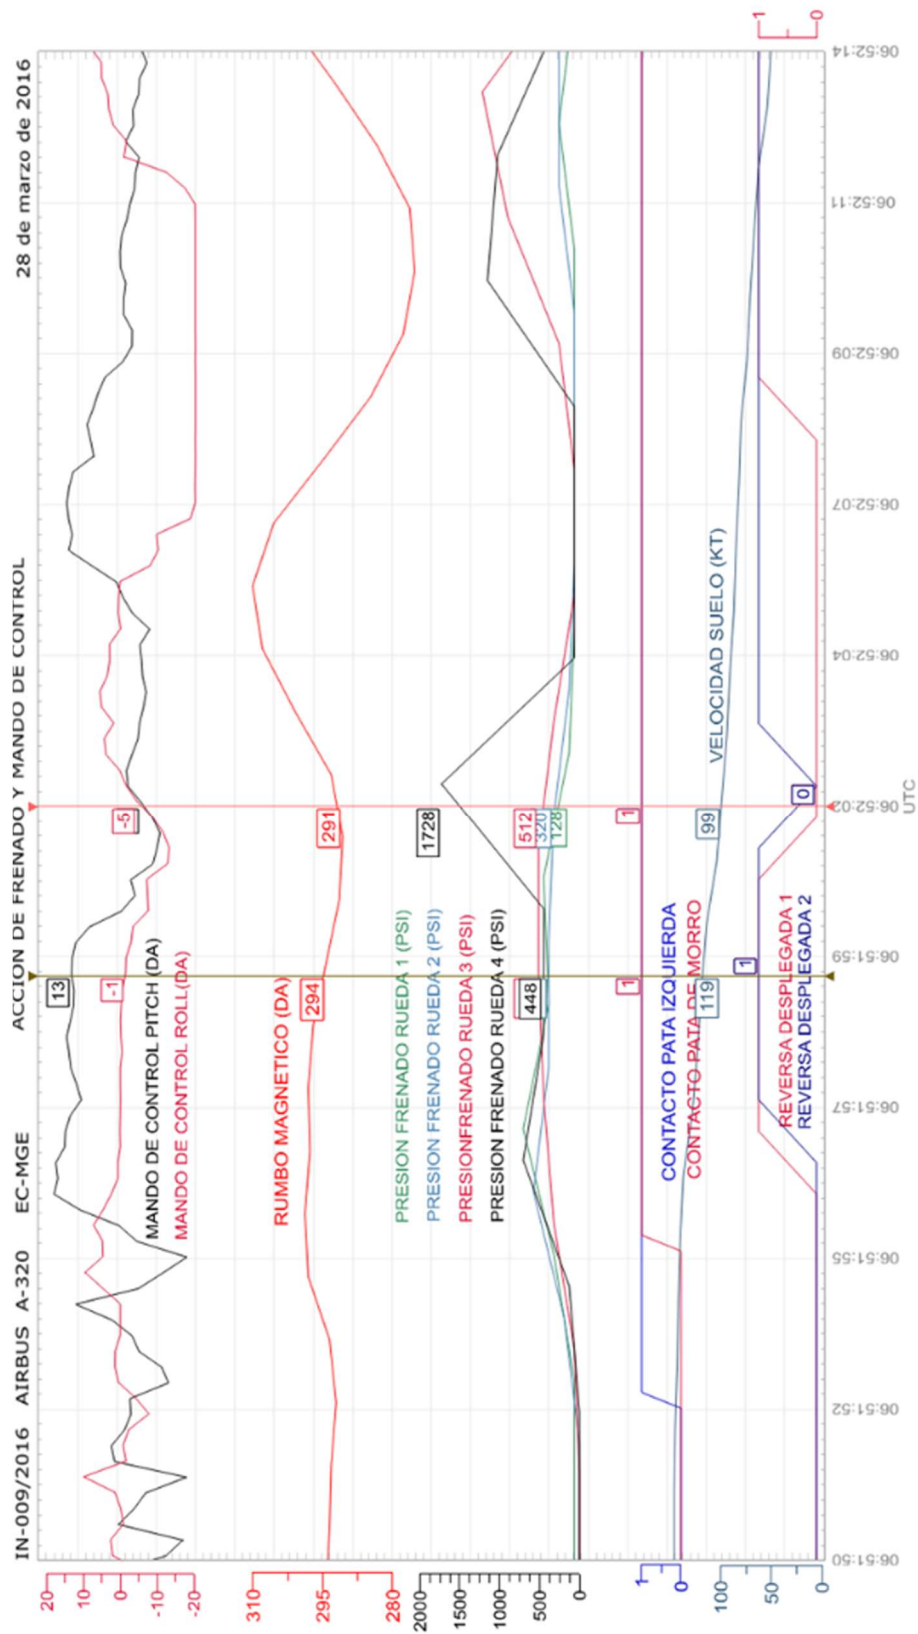
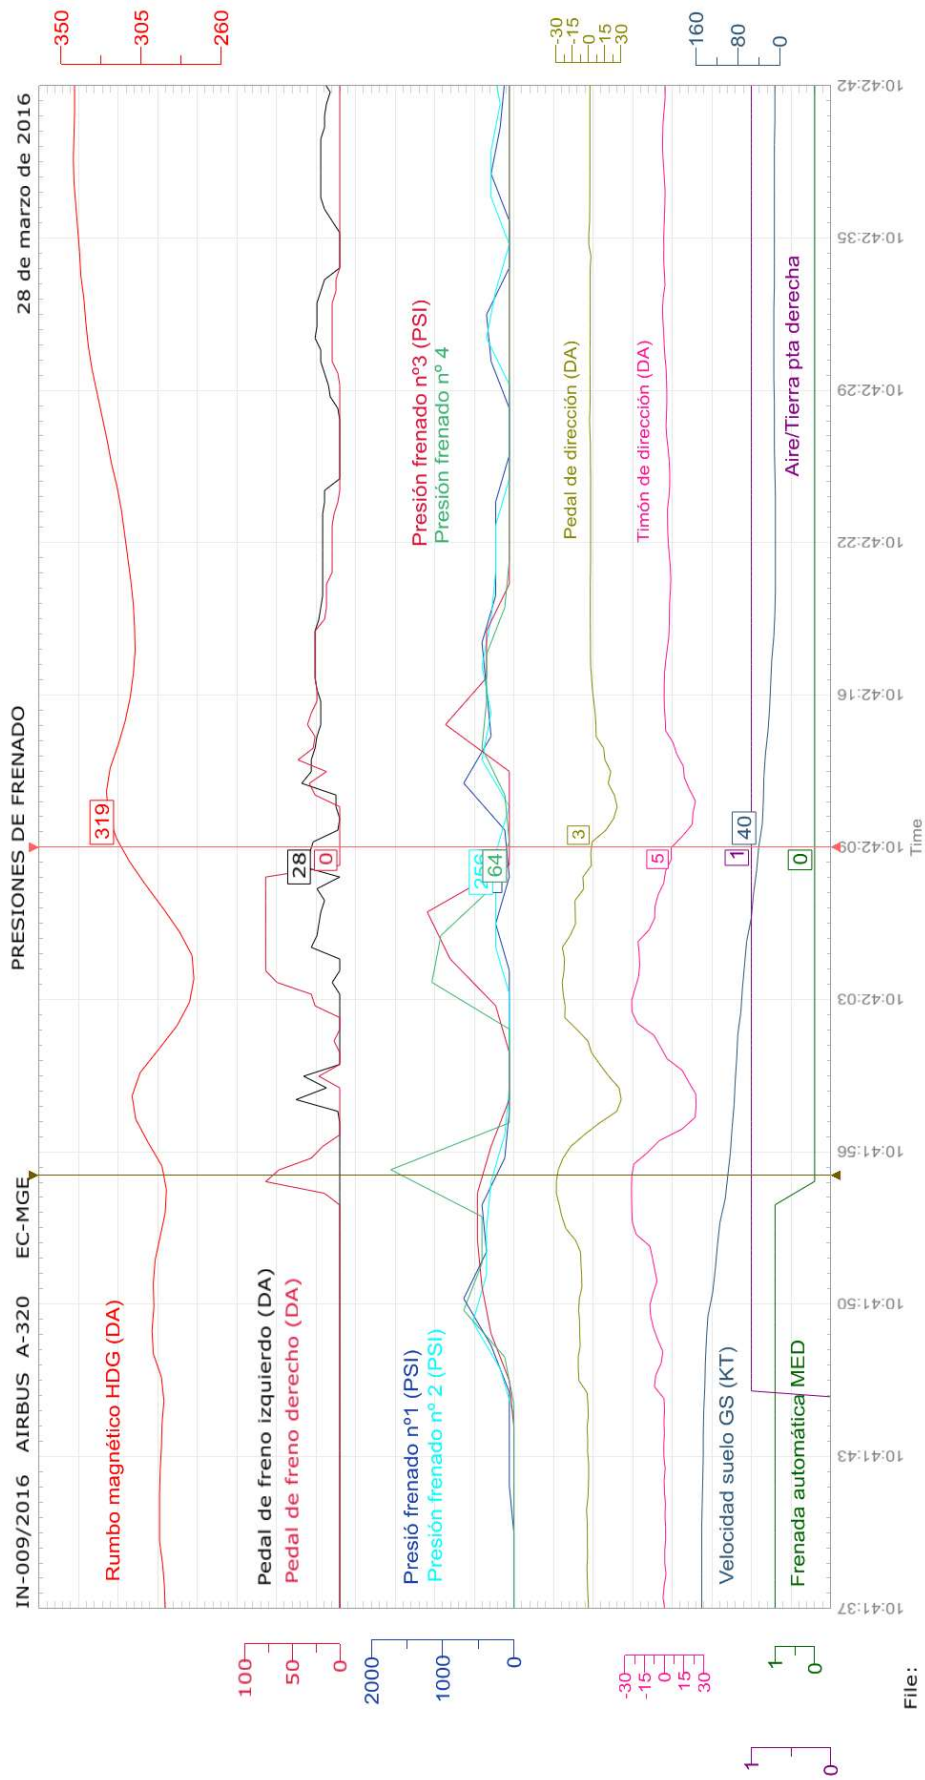
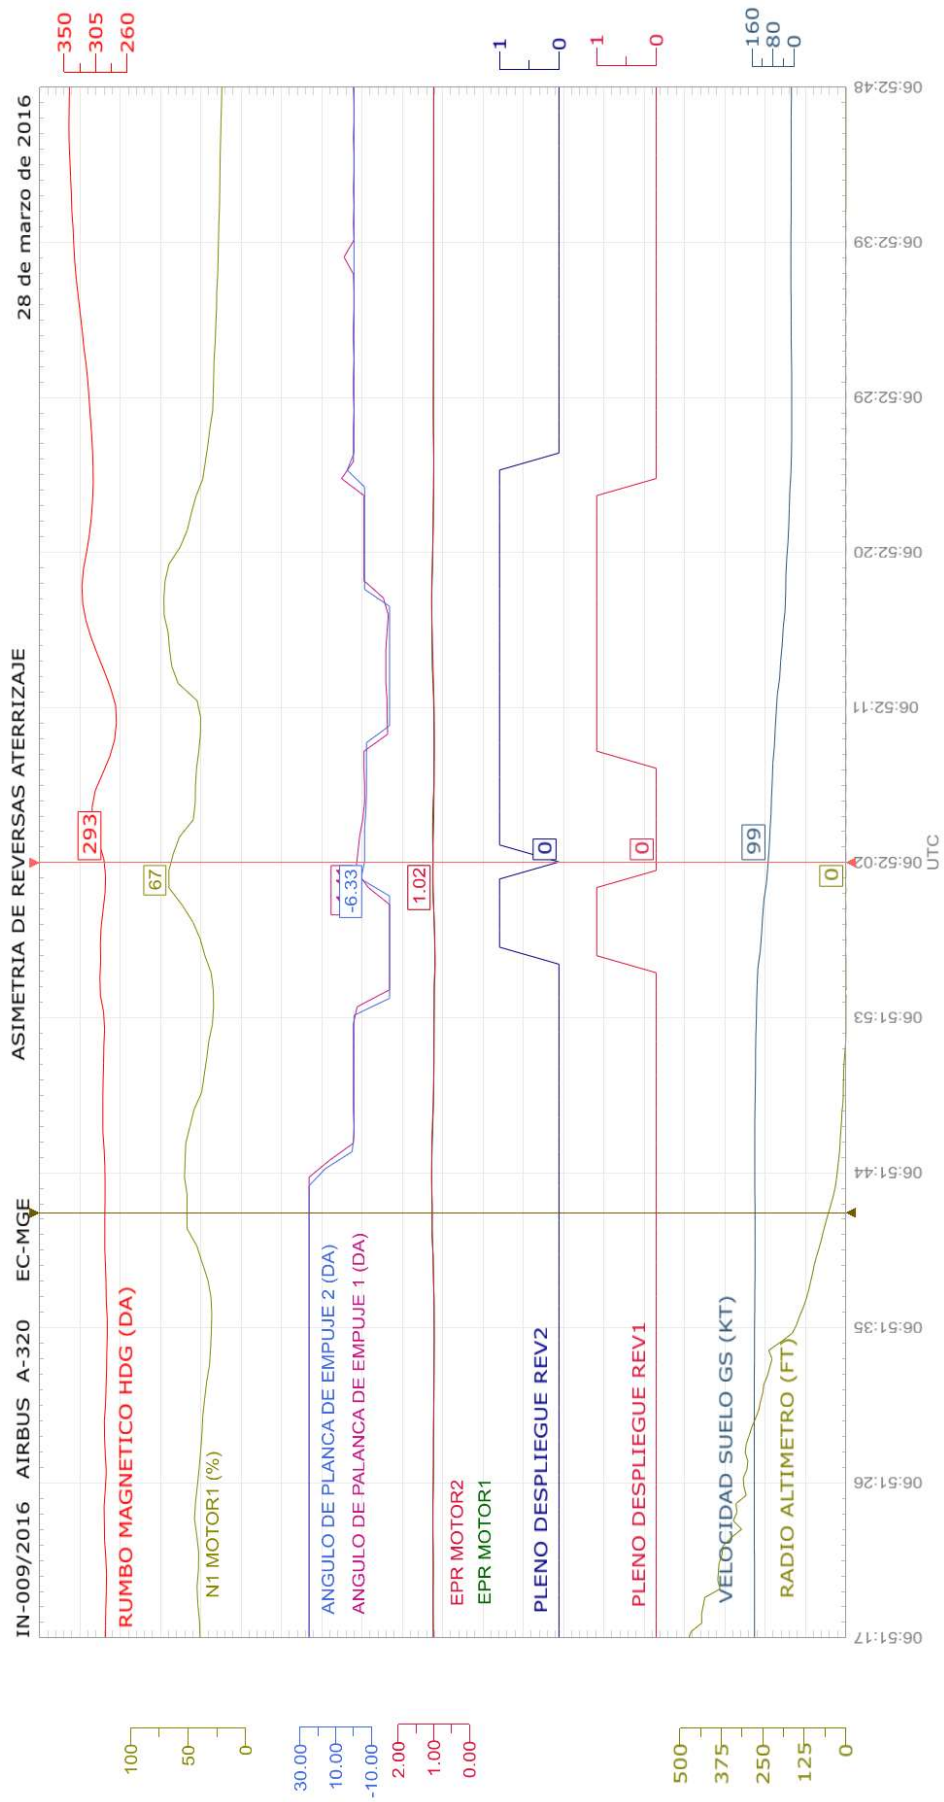
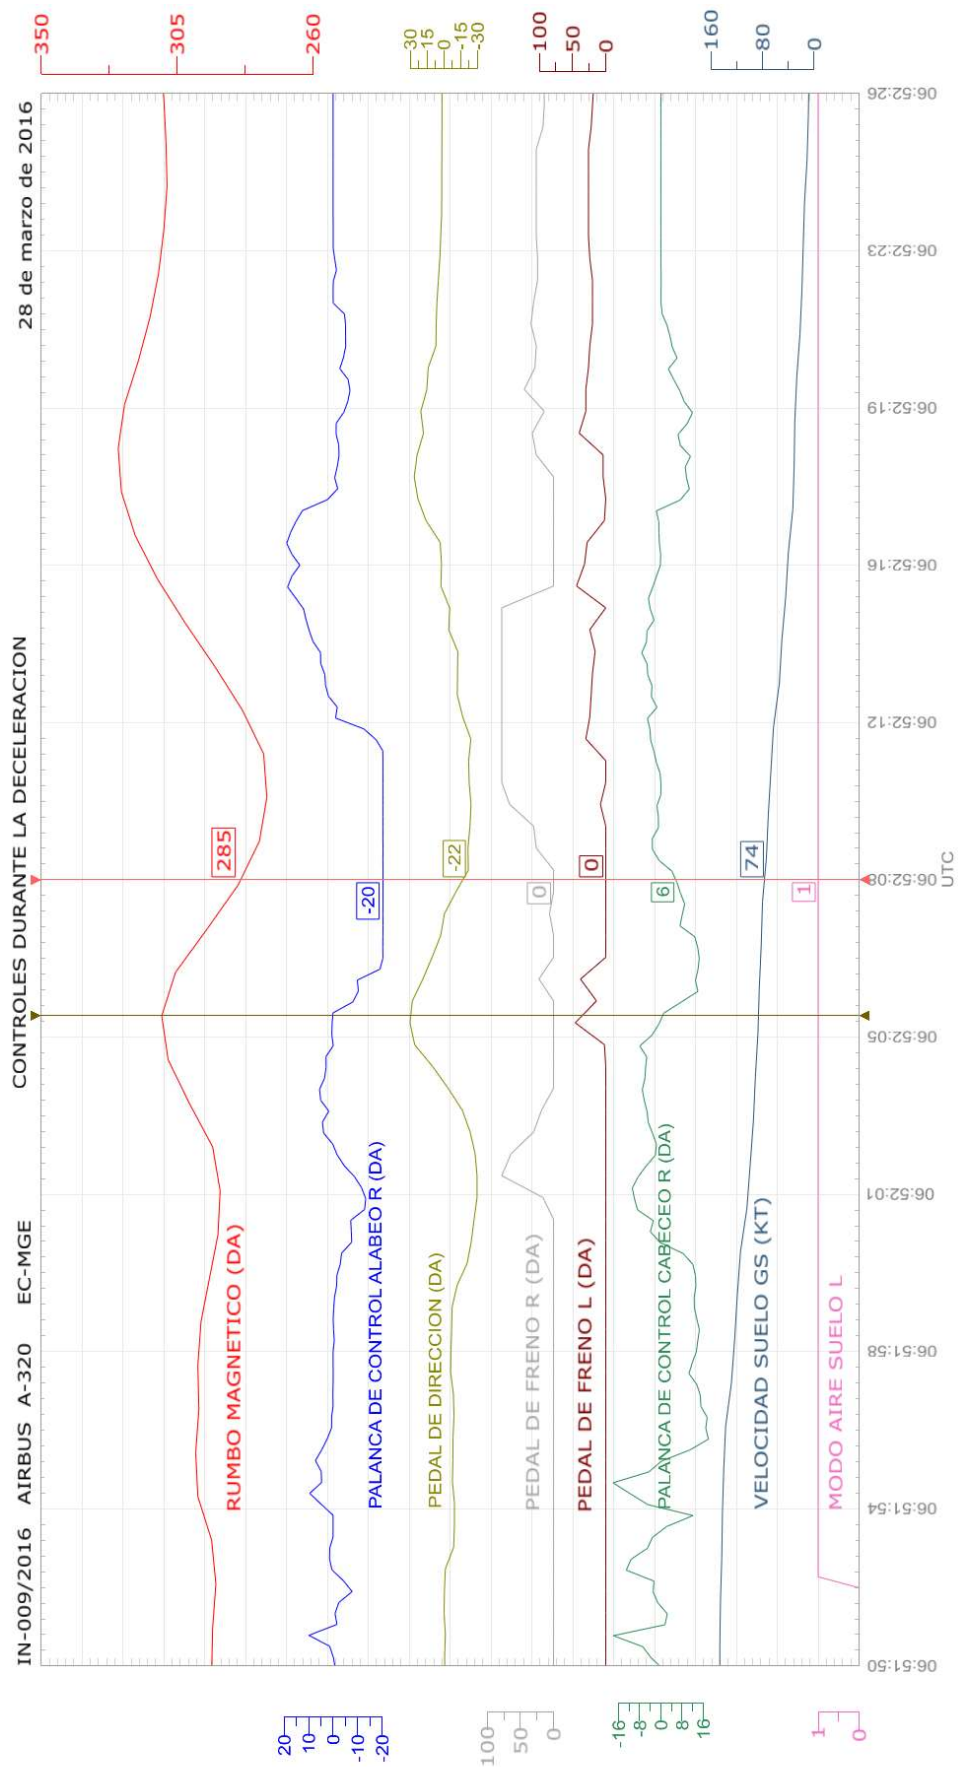
Braking action, use of reversers and side stick inputs

Appendix E contains a graph of the braking parameters, the user of reversers and the inputs to the side stick.
