## DATA SUMMARY

| Site | <b>Palma de Mallorca Airport (Spain)</b> |

| Registration | <b>EC-LAJ</b> | <b>LN-RRH</b> |
| Type and model | <b>AIRBUS A320-214</b> | <b>BOEING B-737-800</b> |

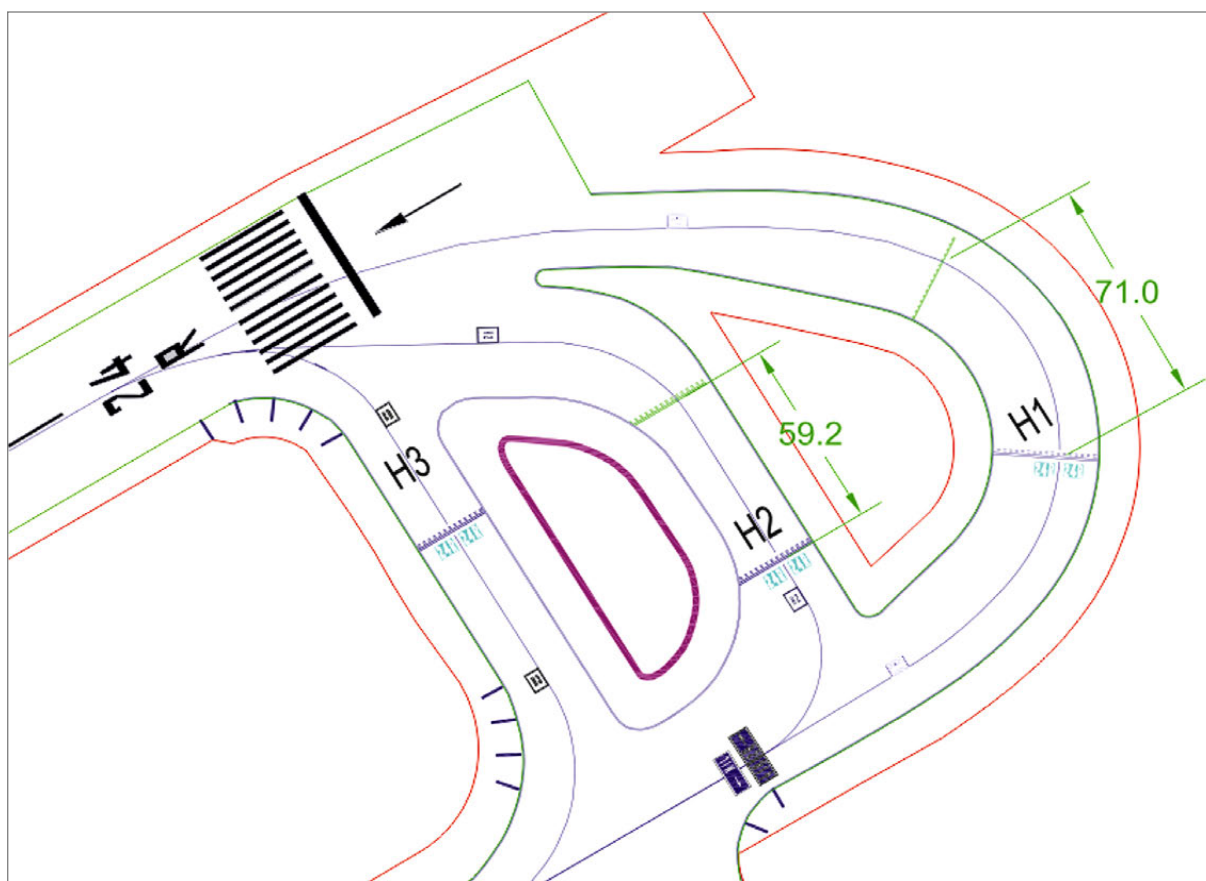
In the first half of 2007, a study was carried out to identify physical hazards at the airport. This study detected that aircraft stopped at the H-1 and H-2 holding points would violate the (obstacle limitation) surface to the runway 24R approach (the H-3 hold point did not affect the obstacle limitation surfaces). This hazard was classified as "tolerable".

Figure 2. Setback of the H-1 and H-2 holding points

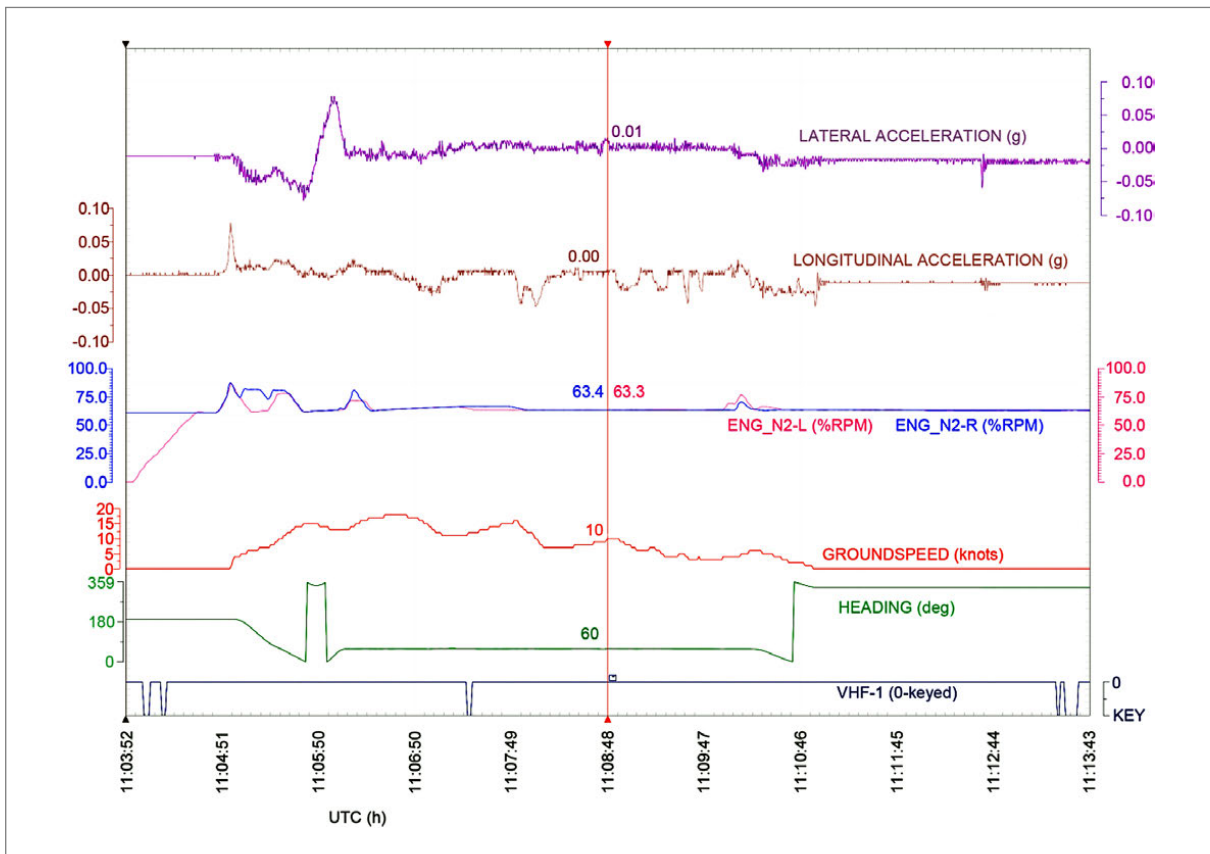
The graph in Figure 3 shows that at 11:12:37, there was a small variation in both acceleration values, though slightly greater in the lateral acceleration, possibly due to the collision between the two aircraft.

Figure 3. Trend in lateral and longitudinal accelerations, engine N2, ground speed, heading and keying of mike switch for the Airbus A320, registration EC-LAJ

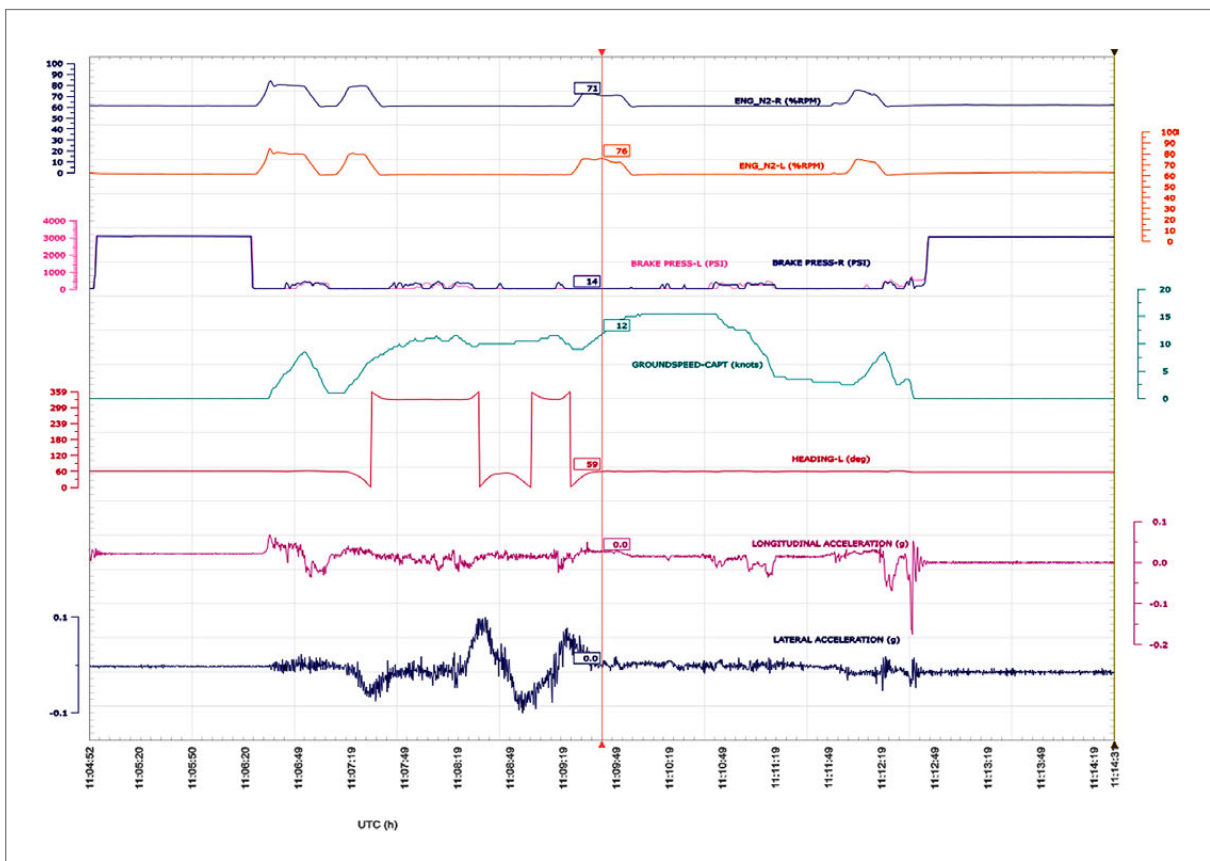
As the graph shows, the aircraft started moving at 11:06:30 UTC. The turn onto the "North" taxiway, which is the last turn to the right, was started at 11:09:19 and completed at 11:09:40. It started moving along this taxiway (heading 060), increasing in speed to a maximum of 15 kt. From 11:10:40 on, the captain applied the brakes and the aircraft started to slow, reaching a speed of 3 kt by 11:11:20 UTC.

Figure 4. Trend in engine N2, brake pressure, ground speed, heading and longitudinal and lateral accelerations for the Boeing B737, registration LN-RRH
