Air Accident Investigation Unit Ireland

INCIDENT REPORT
Boeing 737-8AS, EI-ENB
Kerry Airport (EIKY), Co. Kerry, Ireland
21 December 2010

AAIU Report No: 2012-004

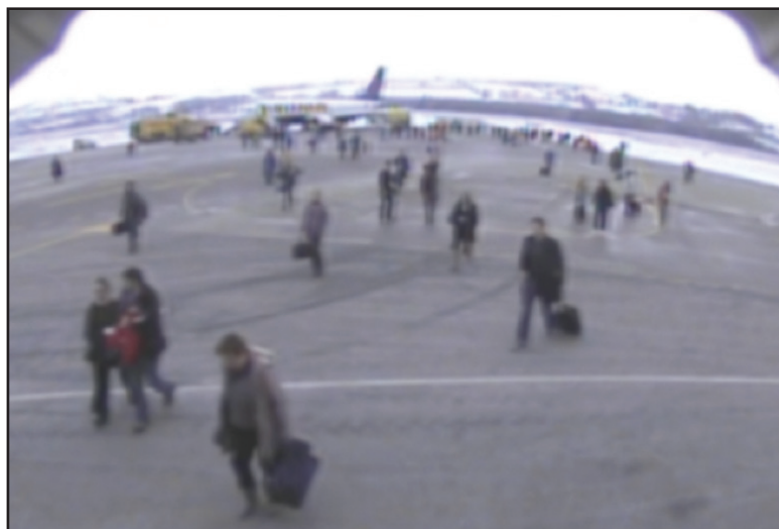
Airport security cameras recorded that the first Fire Service appliance arrived at the aircraft 22 seconds after the aircraft came to a halt. One minute and five seconds later the port doors opened, the slides inflated and passengers immediately began to leave the aircraft. The security cameras (**Photo No. 1**) recorded that a significant number of the passengers carried hand baggage as they walked towards the airport terminal building.

Photo No. 1: Passengers after emergency evacuation.

The airport CCTV recorded passengers leaving the aircraft and approaching the terminal building with hand baggage. The SCM reported that some passengers had brought their hand baggage with them during the evacuation even though they had been told not to do so in the evacuation announcement made by the cabin crew.

Passengers who take carry-on baggage off the aircraft during an emergency evacuation impede the evacuation because it restricts the evacuation flow rate, which is critical especially in the event of a fire or the suspicion of one. Furthermore, aircraft emergency slides are not designed to accommodate hand baggage and can therefore be damaged. There is also a significant risk that a passenger with hand baggage can lose balance while descending the slide and consequently suffer injury on contact with the ground. In addition, it delays the evacuee clearing away from the slide after descent. Finally, it negates the certification process that governs aircraft design and safe evacuation procedures.

The Investigation believes that the only practical option for cabin crew is to repeatedly and vigorously order passengers not to remove carry-on baggage during the evacuation.

1. The Irish Aviation Authority should require airport operators to advise pilots, via NOTAM, ATIS or VHF transmission, when urea is being used as an anti-icing agent on runways or taxiways. **IRLD201202**
2. European Aviation Safety Agency (EASA) should introduce a requirement that the CVR should continue to record in the event of power failure. **IRLD201203**
3. The International Civil Aviation Organisation (ICAO) should examine the issue of passengers taking off carry-on baggage during an emergency evacuation and provide guidance for cabin crew in such situations. **IRLD201204**
