# **Air Accident Investigation Unit Ireland**

**SYNOPTIC REPORT**

**Embraer SA, ERJ 190-200 LR, G-FBEM**

**16 October 2017**

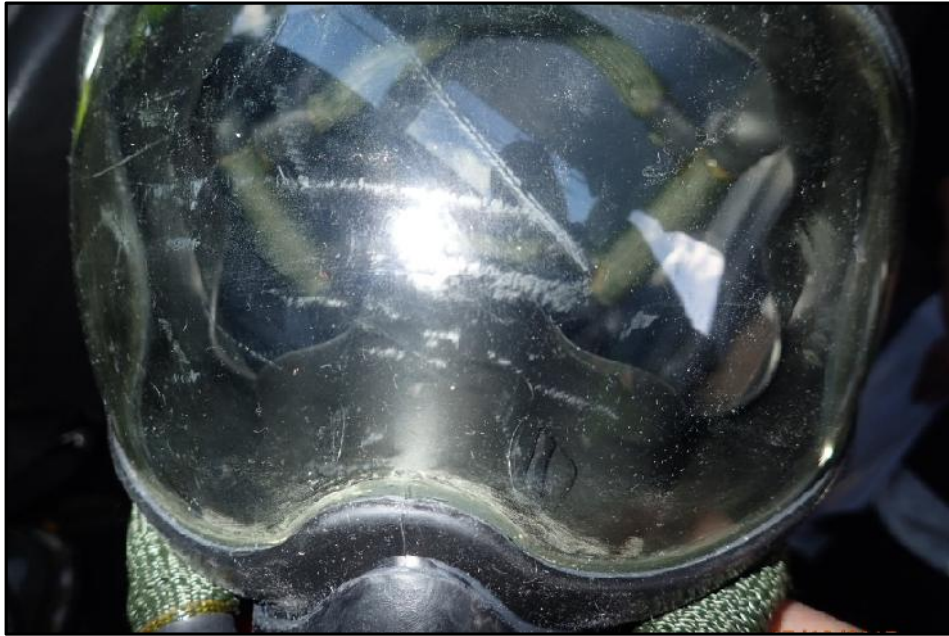
Following the event, the Investigation requested that the aircraft and the flight crew oxygen masks be quarantined at EIDW for inspection by the Investigation. Two Inspectors attended the aircraft, and in the presence of an engineer from the Operator, examined the subject masks. The visibility through the lenses of both the Commander's and Co-Pilot's masks was found to be severely restricted by scratching on the outer surface and an obscuring layer on the inner surface, **Photo Nos. 1** and **2**. Both mask regulator mode selectors were found at the 100% setting.

**Photo No. 1:** Exterior of Commander's Smoke Goggles showing scratches

Inspection of the subject masks following the event identified surface ‘*blooming*’ and scratches on the lenses of the integrated smoke goggles. A further check, carried out by the Operator, of its ERJ fleet revealed a significant proportion of masks lenses showing similar signs of ‘*blooming*’. Although the aircraft Manufacturer’s MPD calls for masks to be inspected every 3,750 flight hours, the Operator is processing a formal amendment to the (AMP) to change the inspection frequency to every A-Check. Consequently, no Safety Recommendation is made to the Operator.

Immediately following the occurrence, the Investigation requested that the Operator carry out a fleet inspection of all ERJ 170-200 STD and ERJ 190-200 LR masks. The Operator carried out a visual check of remaining lenses, and reported to the Investigation, that out of the 57 masks (the occurrence masks were not included), 17 were found serviceable, 36 required *"cleaning to remove deposits on the surface of the lens, and four required both cleaning to remove deposits, and polishing to remove scratches to the surface of the lens"*.

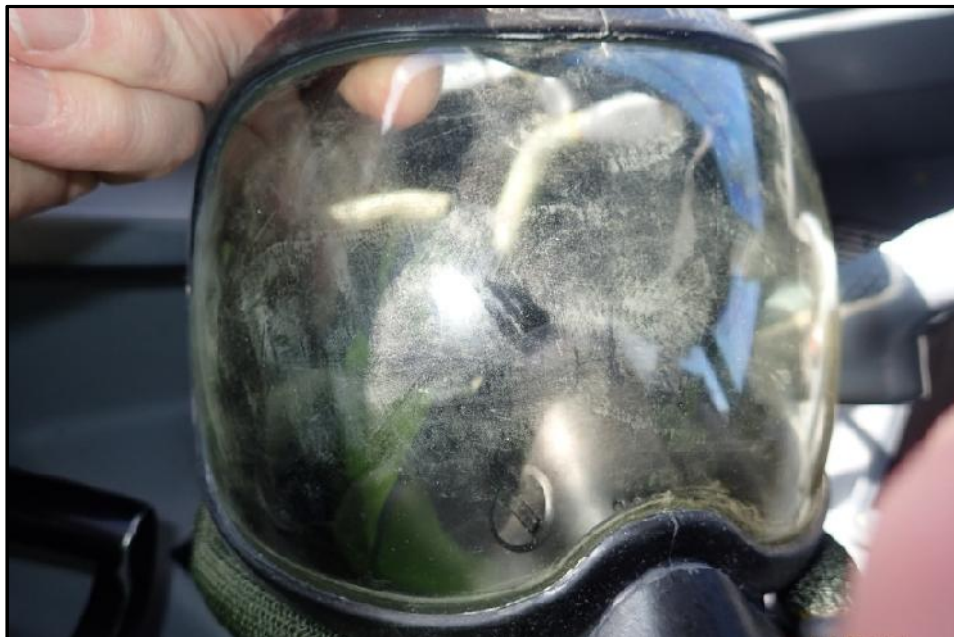
**Photo No. 2:** Co-Pilot's Smoke Goggles showing obscuring layer on inner surface

<sup>12</sup> Blooming is a condition of the lens in which additives in the base material (polymer) have migrated and collected on the surface of the lens, thereby causing a reduction in visual clarity.

*This kind of effect has been reported by some other operators as well and we have issued SIL<sup>14</sup> 1746XX-SIL-001 to inform operators about proper methods for cleaning. Additionally a training video for cleaning can be accessed through our tech publication portal. The procedure as per SIL 1746XX-SIL-001 should be performed at standard maintenance intervals or as required on condition during routine inspections.*

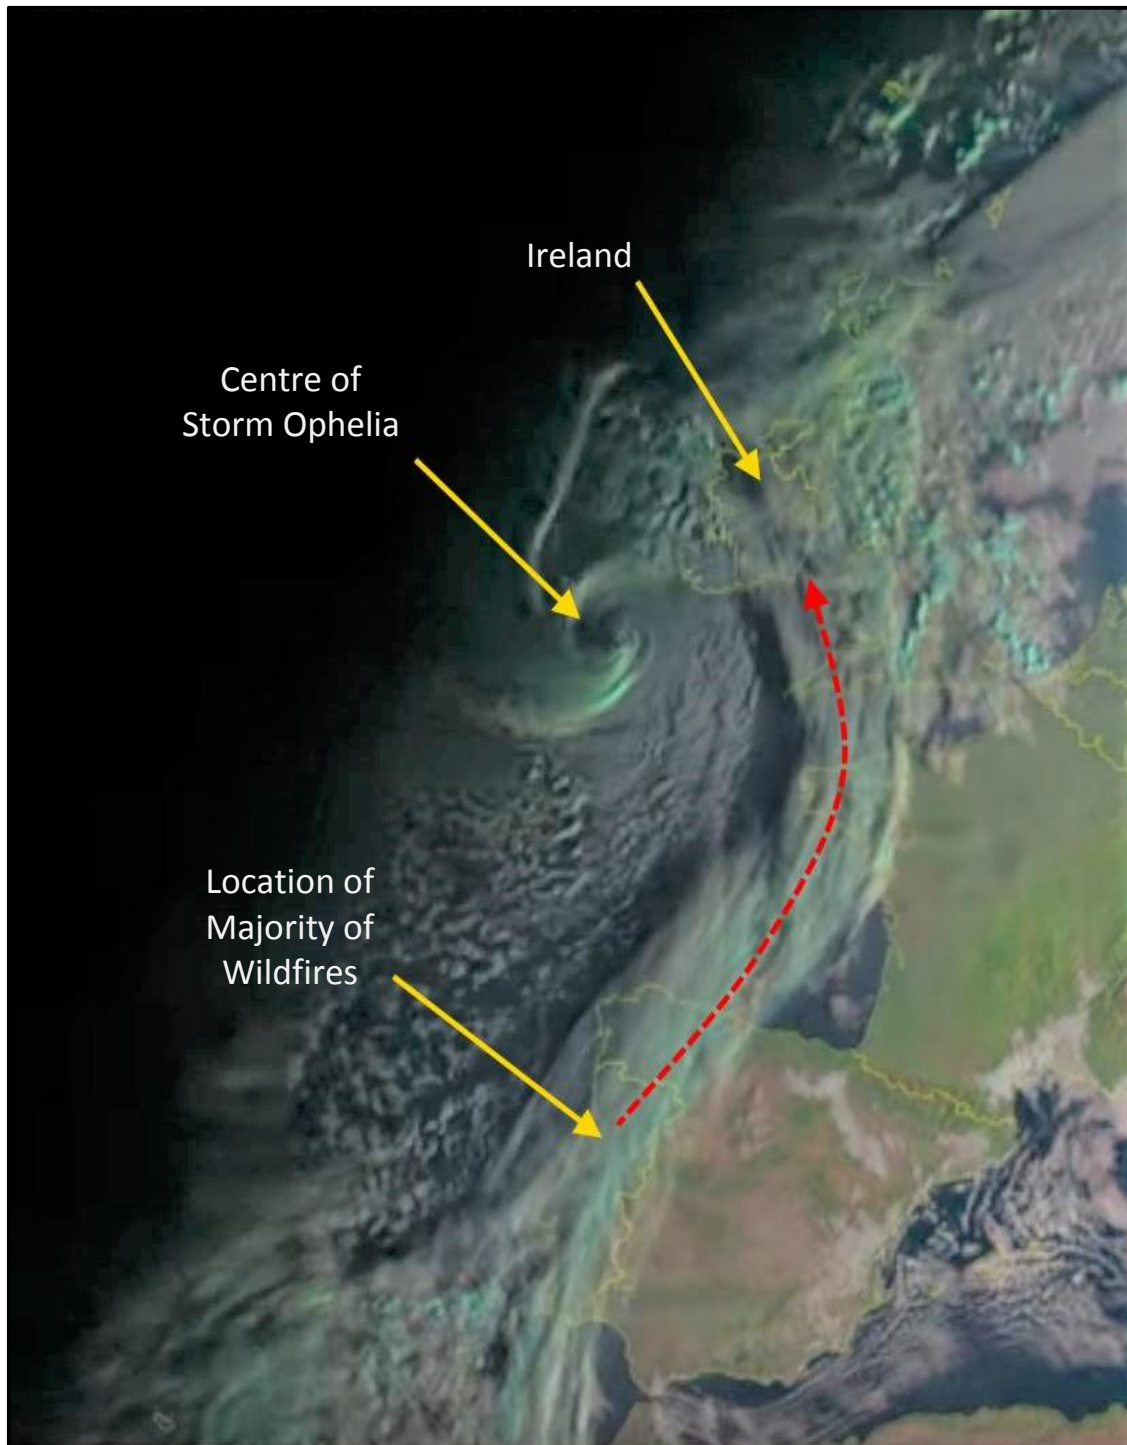
The Investigation examined satellite data available from EUMETSAT, which included an animation that showed the extent of the wildfires that were over Portugal on 15-16 October, along with the track of ex-hurricane Ophelia across Ireland and the United Kingdom. **Figure No. 2** is a screen-grab from the animation for time 07.00 hrs, on 16 October 2017, and shows the air mass containing smoke, being drawn by ex-hurricane Ophelia, from Portugal over the Bay of Biscay towards the east coast of Ireland (dashed red line).

**Figure No. 2:** Satellite image showing path of air (dashed red line) containing smoke from wildfires.

The meteorological conditions on the day of the occurrence were such that smoke from wild fires over the Iberian Peninsula was drawn over the east coast of Ireland and the United Kingdom. In the Dublin area the smoke-laden air appears to have been present in the atmosphere, from approximately 7,000 ft to near the surface. It was this air that the subject aircraft entered as it left the holding pattern and began its approach into EIDW.
