# Accident Investigation Final Report

**State File Number:** A13940723EPMNE  
**Type of Occurrence:** Accident  
**Date of Occurrence:** Oct. 15<sup>th</sup> 2015  
**Place of Occurrence:** Near Mehrabad Airport  
**Aircraft Type:** B747-300  
**Registration:** EP-MNE  
**Operator:** Mahan Air

Date of Issue: 10 Oct 2016

**Final Report**

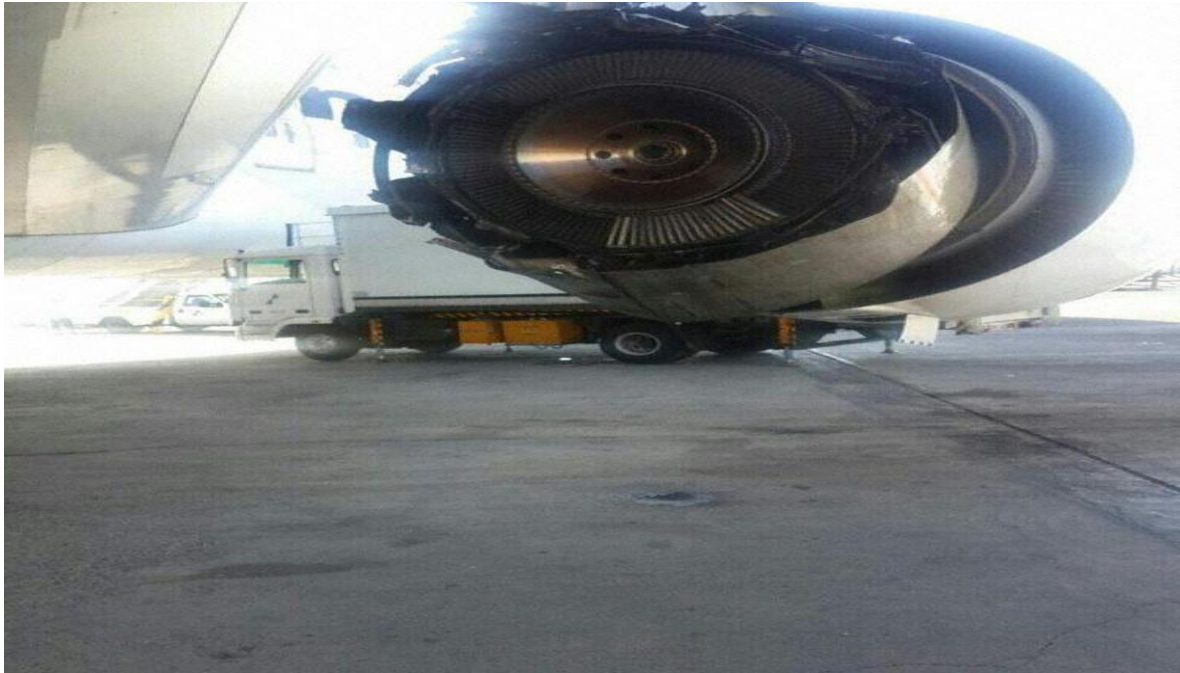
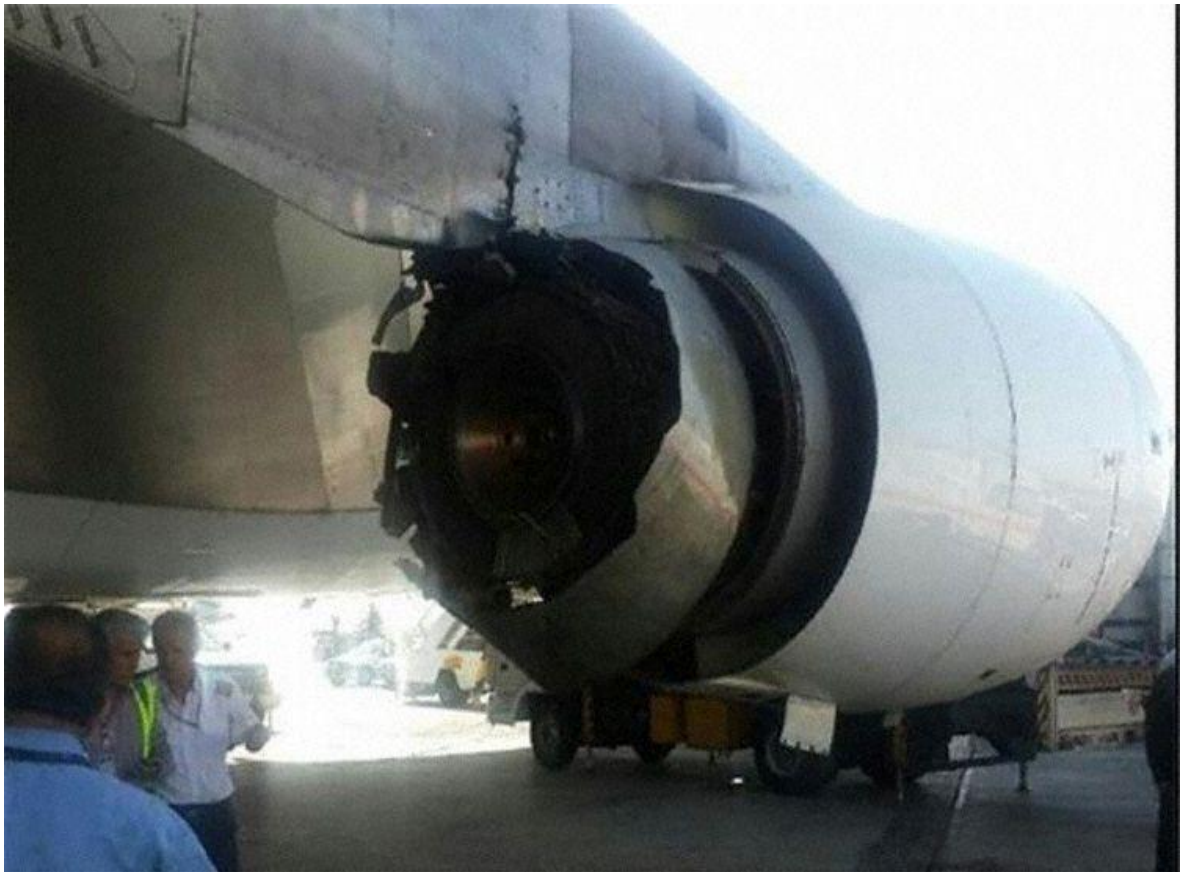
Onboard Damaged Engine

The main damage on ENG#3 " REAR ,LOW PRESSURE TURBINE " was completely detached and as a result the engine exhaust section was detached and fell into livestock ( TEHRAN SUBURB ) and about 10 KG. of engine parts were gathered from it .

Some of ENG#3 detached parts hitting ENG#4 and damaged it

Some of ENG#3 detached parts hitting the aircraft fuselage and caused some significant damage and some hydraulic lines were damaged.

The right hand wing inner was damaged and consequently the related fuel tank was damaged and almost 10 tons of fuel was leaked overboard.

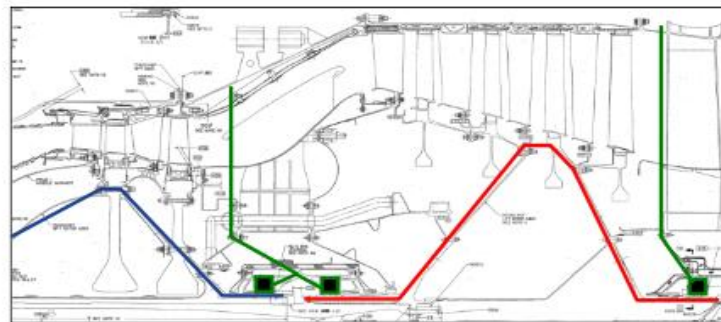
High HPTR imbalance causes secondary vibratory damage in the LPTR

Loads are transmitted between the HP and LP systems through a common sump (#5R & 6R bearing sump)

HCF crack initiates/propagates in LPT S3 disk forward spacer arm

Continued engine operations can lead to 360° crack and separation of LPT

The main related AD is 2012-02-07 which consists of following procedures to detect failures and preventative actions:

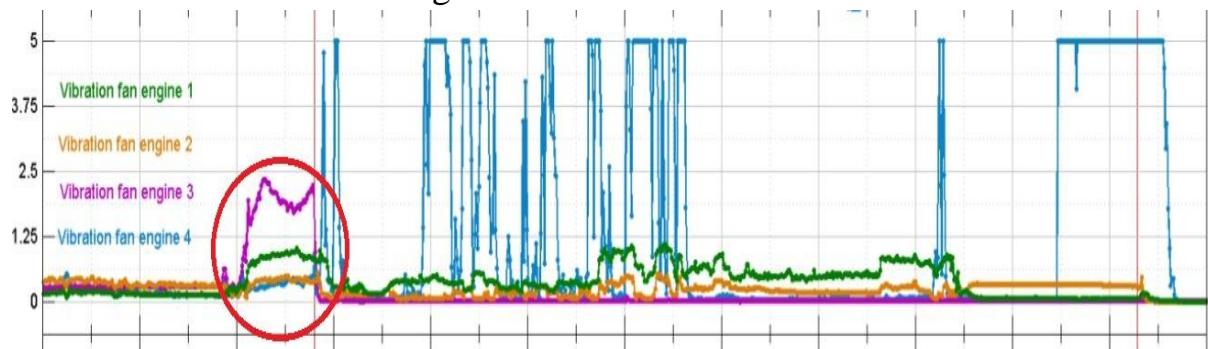
- From this time, engine #3 parameters N1 ENG#3, Engine 3 Fuel Flow, Vibration fan engine #3 and Vibration N1 ENG#3 are recorded to zero until the end of the flight

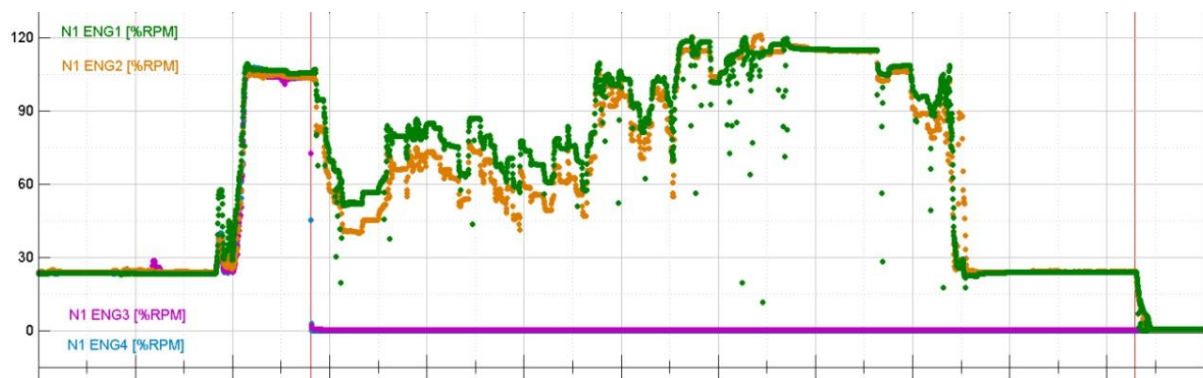
- Parameter EGT3 is recorded at about 983 until the end of the flight

*All engines N1 variation (loss of N1 in Eng#3&4 is obvious)*

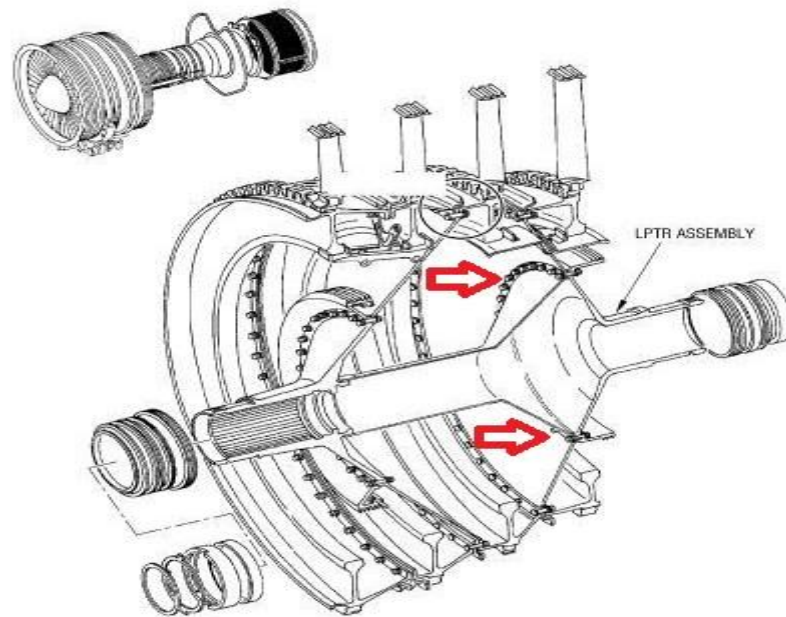
*Cut away illustration of CF6-50 LPT disk#3 Location*

Because the LPT rotor spins rapidly, detachment of Disk#3 from its axis by centrifugal force resulted in radial propagation of defragments with high velocity. Therefore, LPT stage#3 is completely detached from the engine. Figure illustrates the LPT stage 3 with red arrows.

This damage led in complete loss of thrust in engine#3.

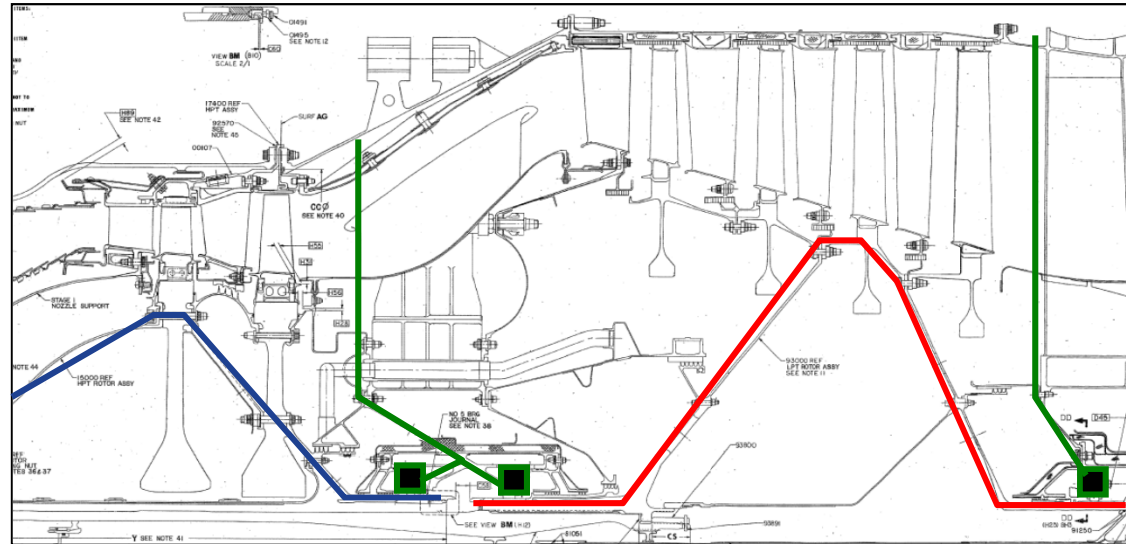
# Root Cause

High HPTR imbalance causes secondary vibratory damage in the LPTR

Loads are transmitted between the HP and LP systems through a common sump (#5R & 6R bearing sump)

HCF crack initiates/propagates in LPT S3 disk forward spacer arm

Continued engine operations can lead to 360° crack and separation of LPT
