## Investigation report

L2014-01

# Experimental Aircraft Accident and Risk of Explosion at Nummela Aerodrome on 27 March, 2014

OH-XAC

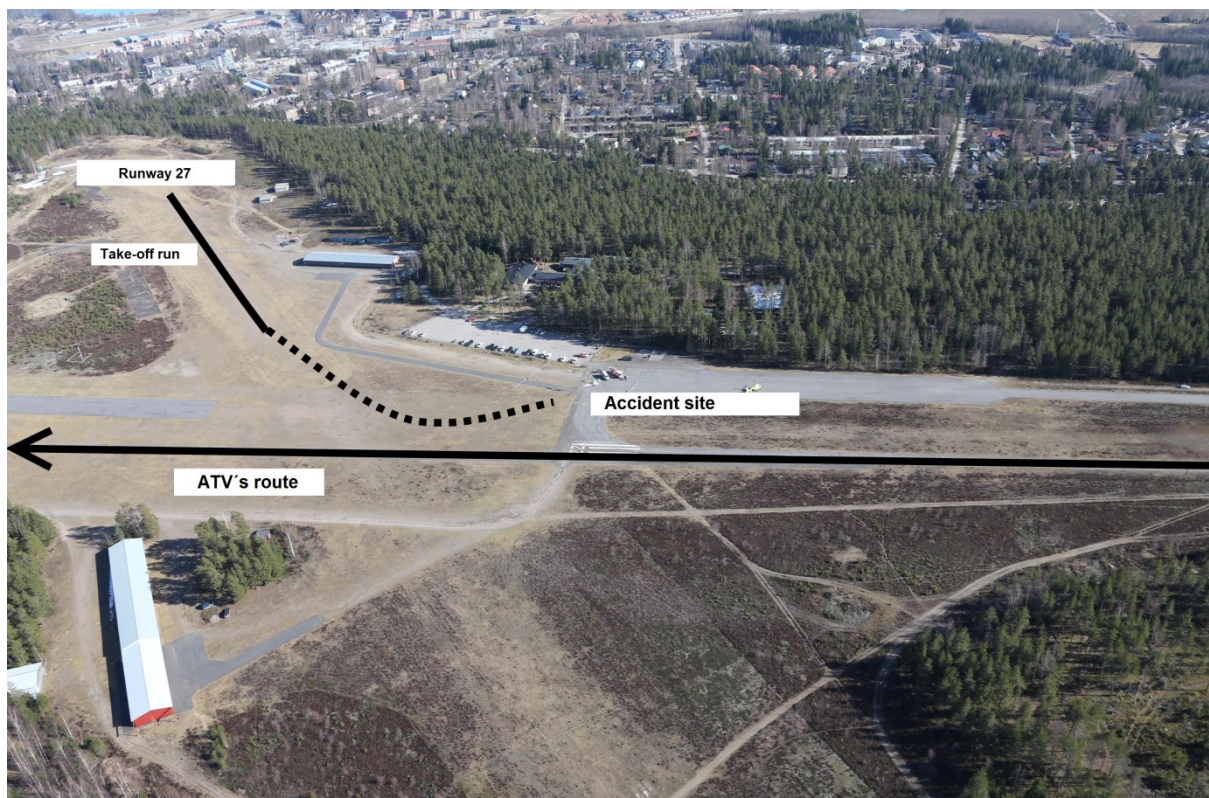
Figure 1. The grass-surface cross runway 09/27 at Nummela aerodrome, viewed from the west. The accident site, where the wreckage and rescue vehicles can be seen, is in the centre of the photo. The black dotted line represents the flight path of the aircraft, drawn as per eyewitness accounts. (Photo: Finnish Border Guard)

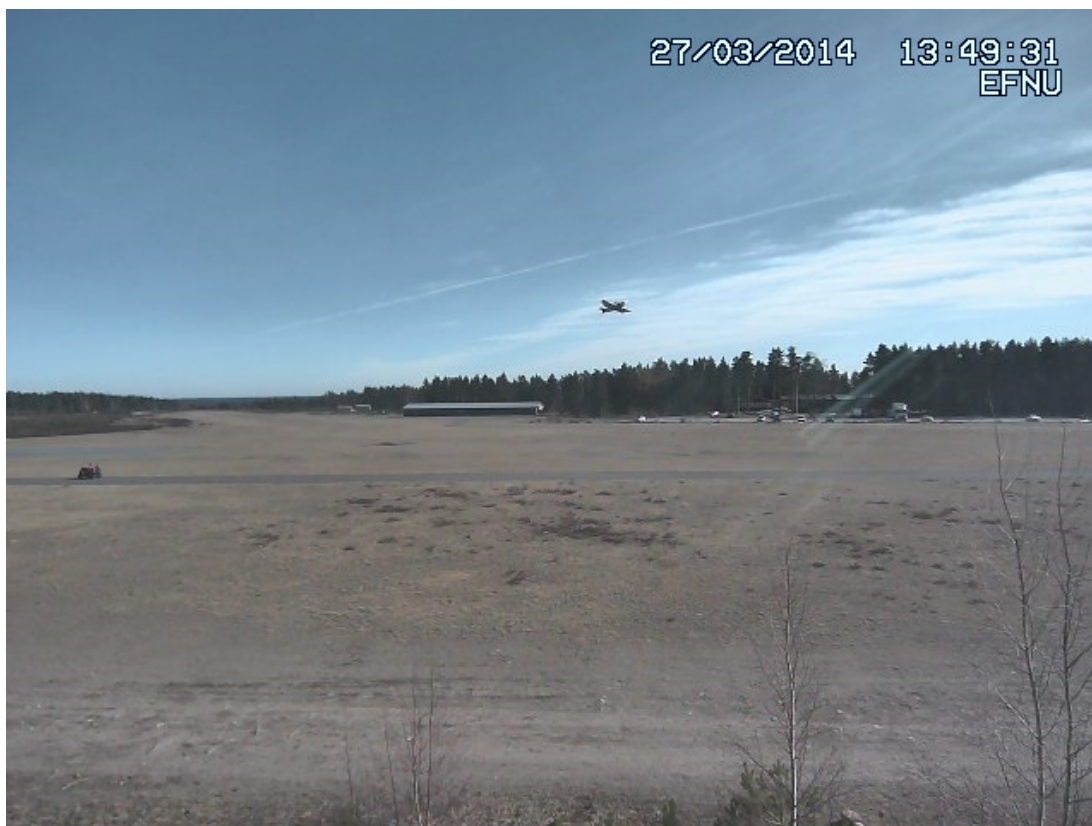
*Figure 2. OH-XAC on the accident flight immediately after takeoff at the onset of the turn, only seconds before the accident. The all-terrain vehicle at the left is the ATV used by paragliders. A moment before the photo was taken the ATV crossed the runway (Photo: Nummela flight centre webcam).*

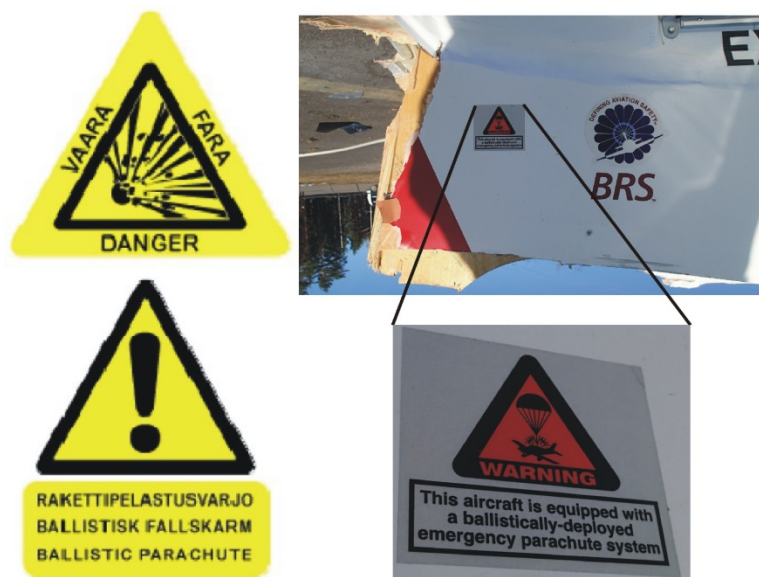
Although an airworthiness inspection was carried out on the aircraft prior to the commencement of the test flights, the markings that warn of the presence of a pyrotechnical system did not comply with Airworthiness Directive M/3102/06.

Figure 4. There is a BRS system warning decal, approximately 50 mm wide, on the right side of OH-XAC. On the left side there is a warning decal which complies with directive M3102/06, requiring a 120 mm wide decal. There was no marking on the accident aircraft which indicated the location of the rocket motor assembly. (Photos: SIAF and Finnish Transport Safety Agency).

The accident aircraft only displayed the manufacturer's decals warning of the presence of the system; they did not guide the rescuers to operate in such a fashion that the hazard would have been taken into consideration. Although the airworthiness inspection had been completed prior to the start of the test flight programme, the markings did not comply with Airworthiness Directive M3102/06.

The markings that comply with Finnish requirements are larger than those on the accident aircraft. They also indicate the hazard more clearly. For example, they would have made it possible to identify the loose suspension lines of the parachute or the activation handle inside the wreckage. However, this would have required training. Generally speaking, it is difficult to recognise the presence of pyrotechnical system in an aircraft or identify its parts because so many variations exist. Moreover, warning markings and practices are not internationally standardised.

*Safety Investigation Authority, Finland recommends that the European Aviation Safety Agency (EASA) standardise the warning markings for pyrotechnical systems.*

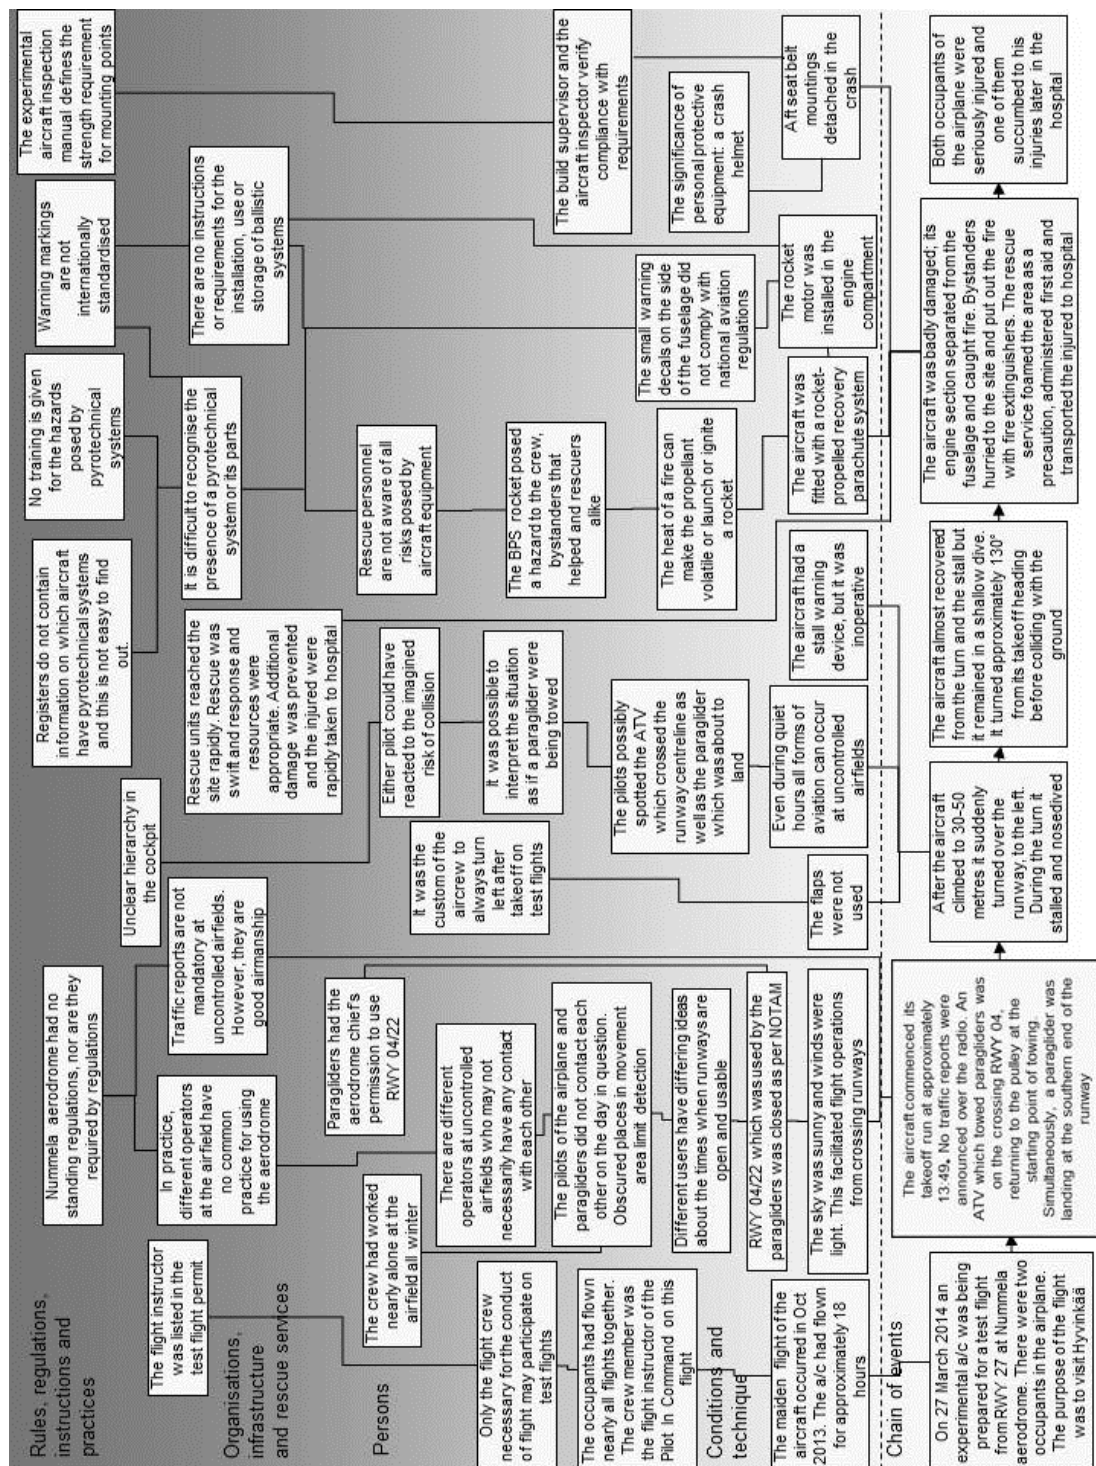
Figure 5. An AcciMap graph drawn during the investigation.
