## ***Final report RL 2017:03e***

**Serious incident at Gällivare Airport on 6 April 2016 involving the aeroplane YR-FZA of the model F28 Mark 0100, operated by Carpatair.**

File no. L-33/16

9 March 2017

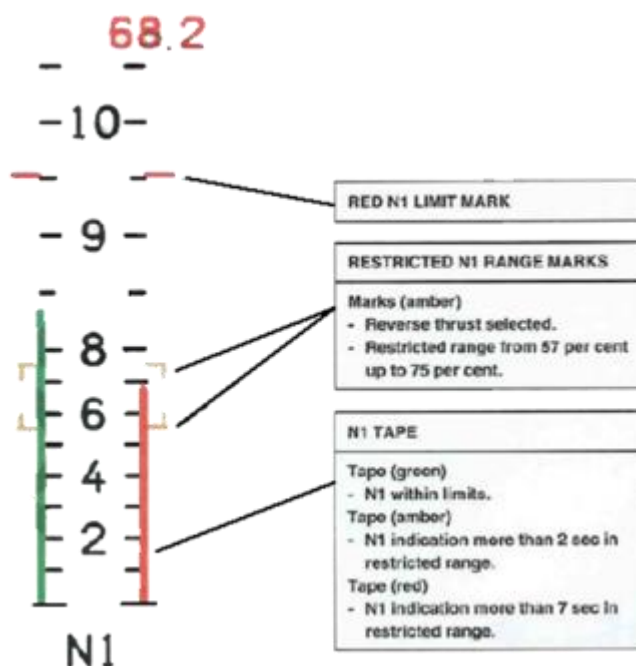
There is a time limitation during reverse in the rpm range between 57 % and 75 % N1, which is indicated with amber brackets on the engine instruments (figure 4 below).

Figure 4. The amber brackets for the engine's rpm indicate the restricted N1 range. Extract from Fokker flight manual.

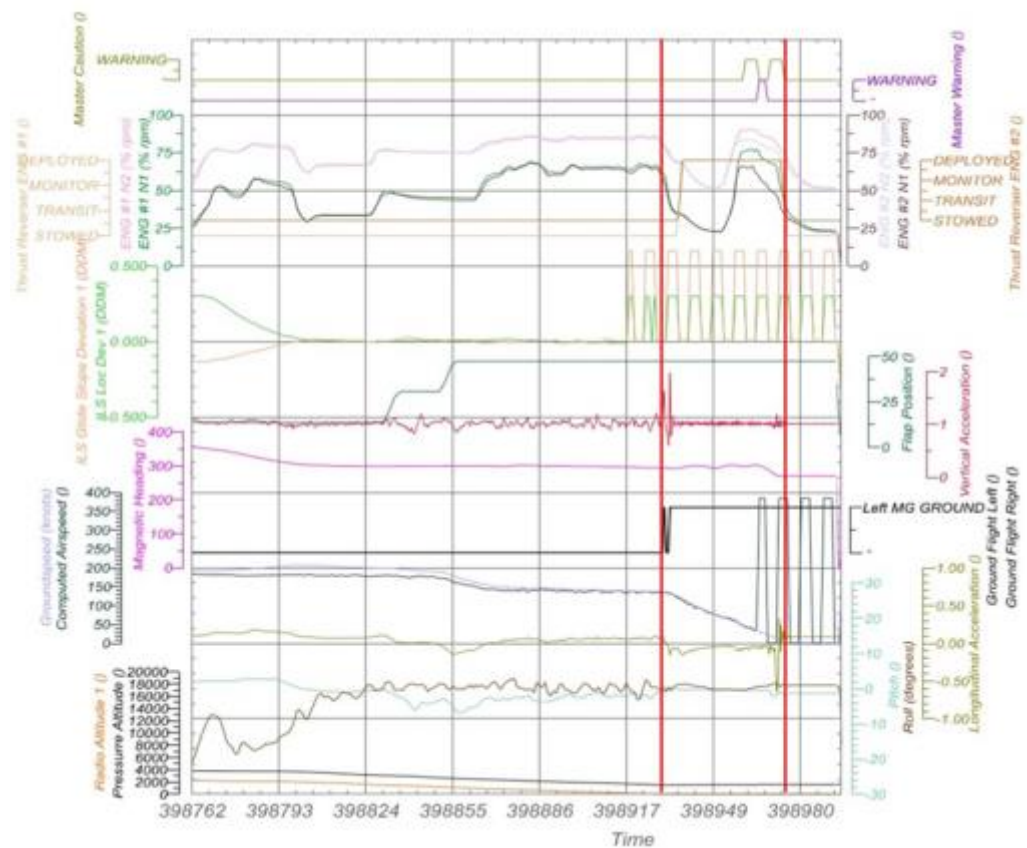
The left red vertical line corresponds to the first touchdown while the other line indicates the time of the complete stop. The time span between the lines is about just over 40 seconds.

Figure 6. DFDR-data printout.

DFDR-data indicate that the longitudinal acceleration during the rollout averaged -0.07 G until the reverse rpm started to increase. This indicates that the wheel brakes had no effect during period, which either might be caused by the absence of brake application, or by a very low friction coefficient. The pilot's statement that the brake temperature indicated low values after landing is also indicates that the wheel brakes had no effect.

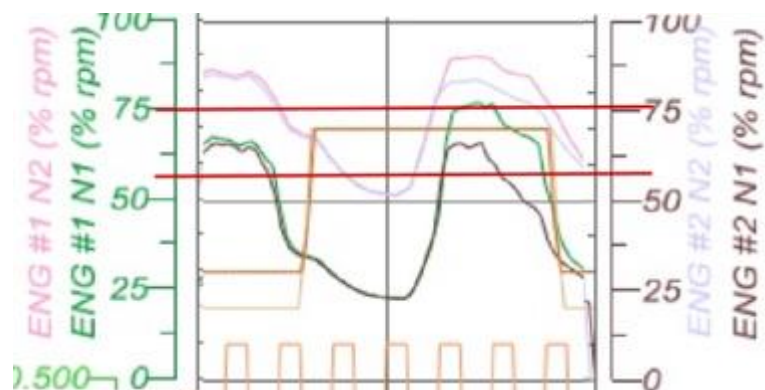
However, DFDR-data indicates that the reverse thrust increased from low idle only 20 seconds after touch down at a speed of about 50 knots. Thereafter the reverse rpm increased to about 75 % on the left engine and 65 % on the right engine.

Figure 7 below is a partial enlargement of figure 6 and displays rpm in % N1 for left and right engine respectively (ENG #1, ENG #2), in green and brown colour. The red horizontal lines indicate the restricted area as described in section 1.6.2.

Figure 7. Detail of DFDR-data printout for engine parameters.

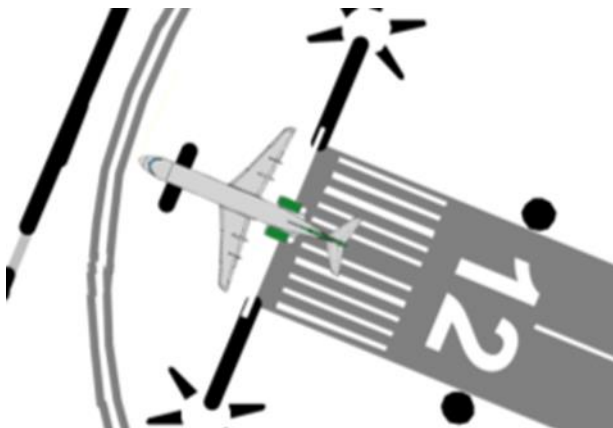
The occurrence took place at the end of runway 30 at Gällivare airport. The aeroplane came to a complete stop on the runway strip. The area was covered by snow.

Figure 8. The aeroplane's position after the excursion.

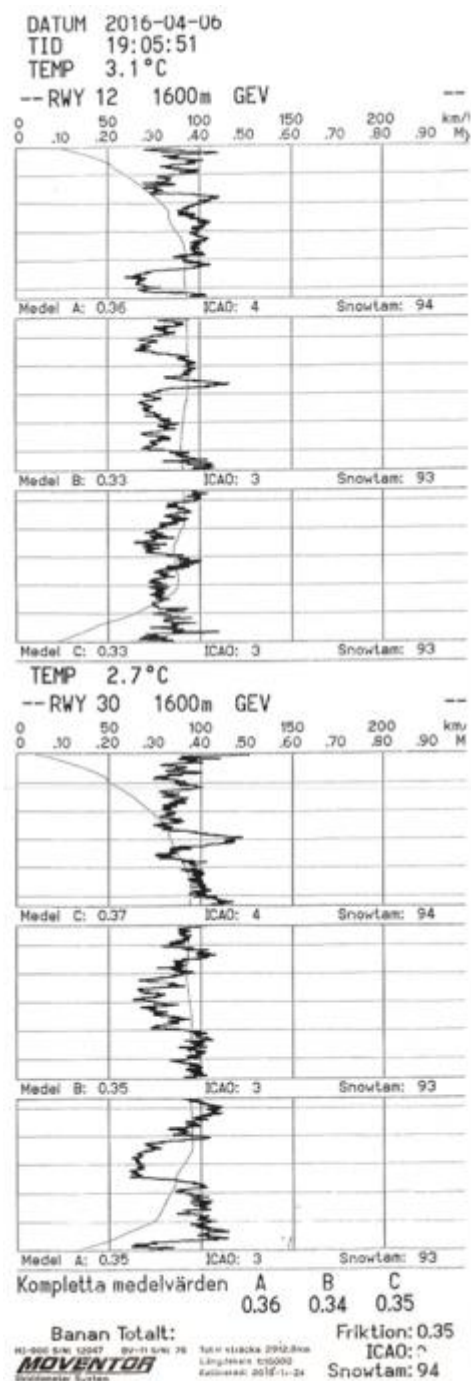
The measurement protocol below (figure 15) shows the last measurement prior to the event. The bold line shows the friction values for both runway directions.

The thin line shows the vehicle speed in km/h. The best possible reliability is achieved at a speed of 95 km/h. As the vehicle needs acceleration and braking distance at each runway threshold, the entire runway cannot be measured with a speed of 95 km/h, which results in a deterioration of the measurement accuracy. As the touchdown zone starts about 300 meters after the threshold, less than half of the first third of the measurement is usable.

Figure 15. Measurement protocol with friction coefficients from Lapland Airport.
