## **INTERSTATE AVIATION COMMITTEE**

#### **FINAL REPORT**

| Type of aircraft | Airplane, Boeing 737-500 (53A) |
| Registration | VQ-BBN (Bermuda) |

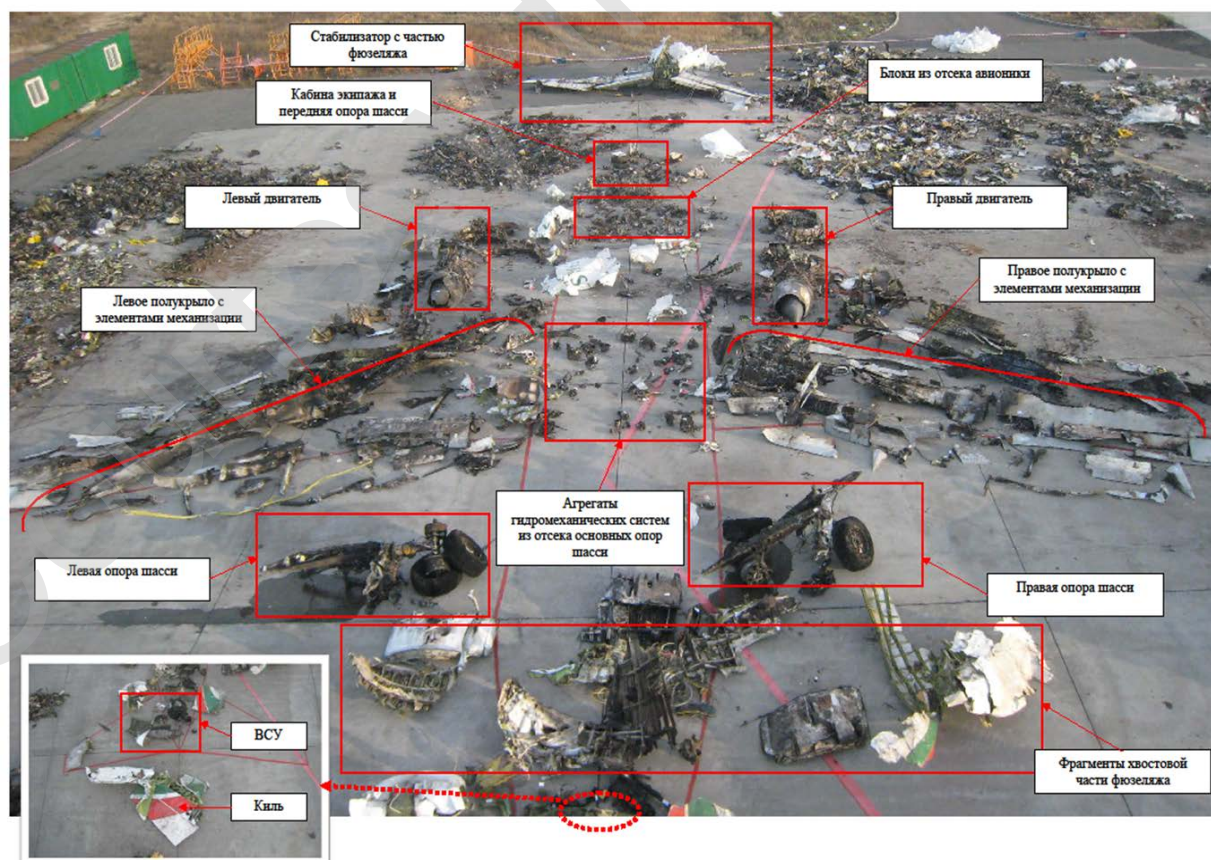
Figure 1 The layout of the remained fragments of the aircraft

The aircraft airframe was broken into a great number of fragmented parts. The biggest aircraft fragments, found at the accident site, are:

On impacting the ground, the aircraft was destroyed and postcrash fire occurred. The seat of fire was located in the area, where the fragments of the cockpit, the center wing section (with the landing gear wheel wells), and also of the left and right wings were found. On the other fuselage fragments, e.g. on the section from frame 360 to frame 500 (left side), horizontal stabilizer and vertical stabilizer, there were no signs of fire found.

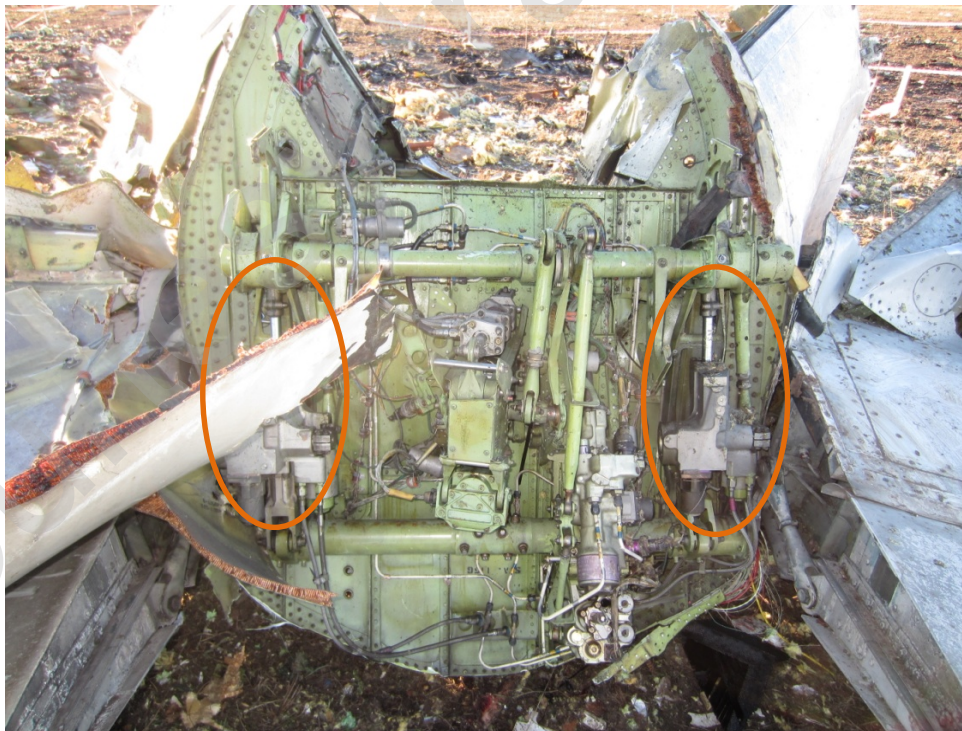
**Figure 2 Appearance of frame 1156 on the air accident site (the elevators actuators are circled orange)**

Frame 1156, on which elevator control units are located, was remained in satisfactory condition (Figure 2).

The elevators control moving elements, located on frame 1156, have visible deformation, caused by crash of the fuselage structure when the aircraft impacted the ground. There were no disconnections of the control system components and hydraulic lines, located on frame 1156.

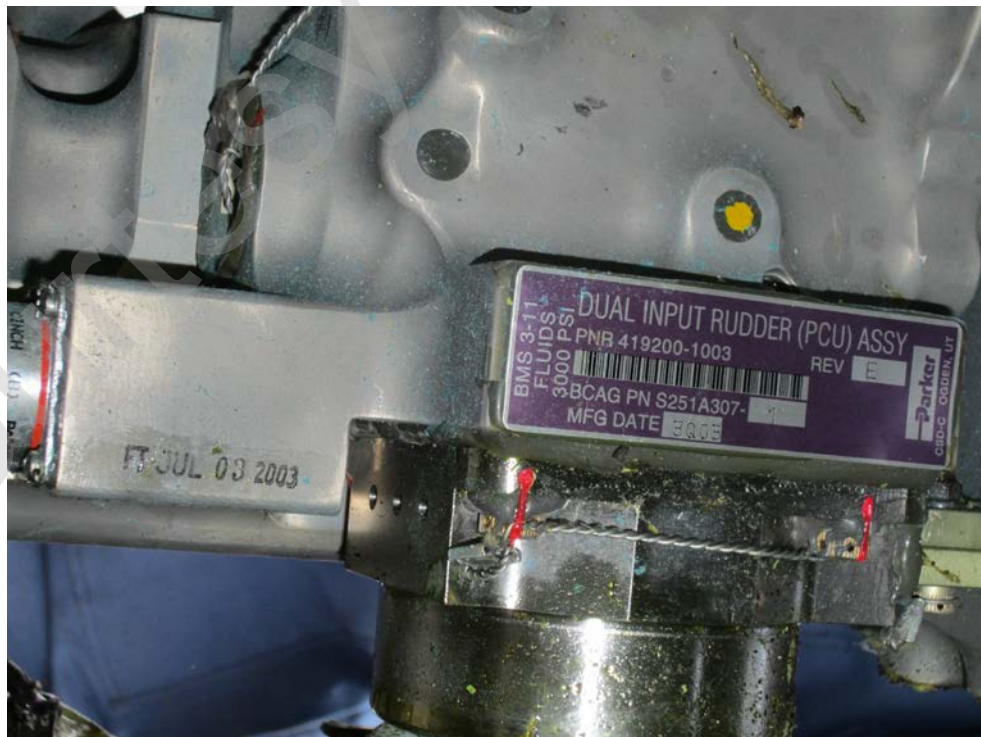
**Figure 3 Main rudder PCU**

The inspection of the main rudder PCU was performed (Figure 3). The rudder PCU had been torn off from its normal position as a result of the fin destruction. It was established that within the framework of the program of rudder control system modification, in accordance with the US FAA Airworthiness Directive No. AD 2002-20-07R1, the aircraft had been equipped with a new main rudder PCU.

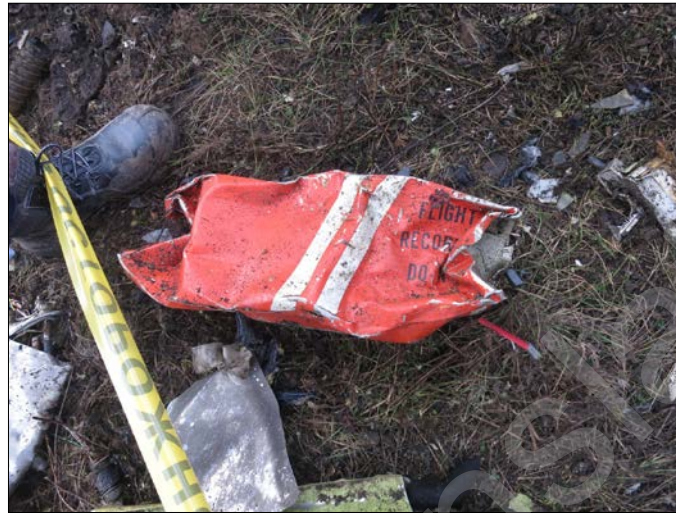
**Figure 10 FDR at the accident site**

The aircraft was equipped with an FDR manufactured by L3 (Fairchild), model – F1000, p/n S800-2000-00, s/n 02109. It was found at the accident site with severe damage (Figure 10).

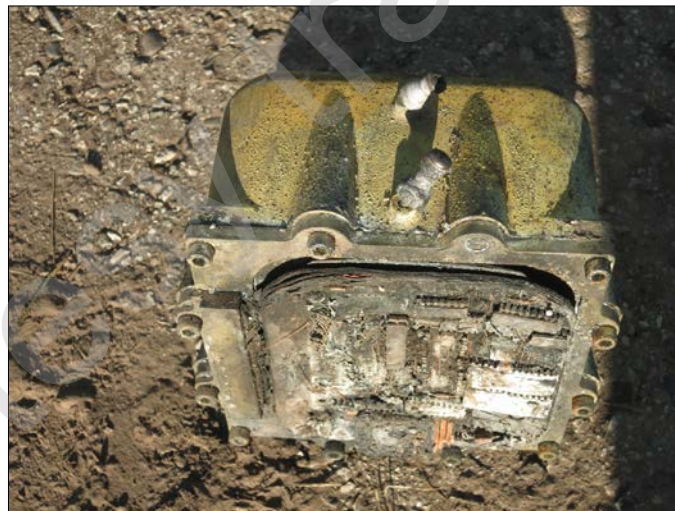
**Figure 14 CVR memory unit at the accident site**

The protected memory unit was found at the accident site later (Figure 14) and provided to the IAC on November 20.

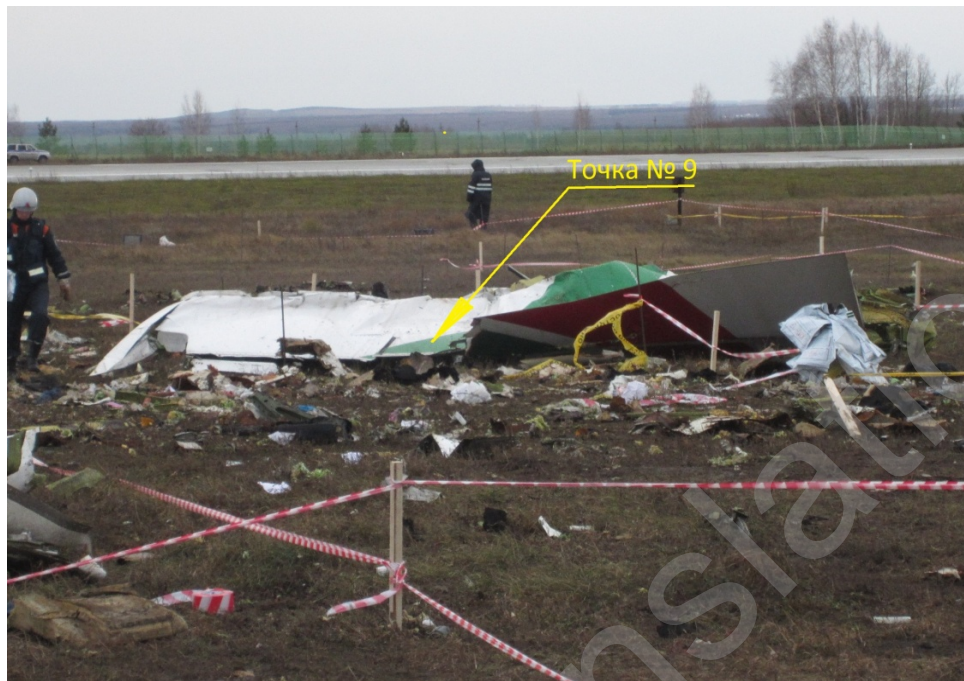
**Figure 21 Rudder fragment**

Forty meters ahead of the tail cone fragment in the flight direction (point 9, Figure 18) a rudder fragment was found (Figure 21).

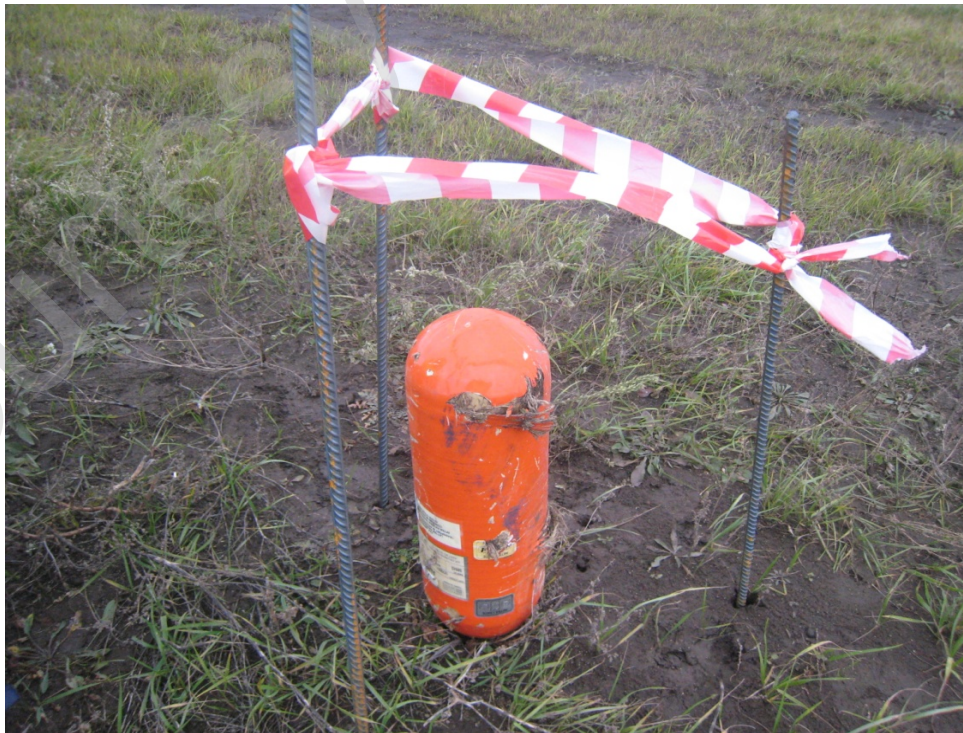
**Figure 22 Fire extinguisher bottle**

At distance of 120 m from the first impact point and 25 m from the right edge of RWY 29 (runway in use) (point 11, Figure 18) a red fire extinguisher bottle was found (Figure 22). This fragment was the closest one to the runway.

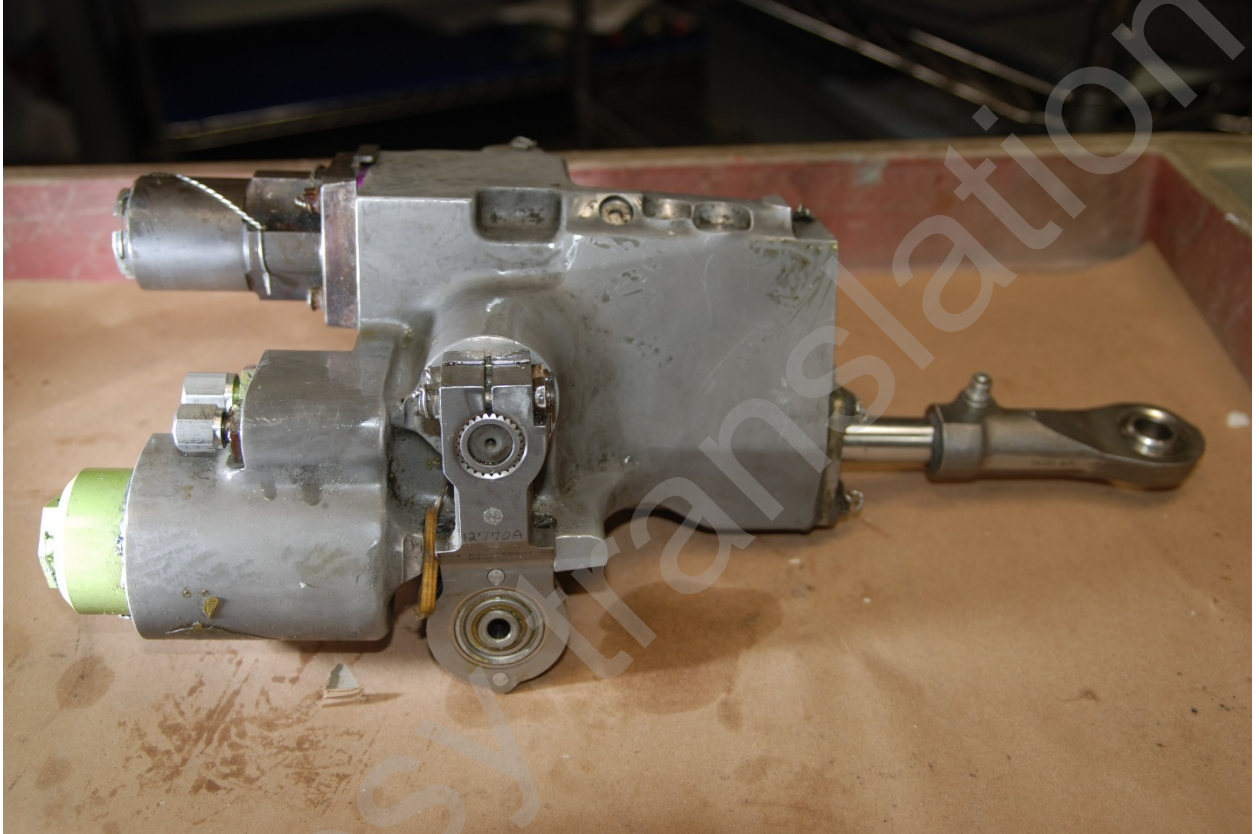
Figure 35 Left hand actuator

Taking into account the accident circumstances and FDR data readout (intense nose down pitching during the final phase of the flight and no nose up inputs) as well as earlier in-service occurrences related to PCU malfunctioning (Section 1.18.7) the investigation team decided to request an examination of the elevator power control units. Figures 35 and 36 below show the PCU as they arrived for the examination.

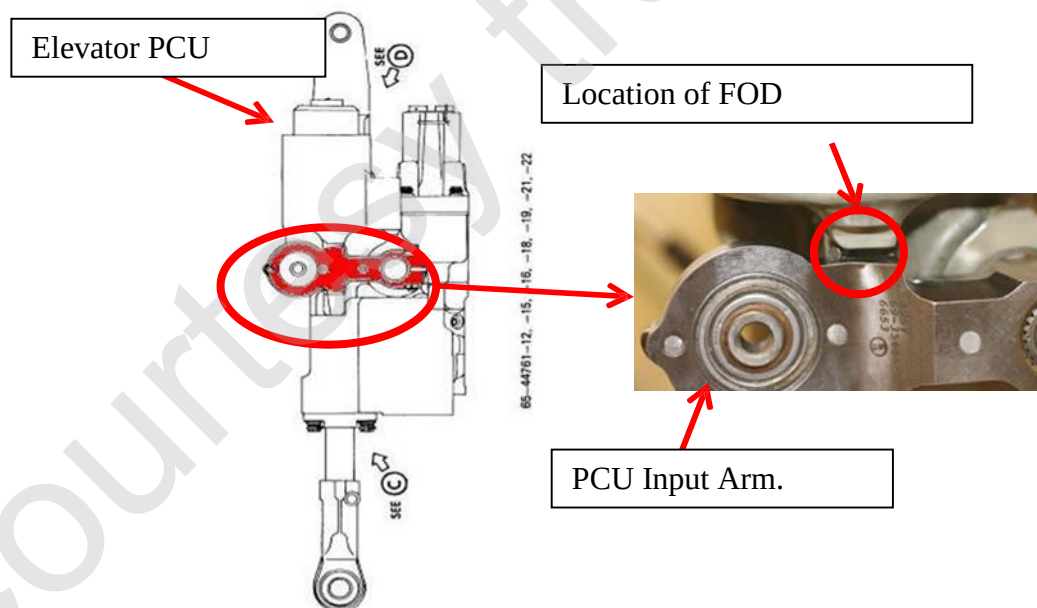
**Figure 70 Location of FOD**

The incident investigation was conducted by the NTSB. The NTSB's investigation found that the incident was caused by an uncommanded elevator deflection as a result of a left elevator power control unit (PCU) input arm assembly jam due to foreign object debris (FOD). The FOD was a metal roller element (about 0.2 inches long and 0.14 inches in diameter) from an elevator bearing. As a result, the PCU would be commanded to move the elevator to a position that would pitch the aircraft nose up.
