DUTCH  
SAFETY BOARD

# Erroneous takeoff performance calculation, Boeing 777

*The Hague, October 2020*

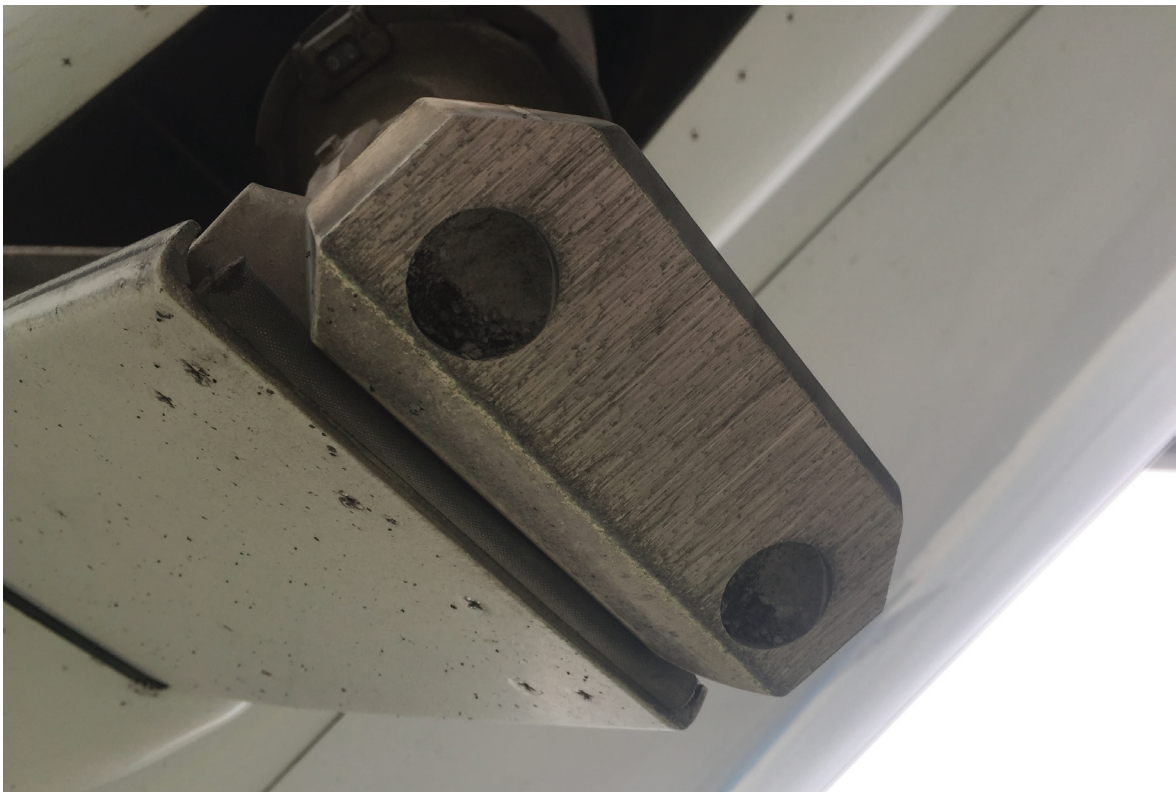
There was no damage to the aeroplane. The tail skid shoe was slightly scraped as a result of the tail strike (see Figure 3), but within limits as stated in the Aircraft Maintenance Manual to allow continued operation of the aeroplane. The fin of the tail strike detection system was still intact, which explains that no 'TAIL STRIKE' warning was generated in the cockpit.

*Figure 3: Tail skid shoe with scrape marks.*

The tailstrike was caused by an overrotation during takeoff, which was the result of a lower than required rotation speed. The reason for this was that the actual takeoff weight was higher than the takeoff weight that had been used for the takeoff performance calculation.
