The Aircraft Accident Investigation Board of the Islamic Republic of Iran

Flight PS752 Accident Investigation

Final Report

Crash of Ukraine International Airlines Flight PS752

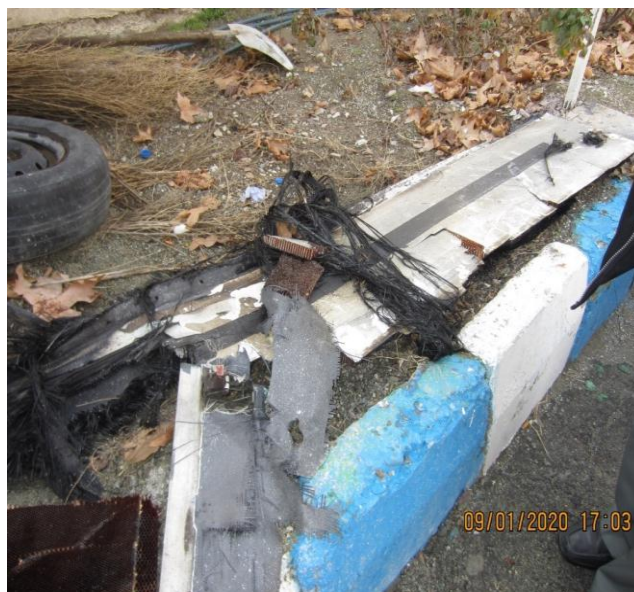
While flying past a village called Boke near Shahriar, some skin pieces belonging to the aircraft wing back end surfaces (Figure 9) were detached and found on the ground at position $35^{\circ}35'55''\text{N}$, $50^{\circ}59'00''\text{E}$. Some small pieces and a piece of the air conditioning system (Figure 10) were found at position $35^{\circ}35'53''\text{N}$, $50^{\circ}59'43''\text{E}$, about 10 kilometers before the crash site, which was collected by the locals in residential complexes and delivered to the respective rural council.

Figure 9- Part of the aircraft wing

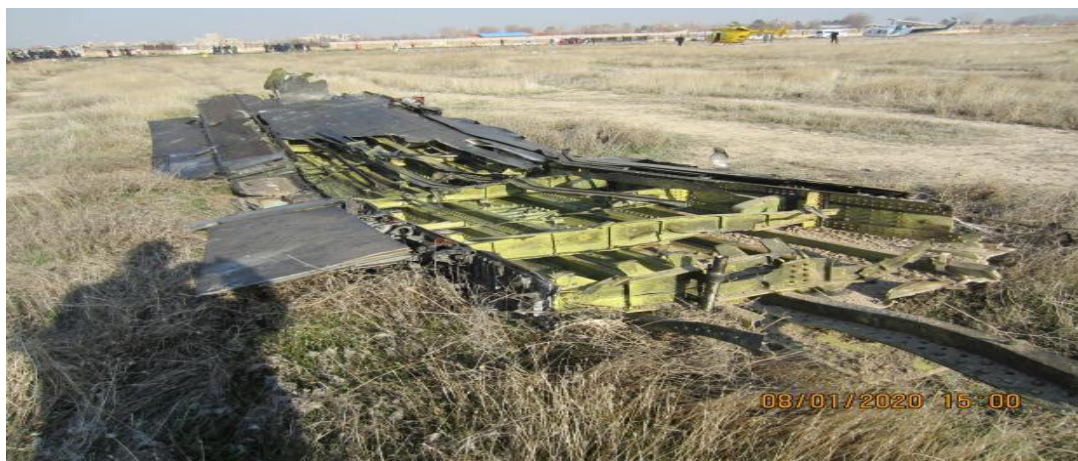
The outer skin of the left wing had signs of burning. Since there was no sign of fire at the place where the piece was found and the vegetation

surrounding it was undamaged, the burn on the wing had occurred before the crash into the ground. The inner walls of the wing indicated that the fire had not broken out into the aircraft fuel tank. (Figure 11)

Figure 11- The aircraft left wing at the crash site

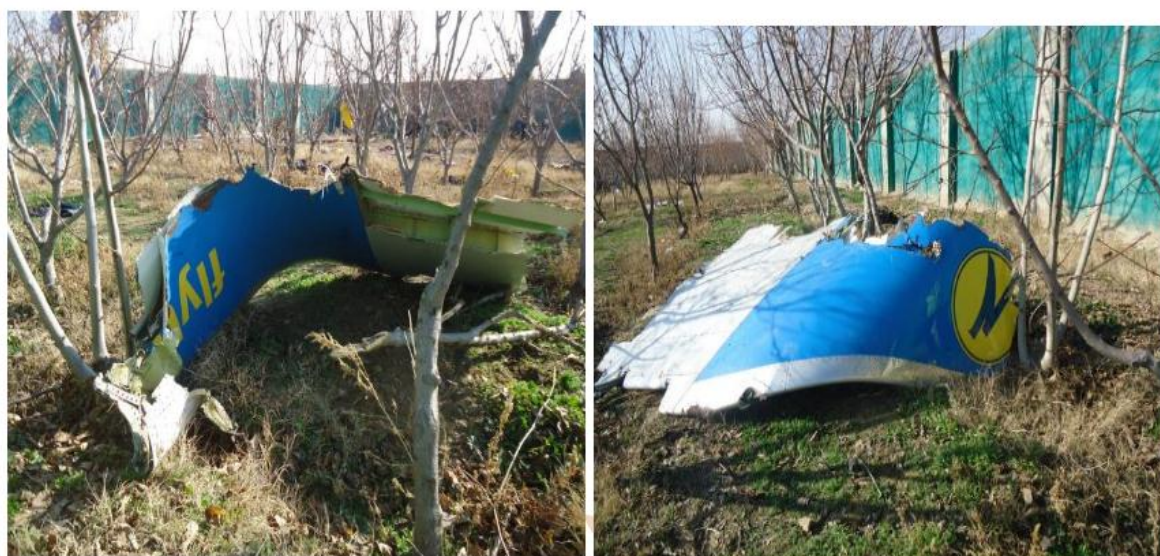
Some parts of the right wing together with the winglet indicated that the fire had not broken out into the right side of it (Figure 12).

Figure 12- The aircraft right winglet

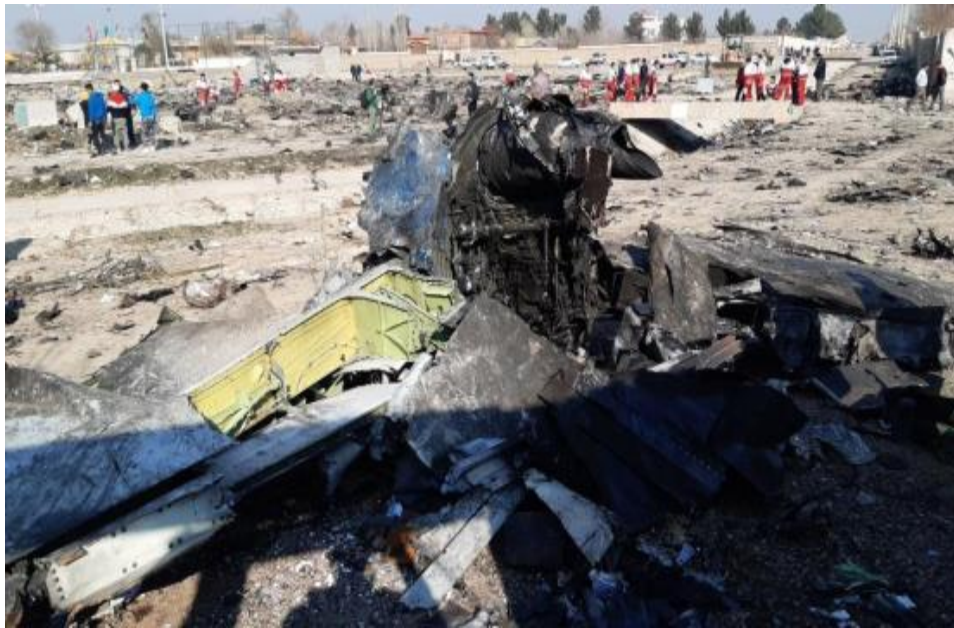
Smoke and burn were observed on the ground close to the Auxiliary Power Unit (APU) (Figure 13).

Figure 13- Auxiliary Power Unit

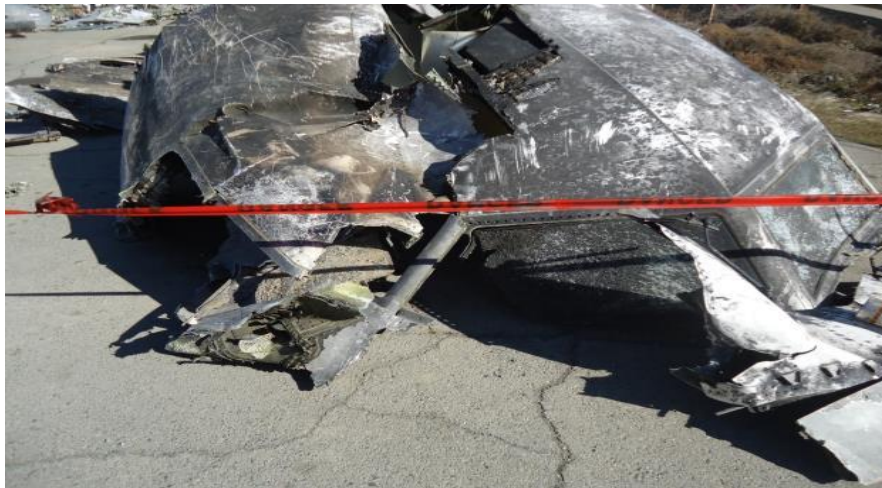
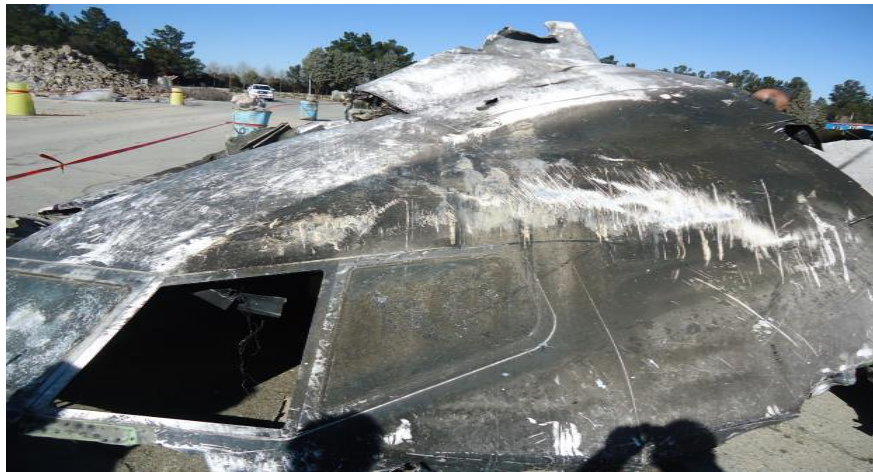
The traces of fire and smoke on the cockpit outer skin mark two situations: before and after the ground impact. In fact, it reveals that the fuselage had caught fire before the ground impact.

Figure 14 - Closer view of the cockpit

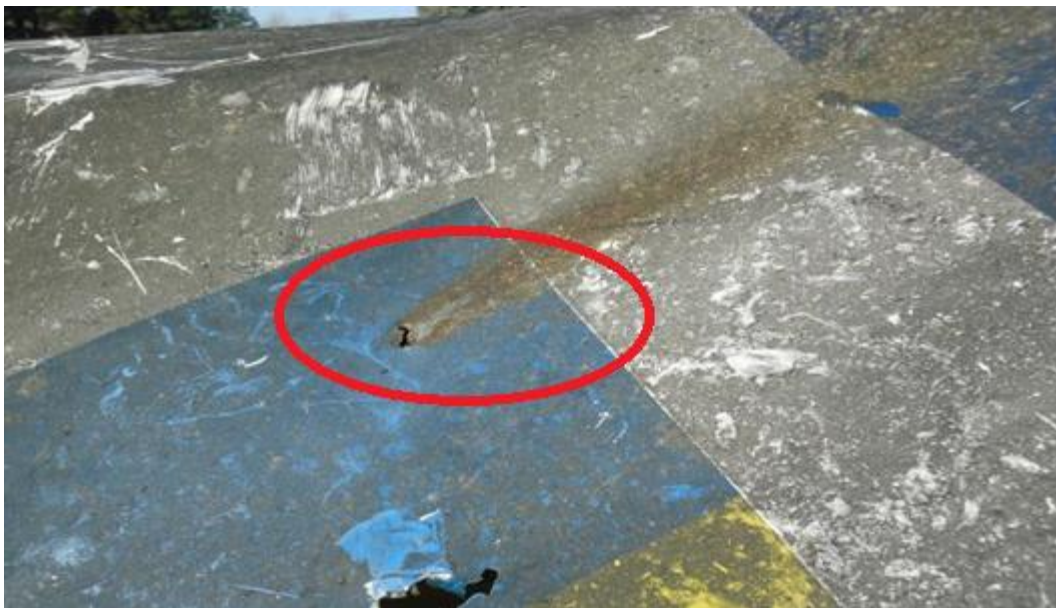
Laboratory results from the sample smoke layers around the holes show that the chemical base of the smoke was carbon, in which no traces of explosives were found.

Figure 16- Hole in the fuselage with a trace of a different color of smoke

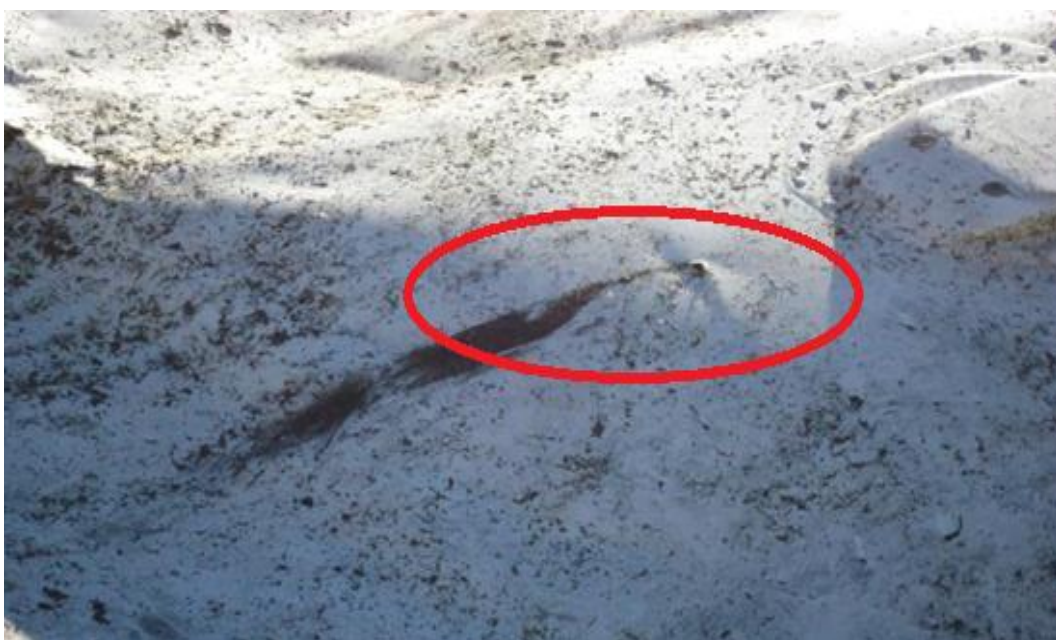
Figure 17- Hole on the fuselage near the cabin with a trace of different color of smoke

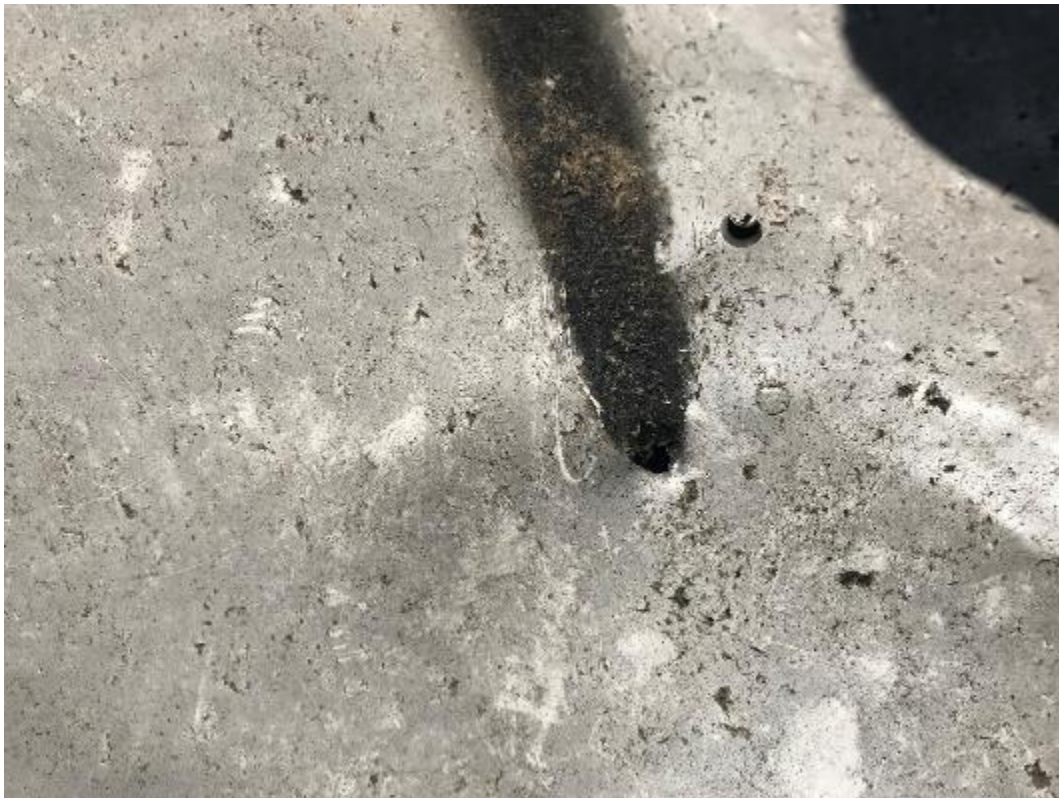
Figure 18- Hole on the fuselage near the cockpit and exhaust fumes

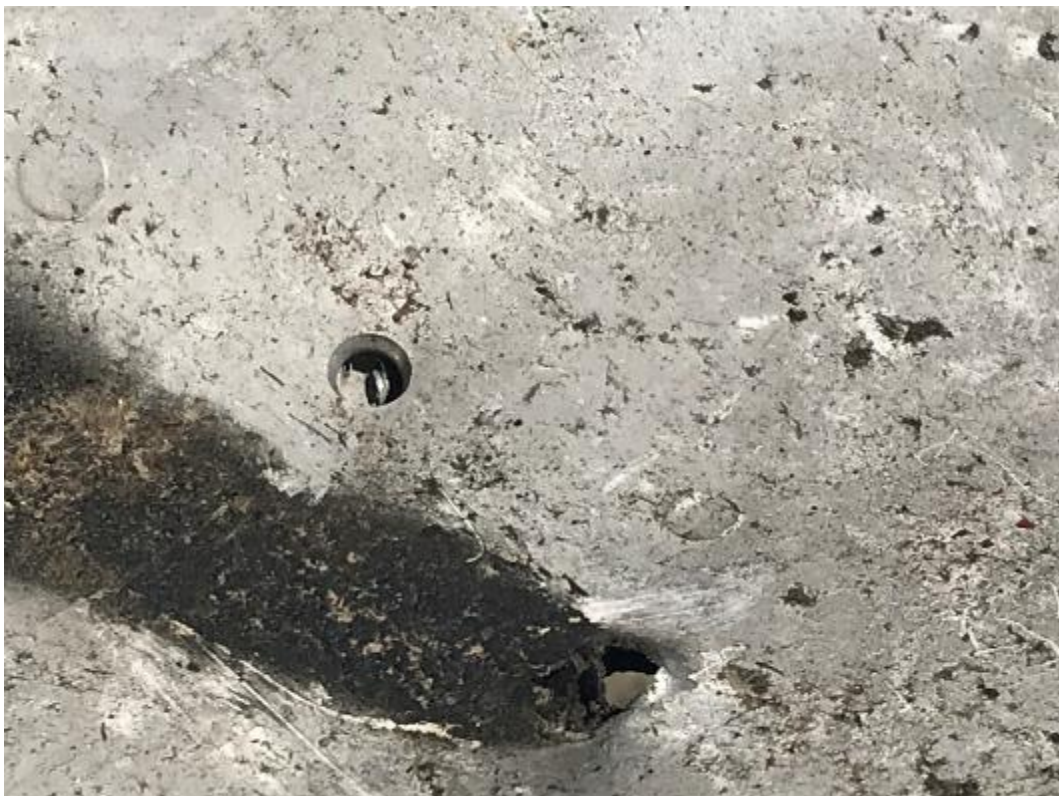
Figure 19- Closer view of the hole on the fuselage near the cockpit and burn signs in the hole area

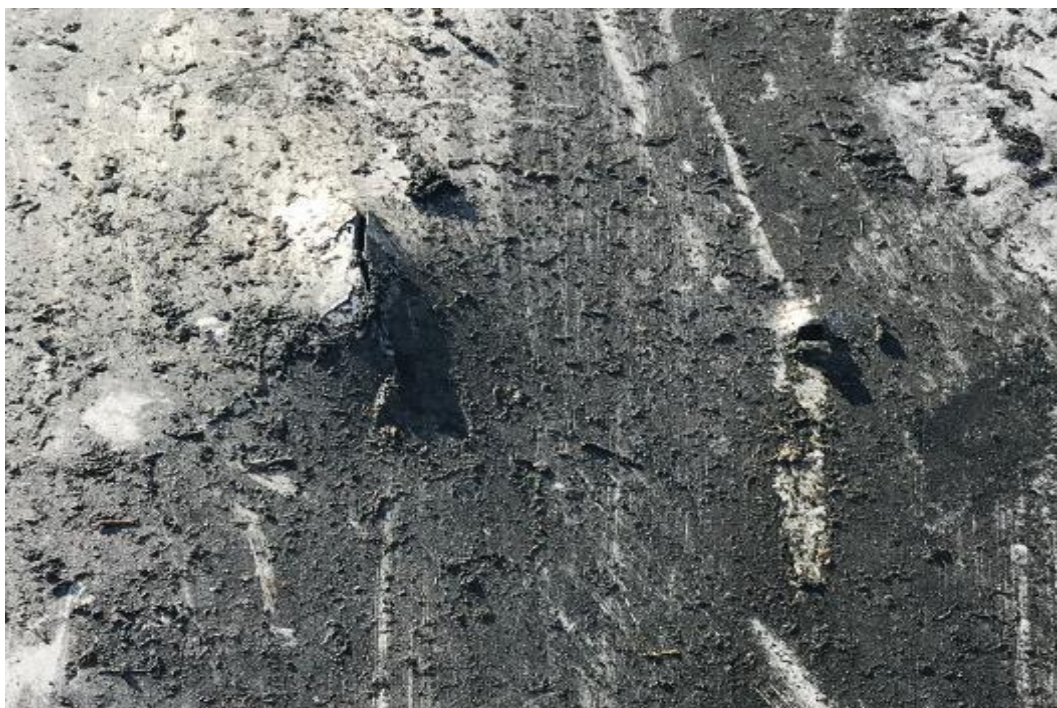
Figure 20- Crack with an outward hole in the skin of the structure near the cockpit

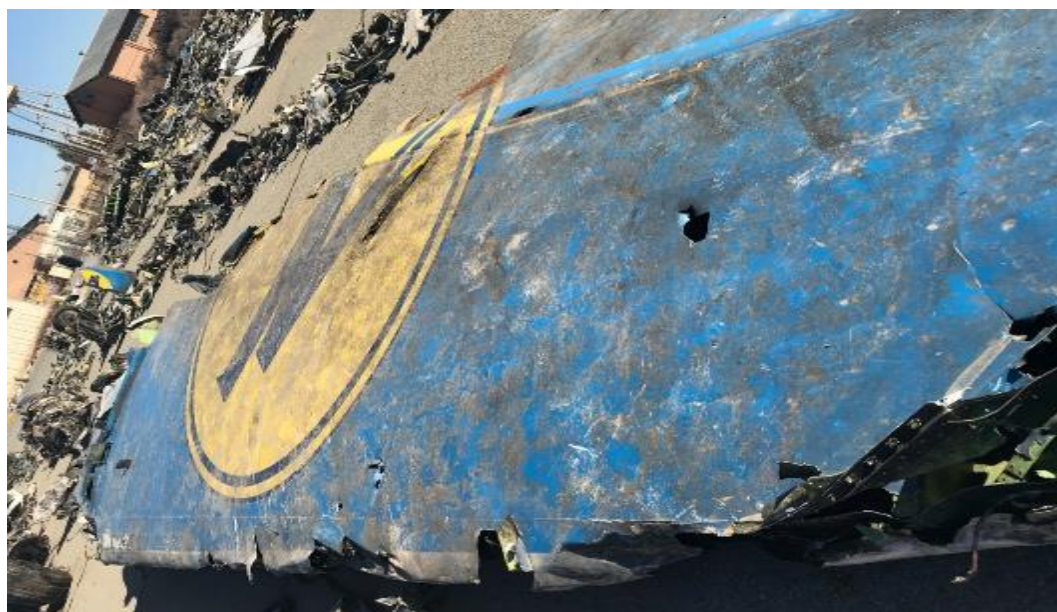
Figure 21- Holes and cracks on vertical stabilizer

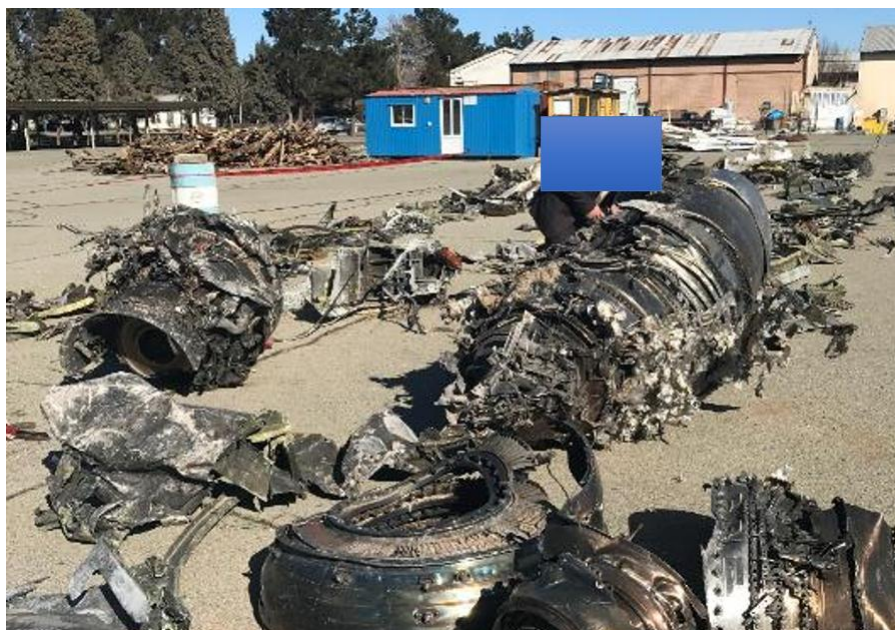
Two aircraft engines were found at the accident site, which were totally destroyed (Figure 23). The damage observed on the rotating parts shows that the engines were working. The evidence revealed no explosion or severe fire on the engines and it seemed that most of the damage had been caused by deforming due to ground impact.

Figure 23- The two aircraft engines

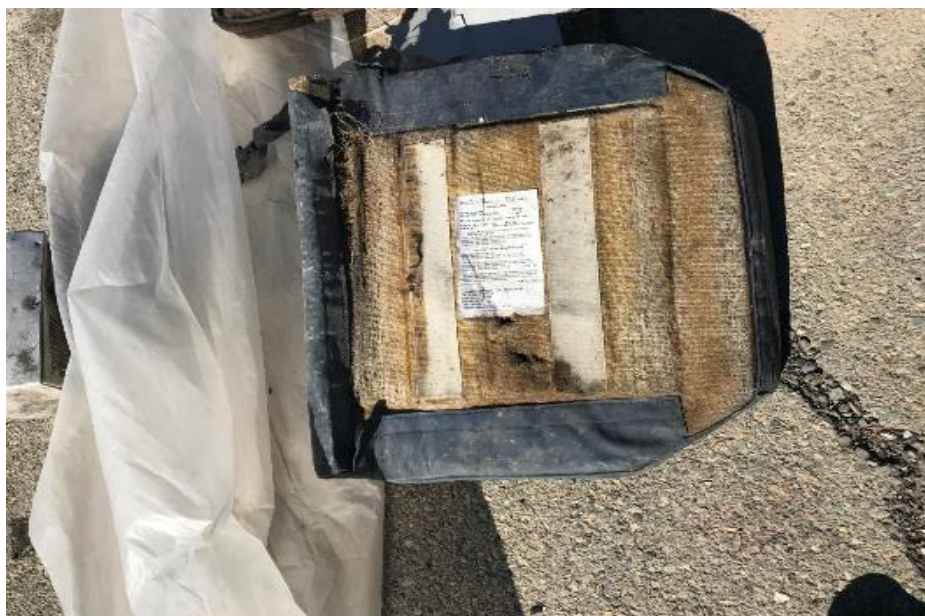
Figure 25- One of the remaining passenger seats with holes in it

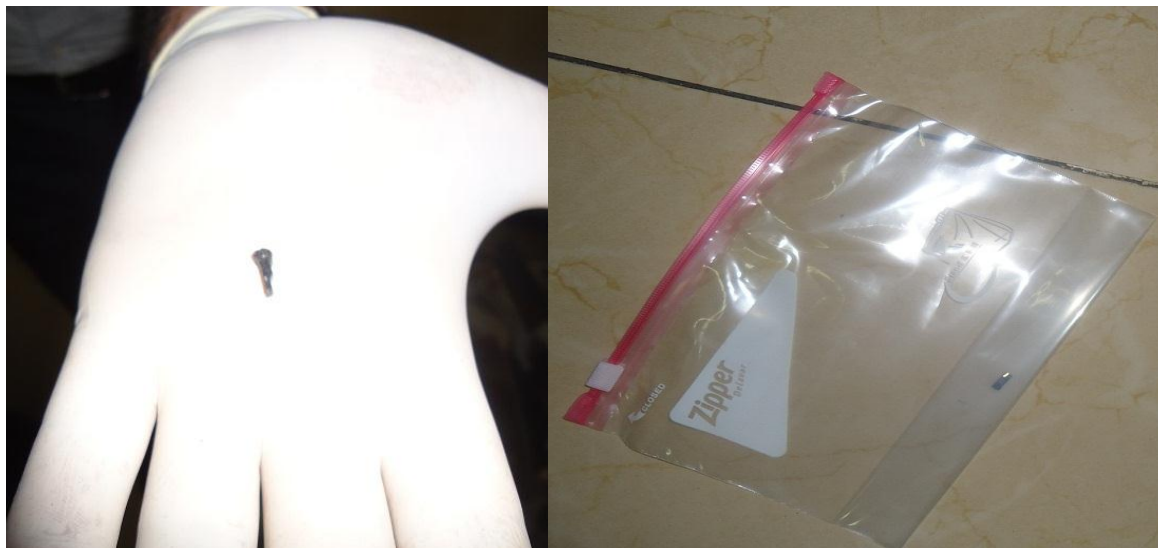
Figure 26- Metal objects found in the passenger seats

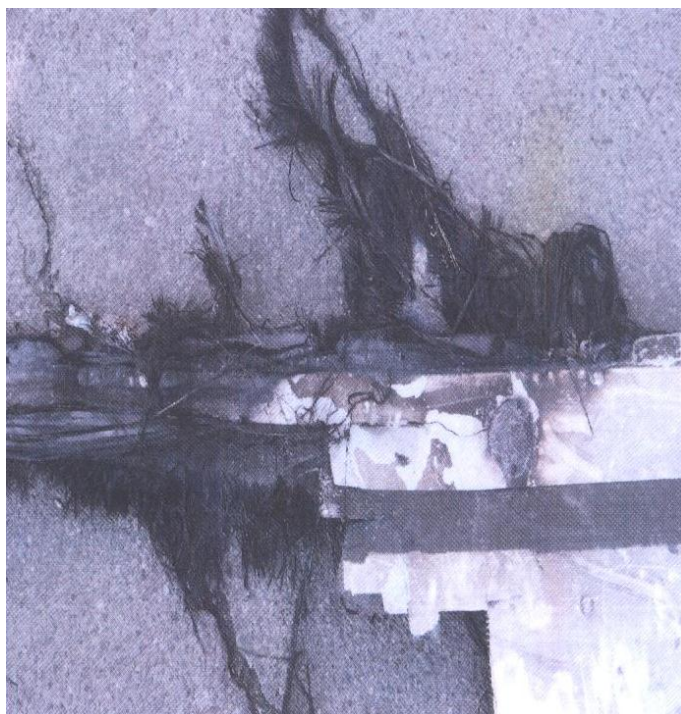
Based on the results yielded through GC/Mass chemical analysis, the existence of Trinitrotoluene (TNT) explosives with a chemical formula C₇H₅N₃O₆ was confirmed in the aircraft wing skin, which was found before the crash site. (Figure 27)

Figure 27- The wing piece found before the accident site

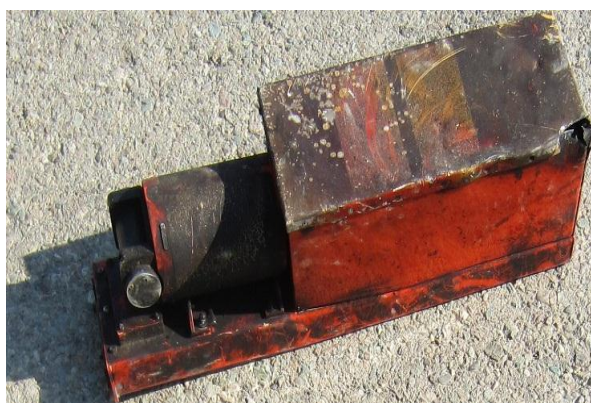
Damage to CVR had been more serious, whose main memory (CSMU) was detached due to the impact severity. The condition of these recorders indicated that the CVR and FDR had not been exposed to the fire in the aircraft, and after the ground impact, they were damaged or exposed to fire. (Figure 35 and Figure 36)

Figure 35- FDR physical appearance after the crash

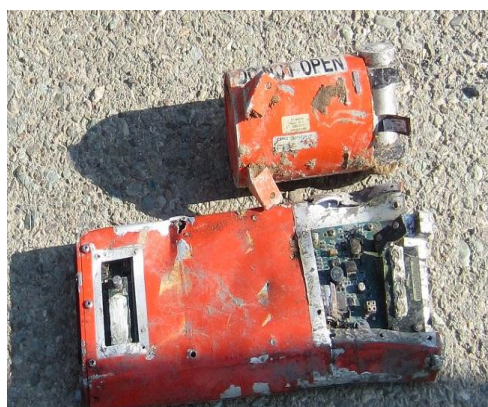
Figure 36- CVR physical appearance after the crash
