Published August 2013

Study

**on Aeroplane State Awareness
during Go-Around**

BEA

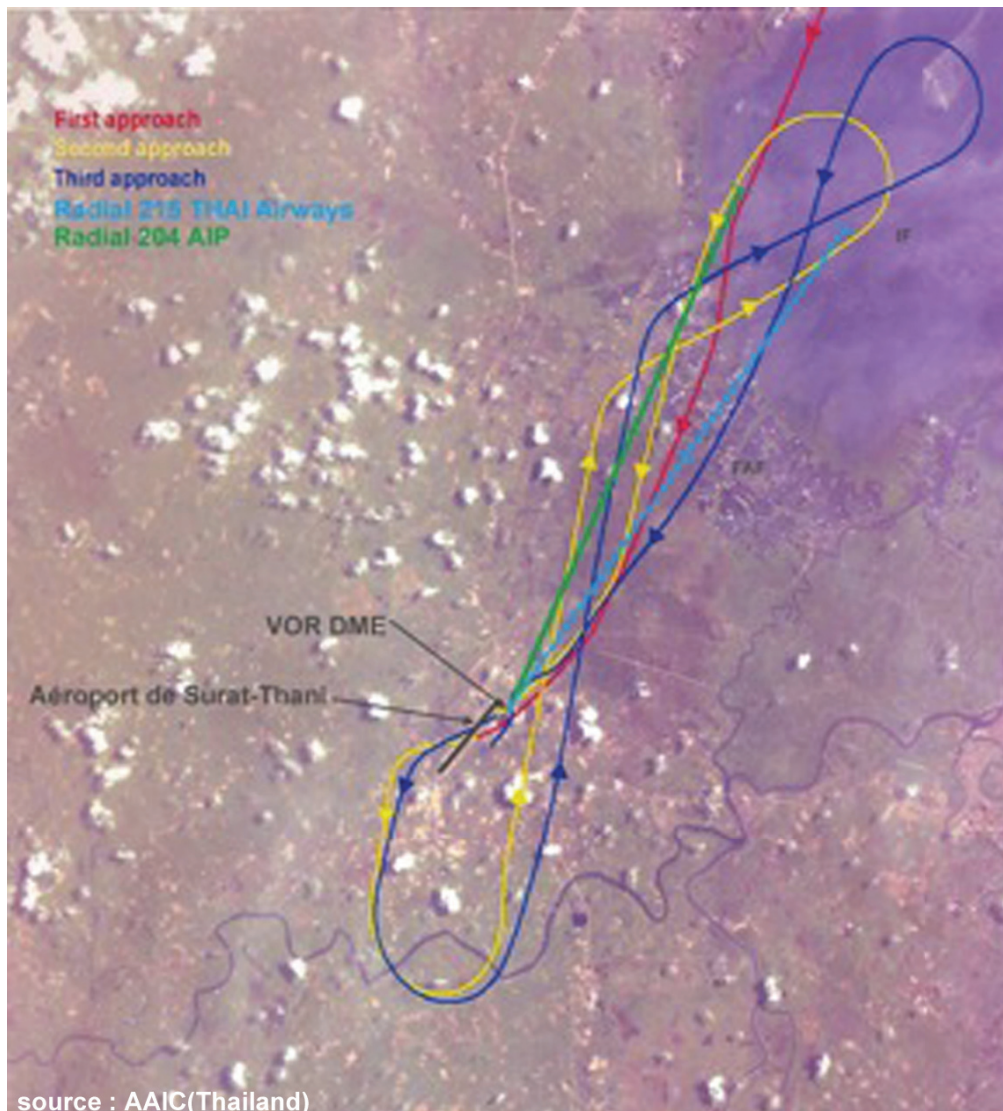
Figure 1 : Approach from 11.37.33 UTC to 12.07.35 UTC

The PF made his first pitch input on the sidestick when the pitch attitude reached 36 degrees. The FCOM recommends a maximum pitch attitude of 18 degrees. During the stall, nose-up inputs on the sidestick were recorded. Similarly, the first input to counter the roll was taken when the roll angle was 50 degrees.

During all three approaches, the PF flew too far to the left of the radial of the final approach segment and did not correct this deviation. Moreover, his last skills checks revealed that he was not very familiar with non-precision approaches.

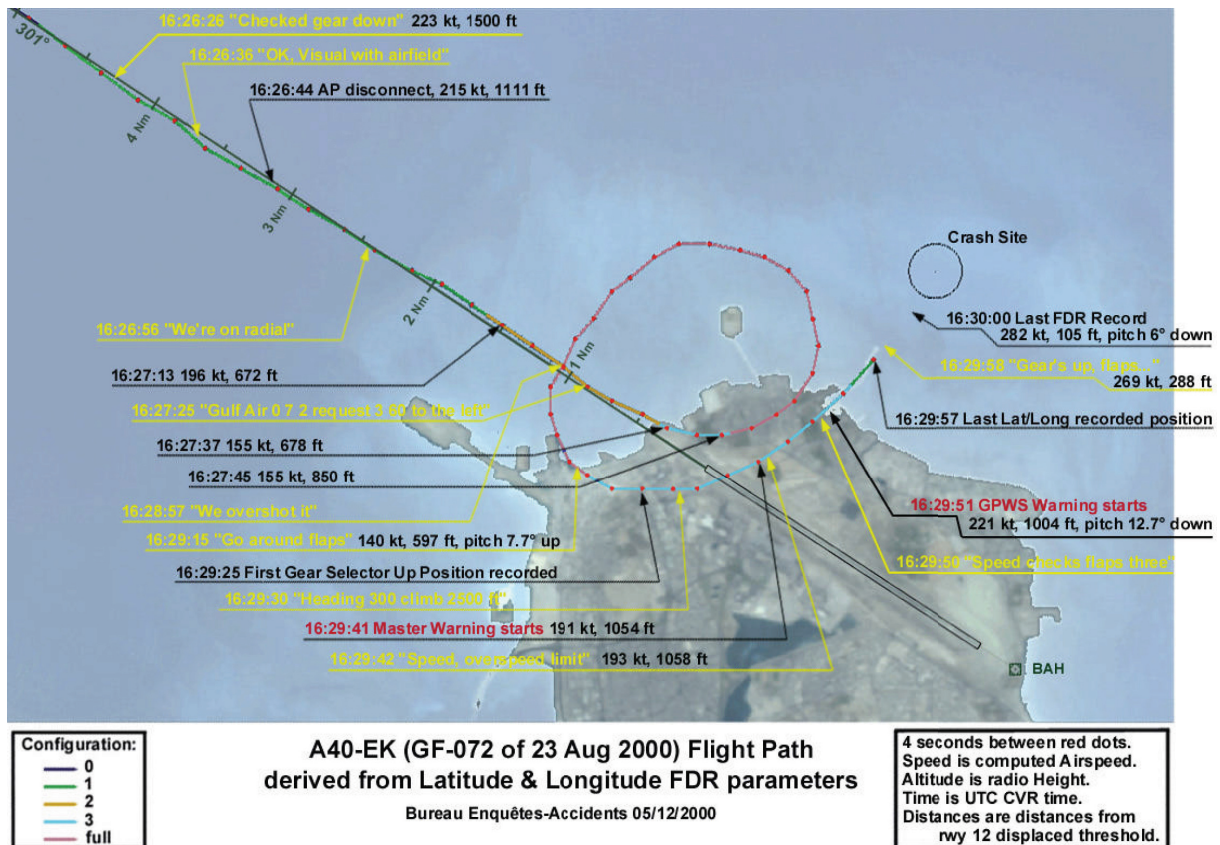
Figure 2

Just as the controller offered new radar vectoring which was accepted by the crew, the master warning associated with VFE overspeed condition sounded. The latter was called out by the PNF/PM. The Captain asked the co-pilot to retract the flaps, without specifying a position. The Captain then held the sidestick forward of the neutral position for 11 seconds, even though the aeroplane's height was 1,050 ft. The investigation considered that the most likely explanation for this nose-down input at night was a somatogravic illusion. The PFD was nonetheless correctly displaying the aircraft's true pitch attitude. The report indicates that this pitch attitude information was not used by the Captain since he was mentally overloaded, while his attention was monopolized by monitoring the airspeed.

The pitch attitude reduced rapidly due to the nose-down input, reaching 12° nose-down. The "sink rate" aural warning from the GPWS sounded and the Captain pushed the sidestick forward. The "pull-up" warning then sounded and continued until the aircraft's impact with the sea. There was no verbal communication between the flight crew members after the activation of the GPWS warning. A few seconds before the impact, the Captain pulled back on the sidestick. The last recording obtained from the FDR indicated airspeed of 282 kt and a pitch attitude of 6° nose-down.

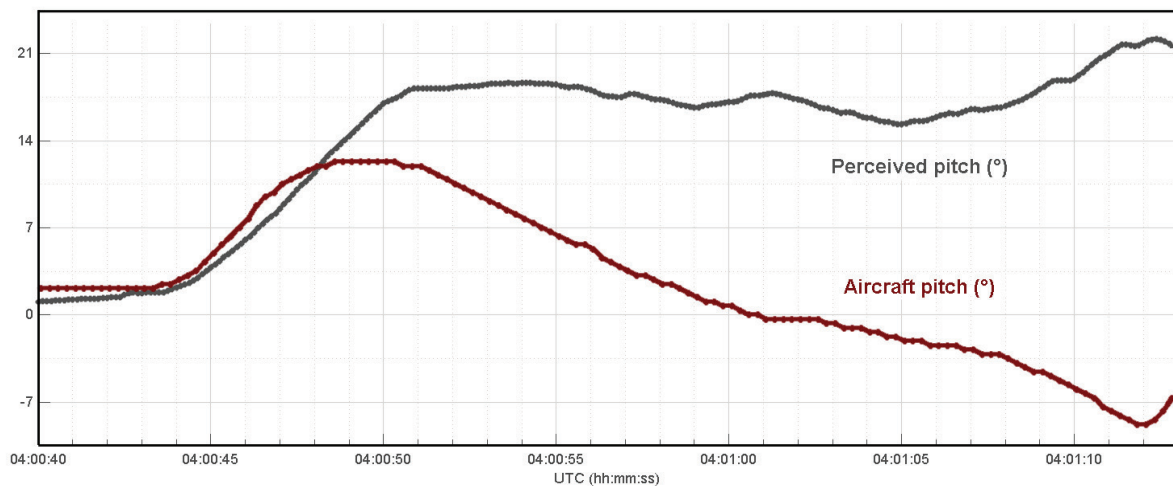
Figure 37 : Real and perceived pitch attitudes during a missed approach

The following diagram shows the real aircraft pitch attitude against the perceived pitch estimated by the model.

When a somatogravic illusion is present, there is therefore a difference between the attitude experienced and the real pitch attitude. This difference may be as much as 25 degrees.
