SERIOUS INCIDENT

Aircraft Type and Registration:	DHC-8-402, G-FLBE	
No & Type of Engines:	2 Pratt & Whitney Canada PW150A turboprop engines	
Year of Manufacture:	2009 (Serial no: 4261)	
Date & Time (UTC):	14 November 2019 at 1950 hrs	
Location:	In-flight from Newquay Airport to London Heathrow Airport	
Type of Flight:	Commercial Air Transport (Passenger)	
Persons on Board:	Crew - 4	Passengers - 59
Injuries:	Crew - None	Passengers - None
Nature of Damage:	Aileron cable broke	
Commander's Licence:	Airline Transport Pilot's Licence	
Commander's Age:	51 years	
Commander's Flying Experience:	8,778 hours (of which 5,257 were on type) Last 90 days - 150 hours Last 28 days - 33 hours	
Information Source:	AAIB Field Investigation

Synopsis

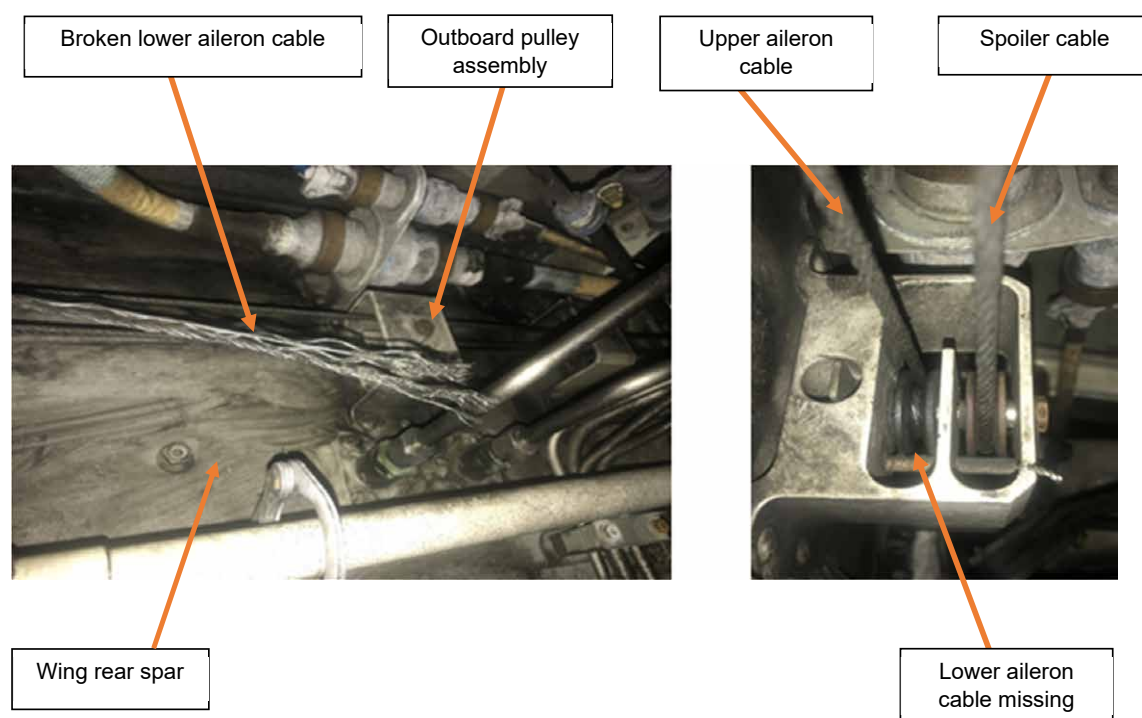
Figure 1

Post-flight examination revealed that the lower left aileron cable broke just outboard of the engine where it passed over a pulley to accommodate a change in the wing dihedral (Figure 1). There was no other damage to the aircraft.

Broken aileron cable and associated pulley

The lower left aileron cable failed where it passed over a pulley mounted on the rear wing spar. The pulley was found to rotate freely on its bearing.

The cable and its associated pulley were examined using optical and scanning electron microscopes. Individual wires showed a variety of features including ductile (tensile overload) failure, wear between wires in adjacent strands, wear between wires in the same strand and wear from an external source. There was no evidence of manufacturing anomalies, corrosion or fatigue.

The pulley was found to be worn with a pronounced imprint of the cable around the entire circumference of the groove. Small particles of metallic debris were found embedded in the pulley and it was concluded that these originated from the control cable. Apart from the wear, dimensional checks of the pulley found it to be compliant with the drawing requirements.

The lower left aileron cable failed due to a combination of internal and external wear. Following the failure, the tension in the upper cable would have caused the aileron to deflect upwards inducing a roll to the left. From the FDR data, it was established that the cable failed between the aircraft landing at Newquay and during the subsequent takeoff.

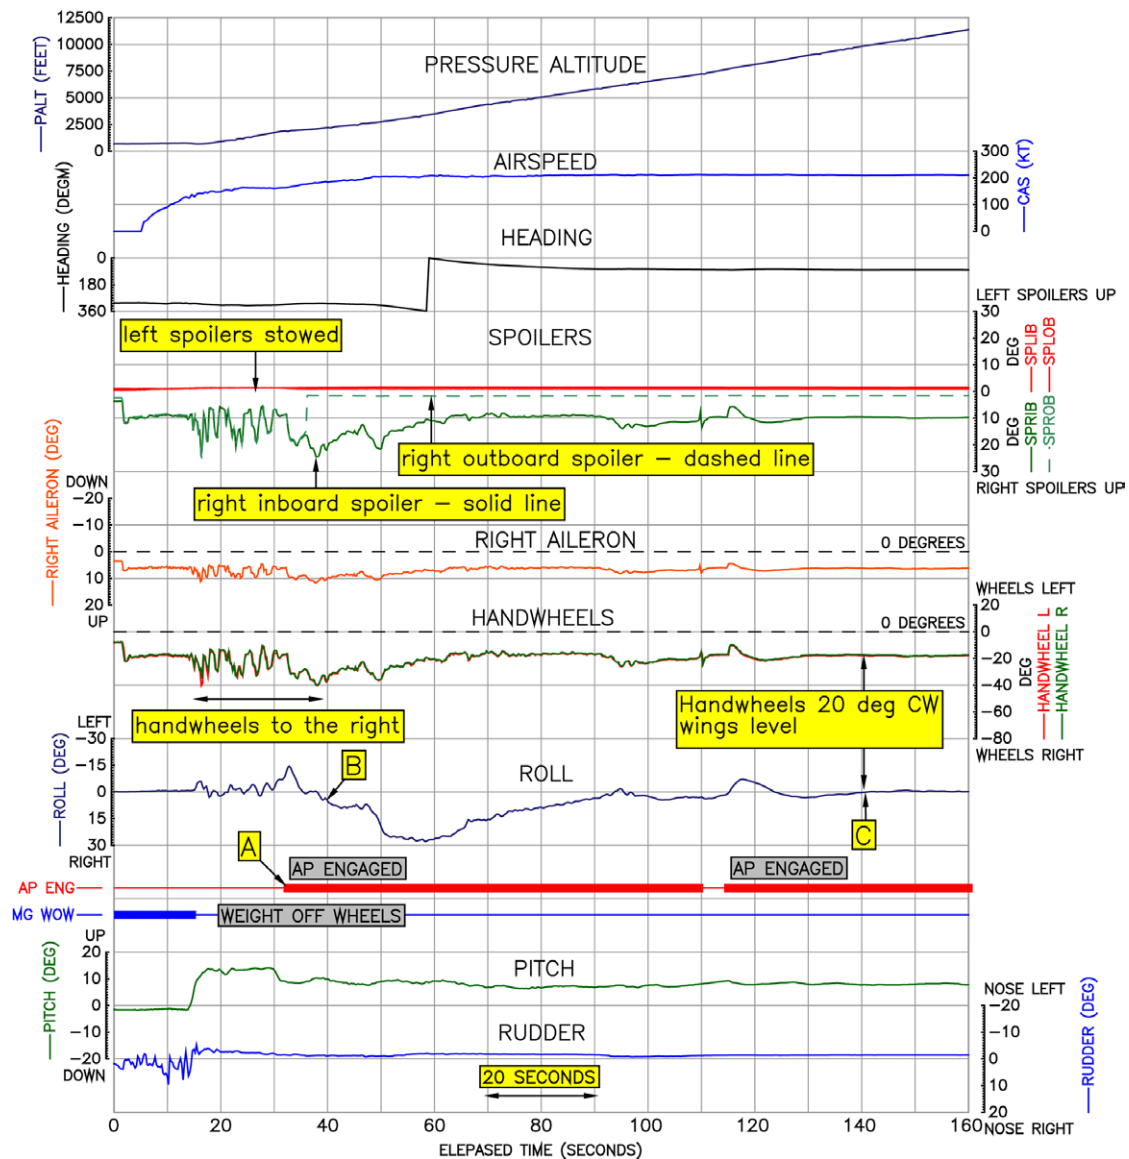
Figure 5

Handwheel offset after departing Newquay

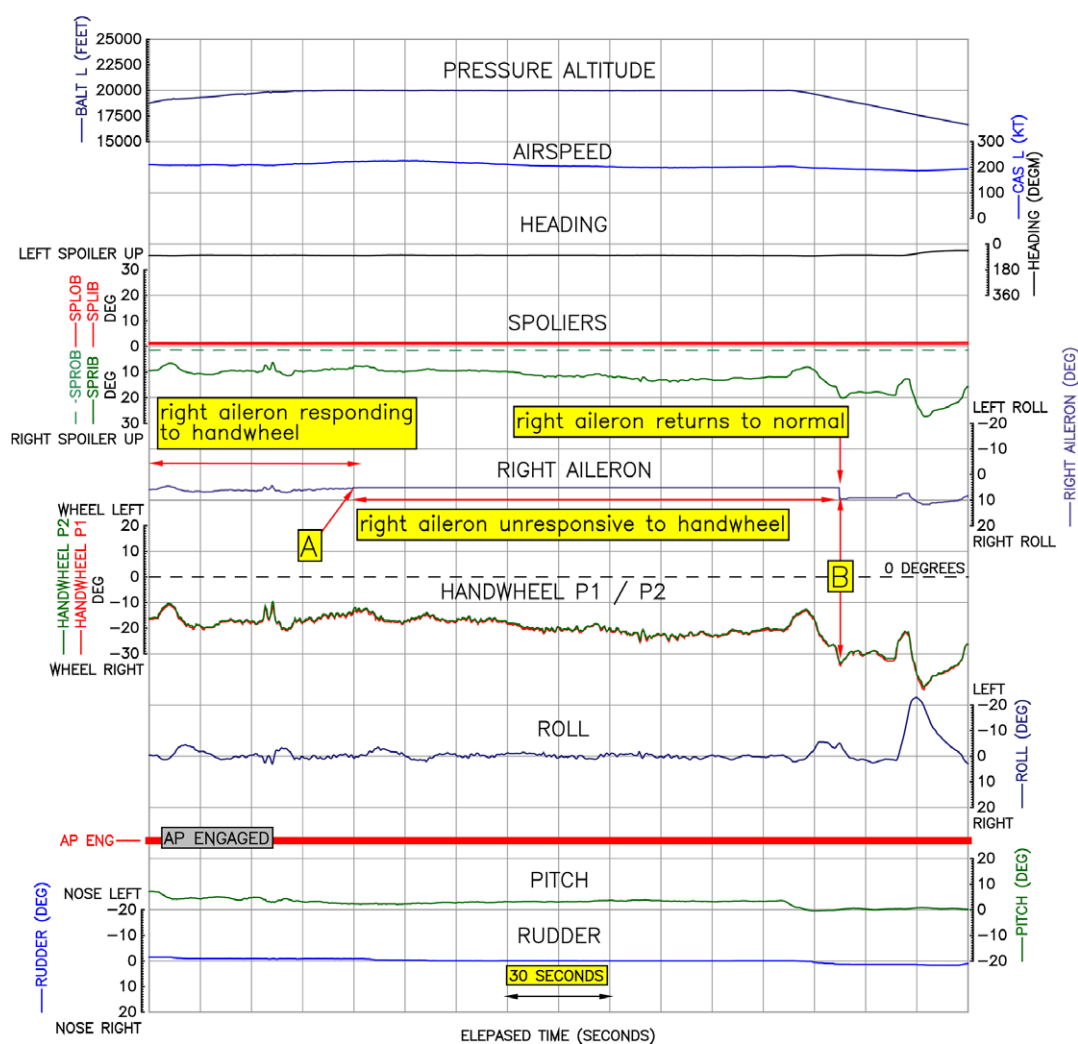
Figure 6

During this investigation an issue, unrelated to the cable failure, was identified with the movement of the right aileron in-flight. Data from the FDR showed that shortly after G-FLBE levelled at FL200, the aileron stopped responding to movement of the handwheels (Point A Figure 6). This lasted for about five minutes, with the aileron remaining in an almost fixed position of +5°. During this period, the AP continued to maintain wings level with handwheel positions between 13° CW and 27° CW. The inboard spoilers continued to operate normally during the flight.

Unresponsive right aileron
