**Deviation below manoeuvring airspeed on final, go-around,  
triggering of Alpha Floor protection**

| <b>Aircraft</b> | Airbus A320-214 registered F-HEPE |
| <b>Operator</b> | Air France |
| <b>Place</b> | Tel Aviv Ben Gurion Airport (Israel) |

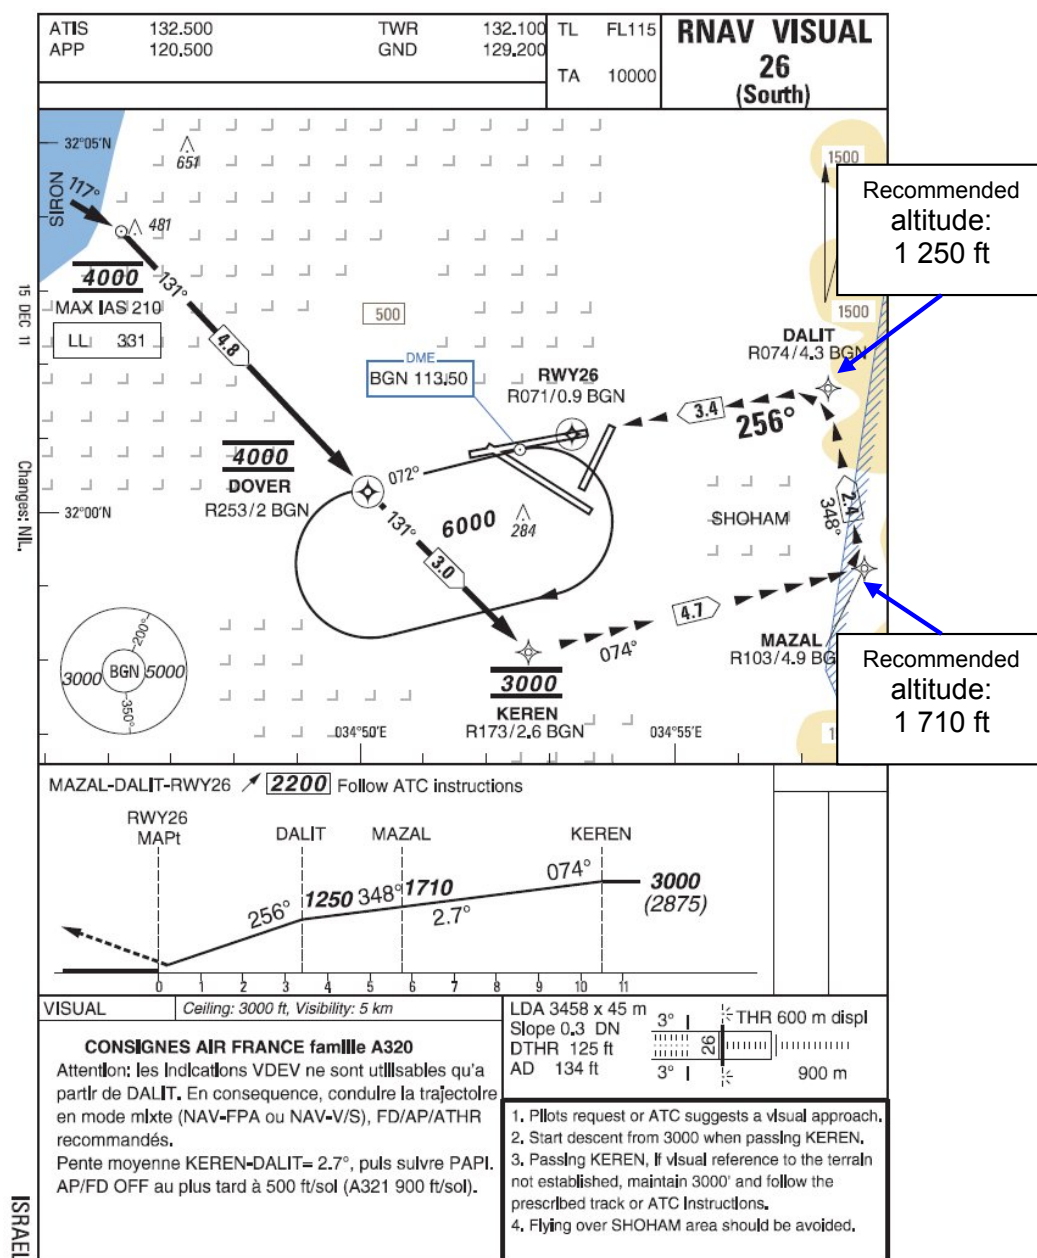
Air France approach chart for the RNAV VISUAL procedure on runway 26 from the south  
 valid on the date of the event

*Attention : les indications VDEV<sup>(8)</sup> ne sont utilisables qu'à partir de DALIT. En conséquence, conduire la trajectoire en mode mixte (NAV-FPA ou NAV-V/S), FD/AP/ATHR recommandés.  
Pente moyenne KEREN-DALIT=2,7°, puis suivre PAPI. AP/FD OFF au plus tard à 500 ft/sol.*

On A320 family aeroplanes, it is technically impossible to code several descent paths in the FMS. Air France did not wish to code a continuous descent path from KEREN to avoid possible GPWS warnings. The airline chose to code the profile only from DALIT, which explains why the VDEV was not usable before this point.

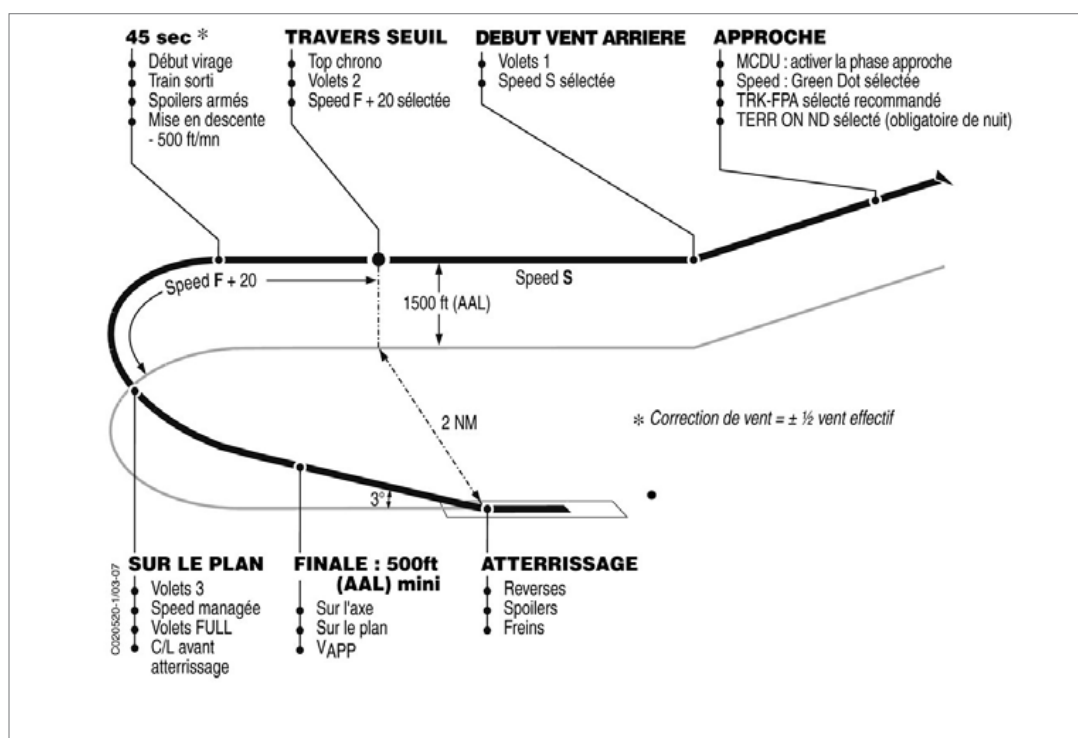
The standard visual approach procedure recommended by Air France and the manufacturer provides for changing to configuration 3 then FULL once established on the glide path, just before lining up on final.

Standard visual approach procedure recommended by Air France on the day of the event
