Nav aids Testing Risks and their Mitigation

L. Nelson Spohnheimer
National Resource Engineer for Navigation
Federal Aviation Administration
Seattle, Washington

November 2001

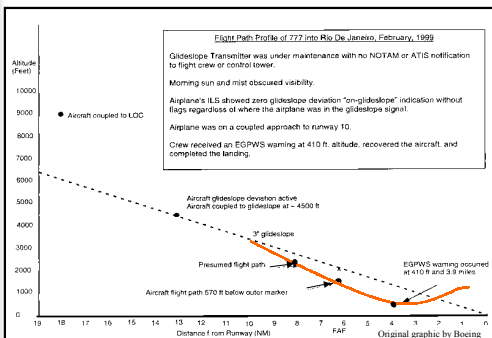
Rio HMI/NCFIT Event

- Aircraft have apparently coupled to, or used, nav aid signals which:
 - Should have been unusable, and...
 - Also were deceptive.
- These events are called Near Controlled Flight into Terrain (**NCFIT**)
- First known case -- Rio, February 1999
 - Boeing 747, VFR, Sun in eyes
 - Autopilot coupled to ILS
 - EGPWS caught premature descent

- Convened Safety Review Board
- Contacted NRE to discuss maintenance activities on ILS
- Prepared Mishap Event-Sequence Analysis
- Modified flight manuals to...
 - Include additional procedural redundancy
 - Add more explicit cross-checking warnings
- February 2000, wrote to FAA and ICAO suggesting potential actions for consideration
