## **INTERSTATE AVIATION COMMITTEE**

#### **FINAL REPORT ON RESULTS OF INVESTIGATION OF ACCIDENT**

| Type of aircraft | ATR72-201 aeroplane |
| Registration | VP-BYZ, Bermudas |

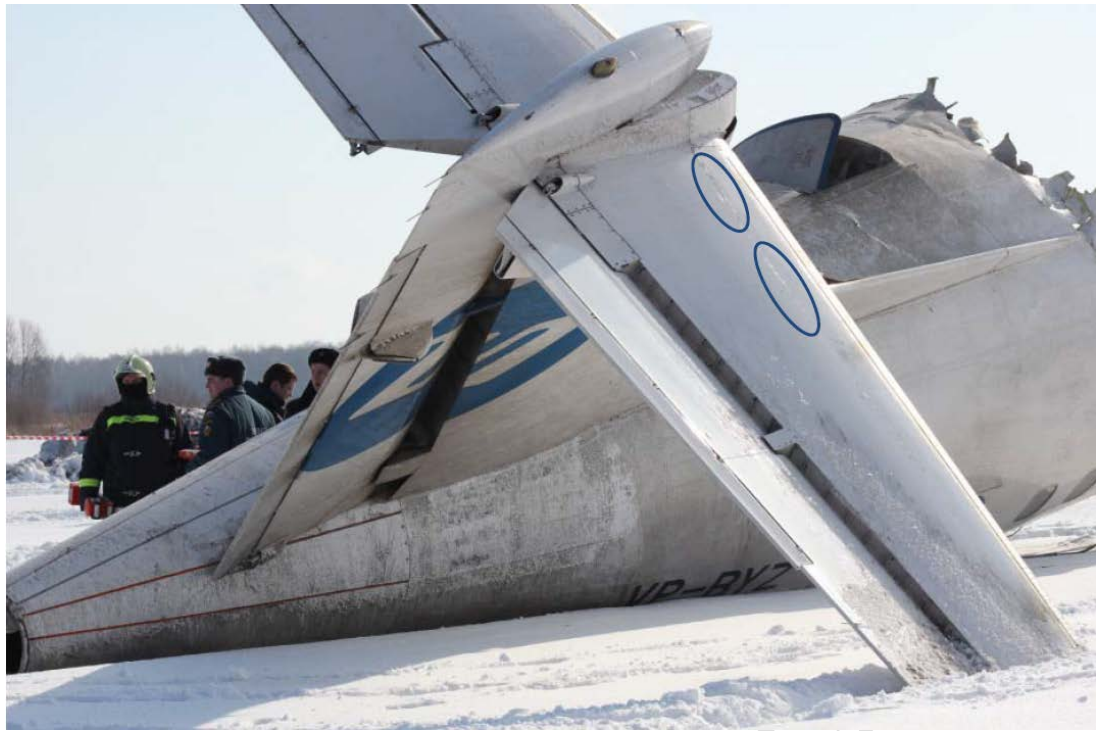
No traces of ice contamination were observed at the fuselage rear section and at the vertical stabilizer at the time of their inspection. However, the examination of photographs taken during the first hours after the accident revealed some snow and ice contamination residues on the horizontal stabilizer right side. The residual snow and ice contaminants are located along the front spar of the stabilizer that was the "cold accumulator" within the period of the aircraft parking that is on this area the contamination must be more abundant (see Figure 1).

**Figure 1. Horizontal stabilizer right side with traces of snow and ice deposits**

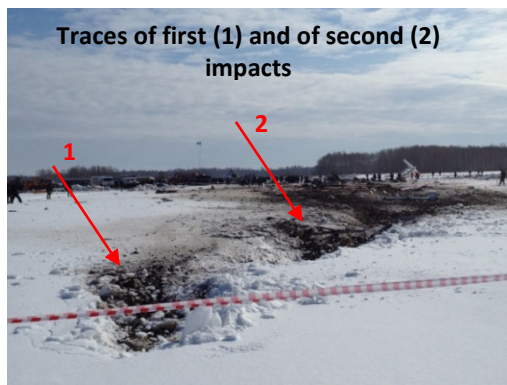
The initial ground impact was with the LH outer wing and resulted in the outer wing destruction. The initial impact “spot” dimension is 1.6 x 4 m.

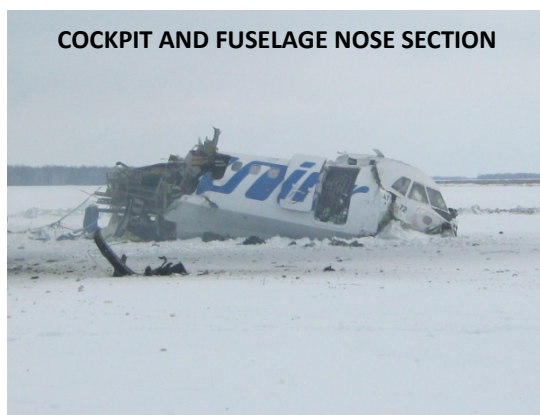
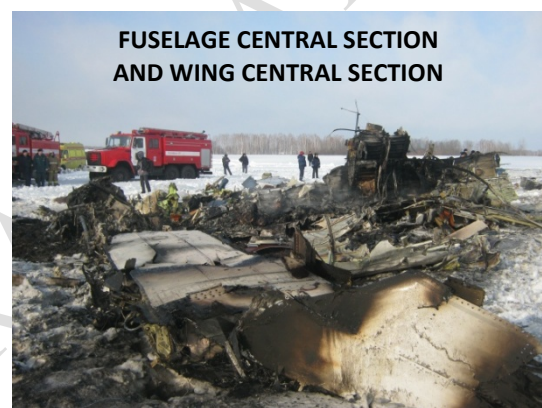
At the point with coordinates N 57°09.428' E 65°16.020' the A/C fuselage hit the ground that resulted in the fuselage breaking into three major parts (cockpit with the fuselage nose section [further FNS], fuselage central section [further FCS] with wing central section, and fuselage rear section [further FRS]) that continued their travelling within the sector from 80° to 110°.

Cockpit with FNS was located at 134 m from the A/C initial impact point. The fuselage major damage, namely deformation, are along the fuselage LH side, and this evidences that the A/C collision first occurred with the fuselage left nose section. This is also evidenced by the absence of the left door that was found about 50 m before the FNS. The FNS did not show any evidence of fire.

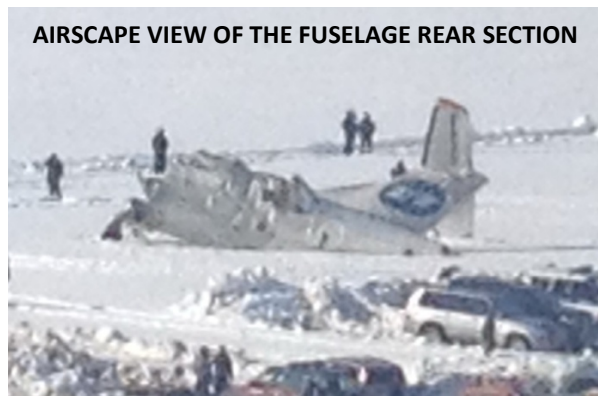
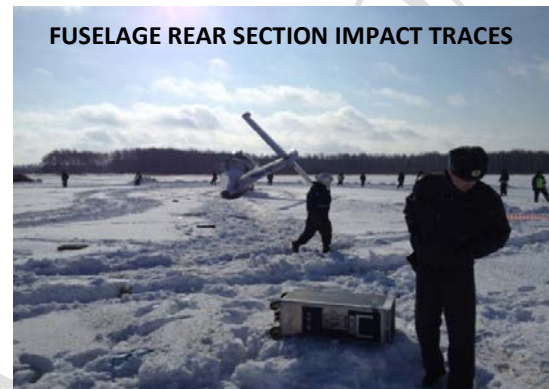
The FRS, as the result of significant A/C ground impact, separated from the FCS near the LH fr. 32 and the RH fr. 31 up to fr. 48.

Approximately 25 m after the initial ground impact point a trace of RH elevator horn ground impact can be seen (coordinates: N 57°09.411' E 65°16.075'); further the FRS continued its in-air traveling heading  $MH \approx 110^\circ$  followed by ground collision. The FRS was located 173 m from the A/C initial ground impact point and 39 m to the right from the general direction of the A/C fragments traveling.

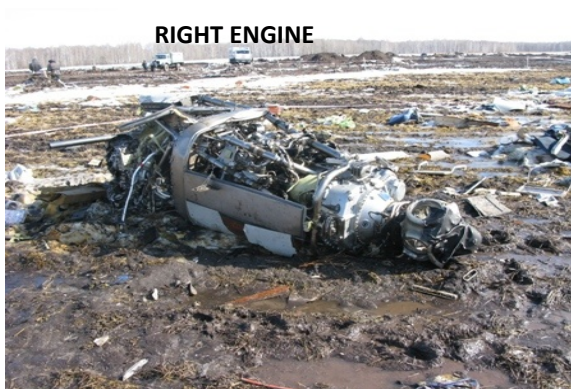
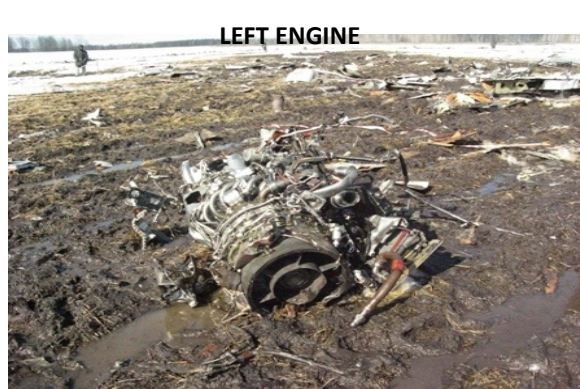
During A/C destruction and its' fragments on ground movement, the engines were torn off their mounting places. The LH engine was located 93 m from the A/C initial ground impact point along the trajectory and 10 m to the right from the general direction of the A/C fragments traveling. The RH engine was located 79 m from the A/C initial ground impact point along the trajectory and 15 m to the right from the general direction of the A/C fragments traveling. The A/C rotor blades showed the deformation and destruction that is representative for the engines being in operation.

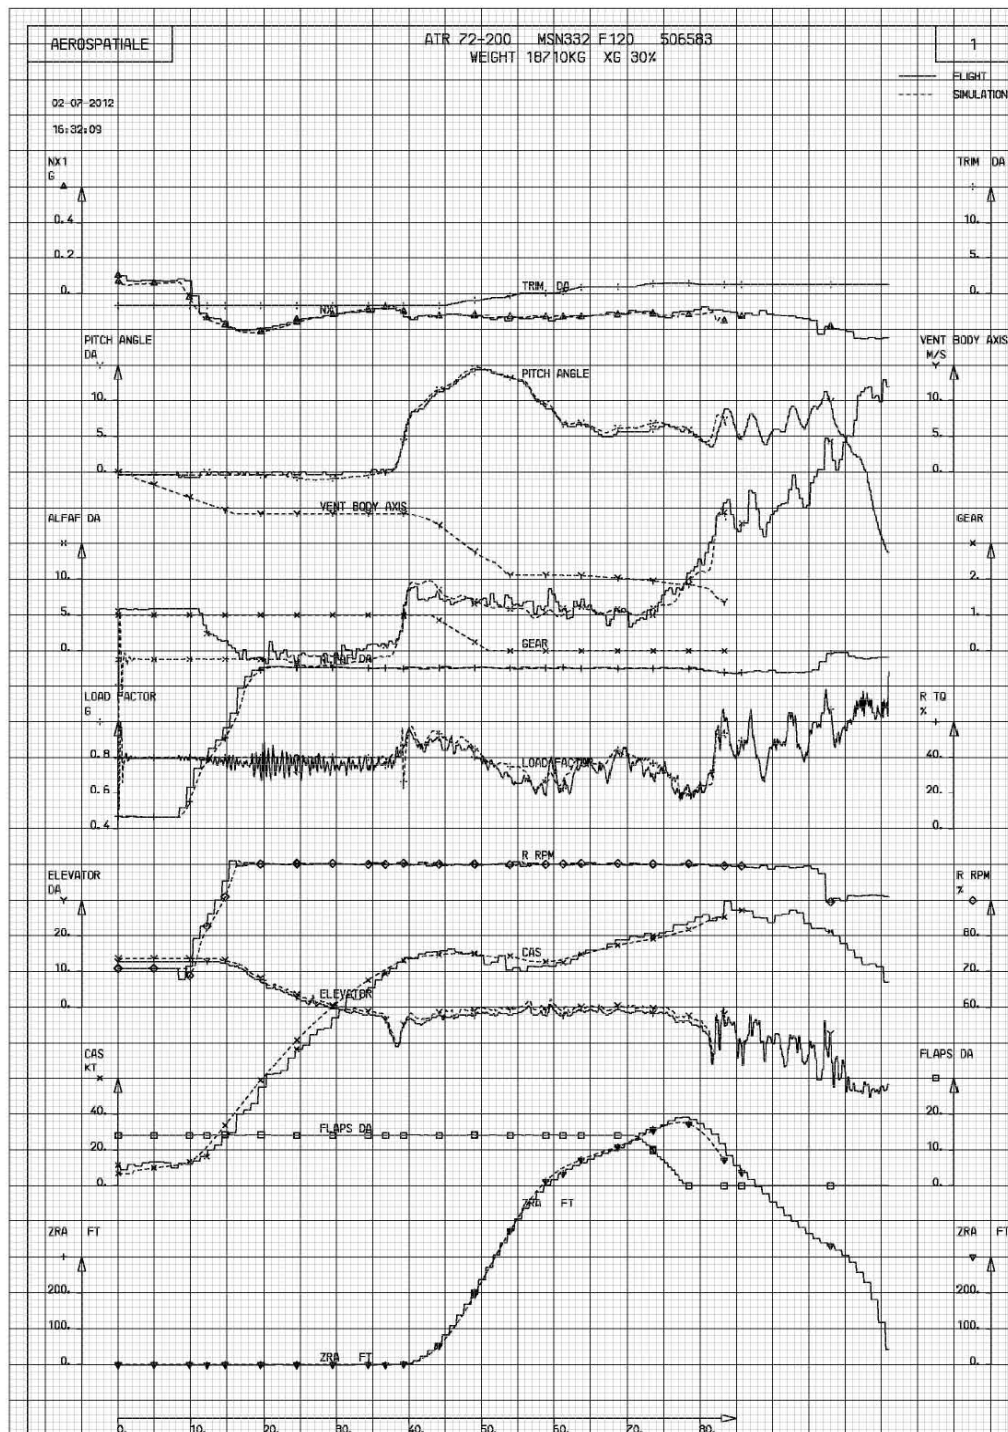
**Figure 435. Simulation compared to FDR Flight UTA-119 – with extra drag and lift**

The simulation revealed that during the takeoff run at angle of attack near  $0^\circ$ , a loss of lift and an increase of drag were  $\Delta CL_0 = -0.23$  and  $\Delta CD_0 = 0.05$  (Figure 46). The graph analysis shows that at that phase of flight CL was reduced by approximately 25%, while drag was doubled. Further after the landing gear retraction the loss of lift remained more or less constant, while the drag increased with angle of attack, providing a  $\Delta CD_0 = 0.064$  (Figure 46). After the flaps retraction the loss of lift still remained almost constant, while the drag increasing was  $\Delta CD_0 = 0.05$  (Figure 47).
