Collision with water involving de Havilland Canada DHC-2, VH-NOO

Jerusalem Bay (Hawkesbury River), New South Wales, on 31 December 2017

ATSB Transport Safety Report

AO-2017-118

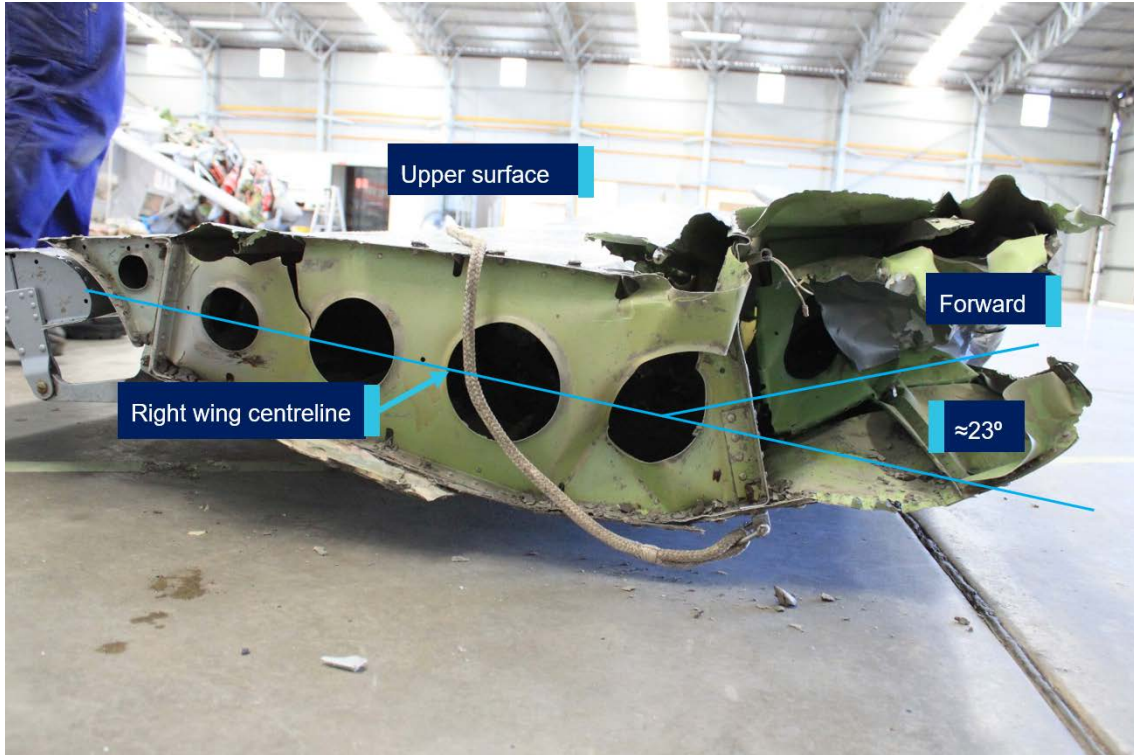
Figure 22: Right wing tip leading edge deformation (view from outboard)

- The right wing tip leading edge impact damage indicated a considerable upward pressure relative to the wing chord on impact. The wing tip indicated deformation of approximately 23° upwards (Figure 22).³²

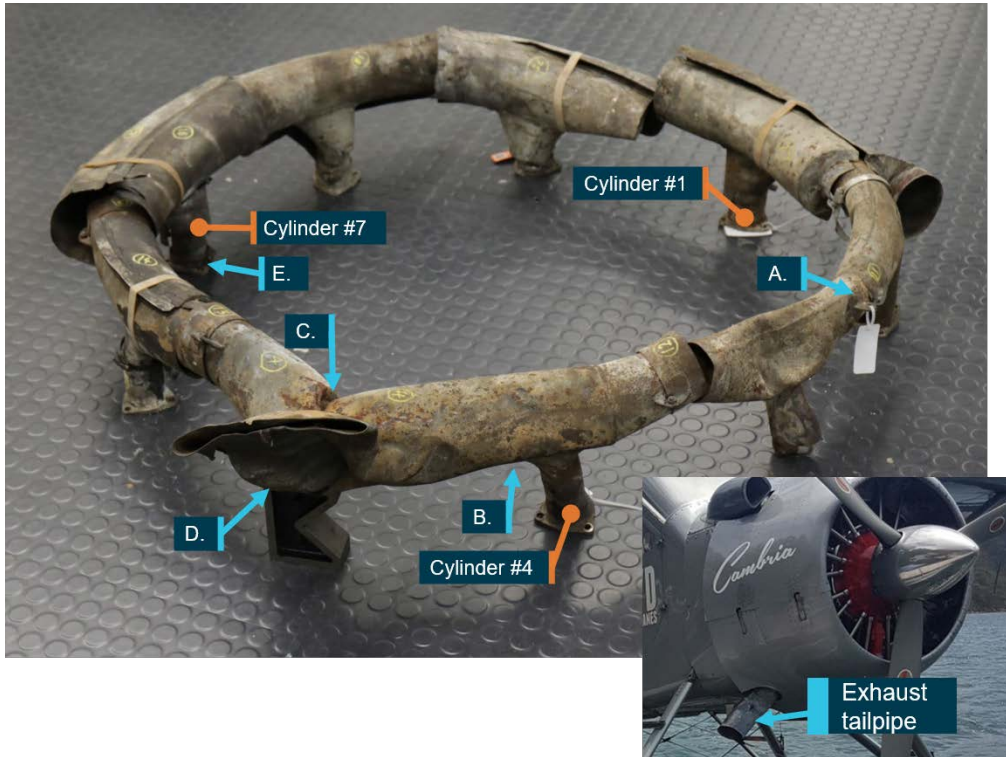
Figure 25: VH-NOO exhaust segments and location of exhaust tailpipe on aircraft (inset)

Note: Image includes carburettor heat muff. Cylinders numbered clockwise. Labels A through E shows location of fractures examined.
 Source: ATSB and passenger, annotated by the ATSB

The Y-segment (D) had been repaired or re-manufactured, but the extent to which the repairs may have influenced the observed cracking could not be determined. Further, it was worth noting that the extent of the exhaust deformation meant that all of the cracks identified were wider (more ‘open’) than they would have been pre-accident.

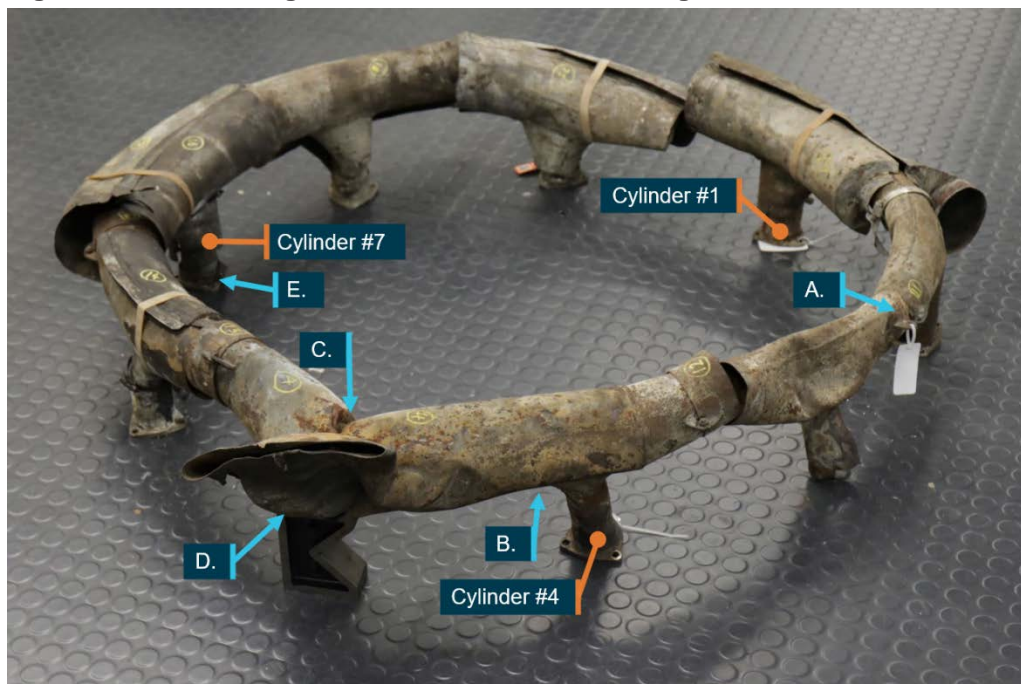
Figure 47: Exhaust segments from VH-NOO, including carburettor heat muff

Note: Cylinders numbered clockwise. Labels A through E shows location of fractures examined.
Source: ATSB
