# **Final Report No. 1980 by the Aircraft Accident Investigation Bureau**

concerning the serious incident  
to the AVRO 146-RJ100 aircraft, HB-IXU  
operated by Swiss European Air Lines AG  
under flight number LX 1105  
on 12 December 2006  
approx. 20 km north of Kempten (D), FL 200

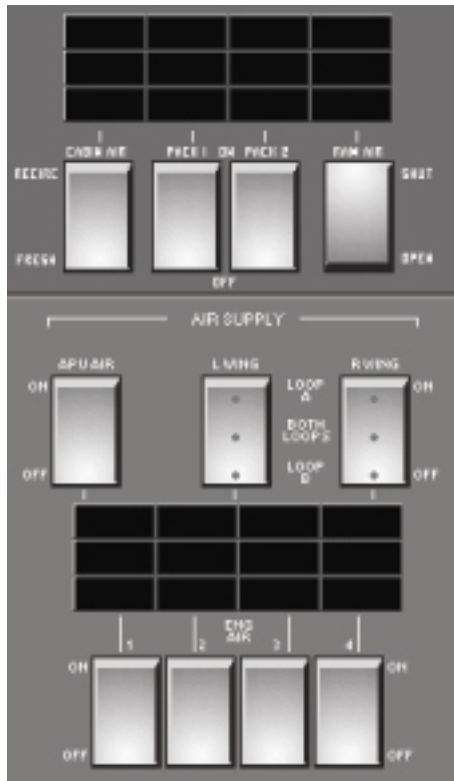
## Annex 1: Switch panel for the AVRO 146-RJ pneumatic system

In the meantime, the commander had realised that there was another aircraft ready to taxi behind HB-IXU. According to his statement, the crew allowed themselves to be put under time pressure as a result of this. Subsequently, after resuming the after engine start checklist, they omitted to switch on both packs of the air-conditioning and cabin pressurisation system (Annex 1).

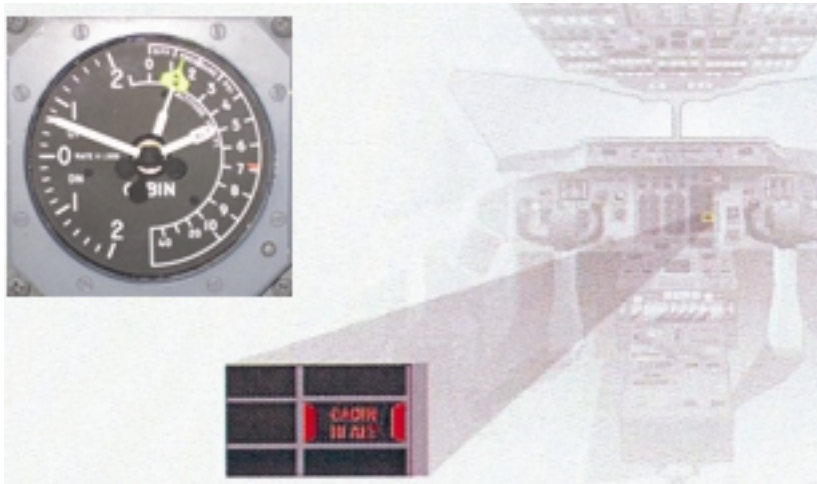
## Annex 2: Triple instrument and warning annunciator CABIN HI ALT

According to his information, the commander thought he had read off a cabin altitude of approximately 10 000 ft at this time. The flight crew were astonished that the warning had failed; it should have been triggered at a cabin altitude of  $9300 \pm 300$  ft. This warning consists of two red flashing lights (attention getters), a red CABIN HI ALT annunciator (Annex 2) and a repetitive triple chime (audible warning).

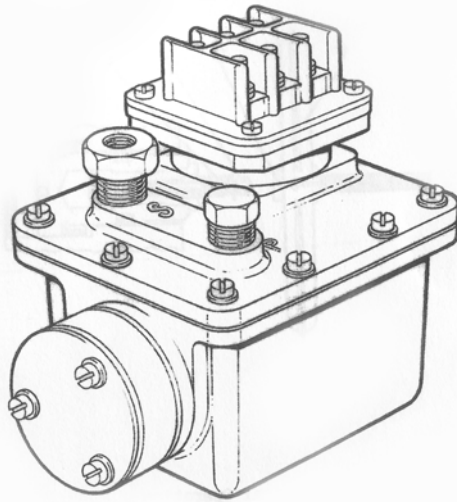
Fig. 1: External view of the cabin altitude warning switch

The serious incident was not caused by a technical fault but by a manipulation which was omitted by the cockpit crew. However, a defective cabin altitude warning switch did prevent the cockpit crew from being warned when the cabin altitude exceeded the value of 9300 ft  $\pm$  300 ft.

- The aircraft was licensed for air transport.
- The cabin altitude warning switch was defective and was unable to trigger the CABIN HI ALT warning.
- The cabin altitude warning switch was last checked on 4 October 2001.
- The next functional check on the cabin altitude warning switch was scheduled for 30 May 2007.
- The cabin altitude is not recorded on the DFDR.

As a result of the recent incidents where the cabin altitude warning switch failed to operate when required a review was carried out by the manufacturer. The outcome of this review is to change the maintenance review board report - MRBR to have the first function check carried out at 15 000 cycles with repeat checks at 5000 cycle intervals. This change will be promulgated through the MRB process with presentation to the associated working group in March 2008.
